Rail Accident Investigation Branch

# Rail Accident Report

## Collision at Aviemore station on the Strathspey Railway 29 September 2023

Report 09/2024  
September 2024

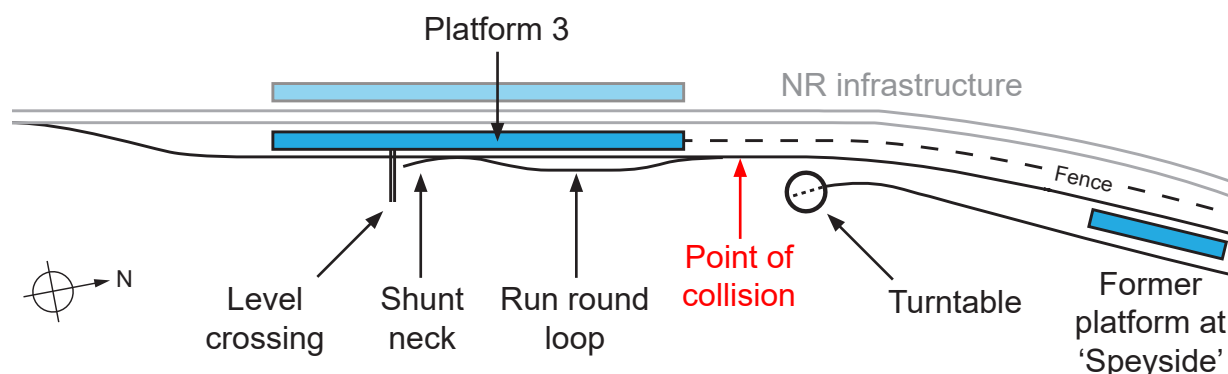
Figure 3: Track layout.

- 9 The movement of Flying Scotsman from the Speyside platform towards Aviemore station was under the authority of a 'calling-on signal' (a subsidiary signal which allows a train to enter a section of line occupied by other rail vehicles). This meant that, at the time of the accident, the locomotive was being moved on the 'line-of-sight' principle. In this situation, it is the responsibility of a train's driver to ensure that the railway ahead is clear of obstructions. A stop board is located between the Speyside platform and Aviemore station. This is no longer part of the system used for controlling trains but is still used as a location landmark by drivers.

## The sequence of events

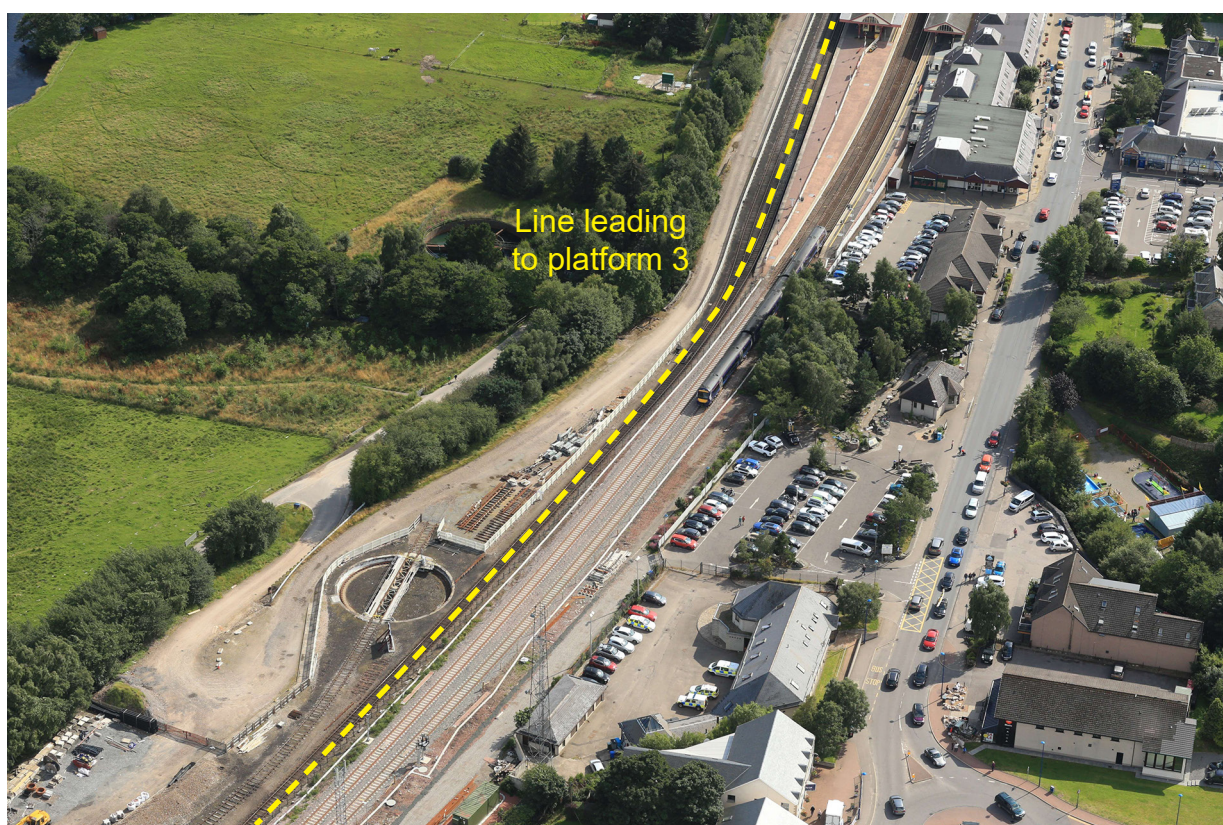
Figure 9: Aviemore station and features north of Aviemore (turntable and track leading to it) (courtesy of Network Rail).

74 The track through platform 3 at Aviemore station is straight but, north of the platform, it starts to curve to the east, with the tightest curvature immediately north of the platform (figures 3, 6 and 9). The curve then eases towards the disused platform at Speyside.

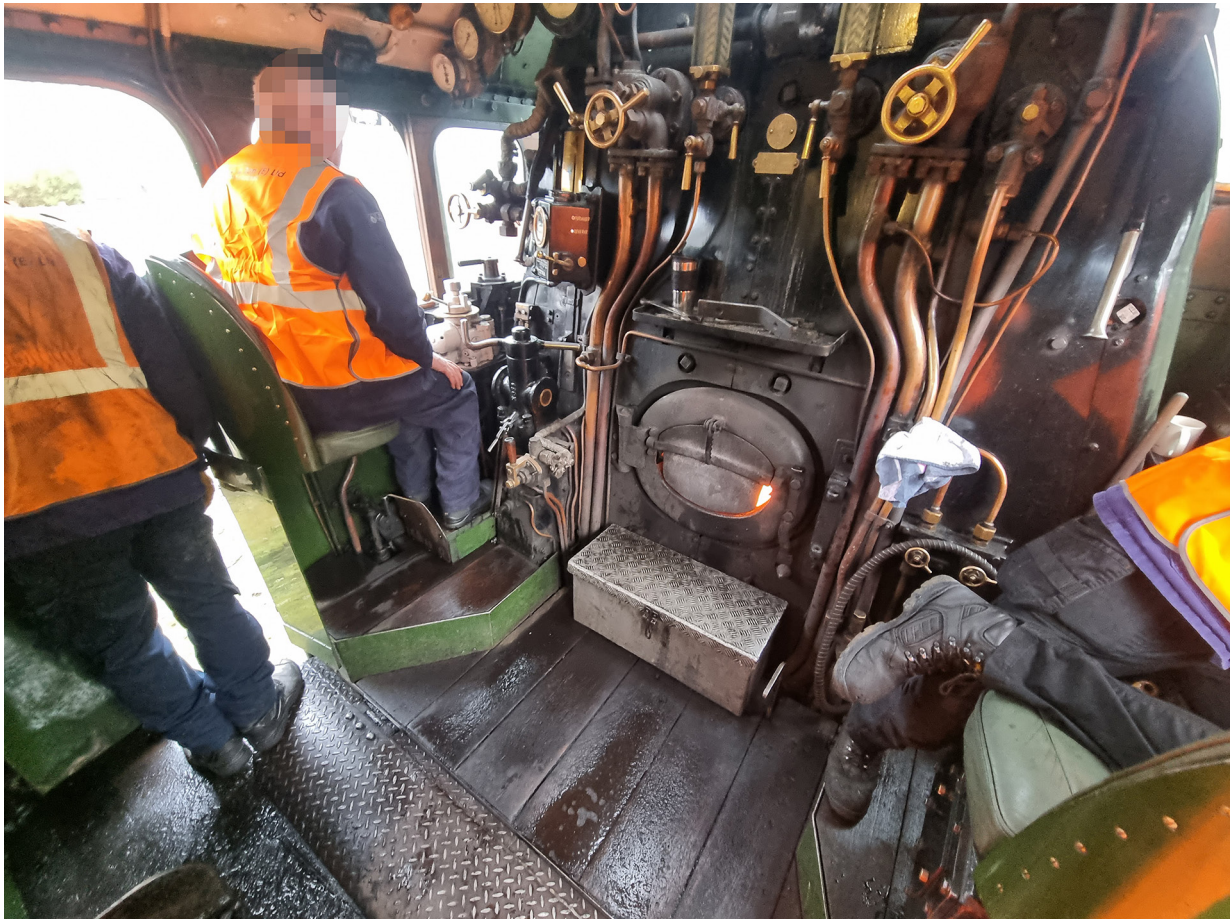
Figure 10: Driver at the controls, with fireman’s seat on the right.

75 At the time of the accident, the locomotive was moving in the reverse direction, with the tender leading. This meant that the driver needed to turn to look behind them to see the line ahead, while using the driving controls. The reconstruction undertaken by RAIB (paragraph 73 and figure 8) showed that the tender restricts the driver’s view ahead when the locomotive is operating with the tender leading and approaching a left-hand curve.
