Fatal man overboard from the sail training vessel *Pelican of London* at Sharpness, England on 2 October 2023

SUMMARY

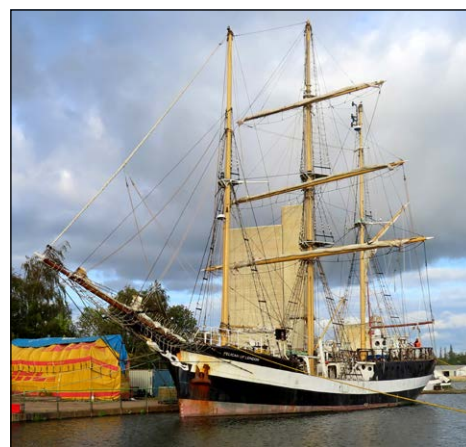
Figure 1: The accident location

At 0803² on 27 September 2023, the sail training vessel *Pelican of London* moored starboard side to at Sharpness shipyard (**Figure 1**) for maintenance and repair ahead of a planned dry-docking on 4 October. Shortly after arrival the vessel's master departed without relief, leaving the chief mate to run the maintenance period. Later that day, holding off lines were rigged and adjusted to keep the ship from touching the sides of the dock and the gangway was also moved to align with a gap in shoreside safety barriers. On 28 September, a volunteer joined *Pelican of London* to act as relief cook while the permanent cook was away on training courses and leave.
