AAIB Bulletin

9/2024

Boeing 767-332(ER)	N197DN	10-Feb-23	3
--------------------	--------	-----------	---

Aircraft Type and Registration:	Boeing 767-332(ER), N197DN	
No & Type of Engines:	2 Pratt & Whitney PW4060 turbofan engines	
Year of Manufacture:	1997 (Serial no: 28454 LN: 683)	
Date & Time (UTC):	10 February 2023 at 1130 hrs	
Location:	Prestwick Airport	
Type of Flight:	Commercial Air Transport (Passenger)	
Persons on Board:	Crew - 10	Passengers - 211
Injuries:	Crew - None	Passengers - None
Nature of Damage:	Contained engine failure, fractured water drain tube	
Commander's Licence:	Airline Transport Pilot's Licence	
Commander's Age:	62 Years	
Commander's Flying Experience:	21,000 hours (of which 12,000 were on type) Last 90 days - 180 hours Last 28 days - 50 hours	
Information Source:	AAIB Field Investigation

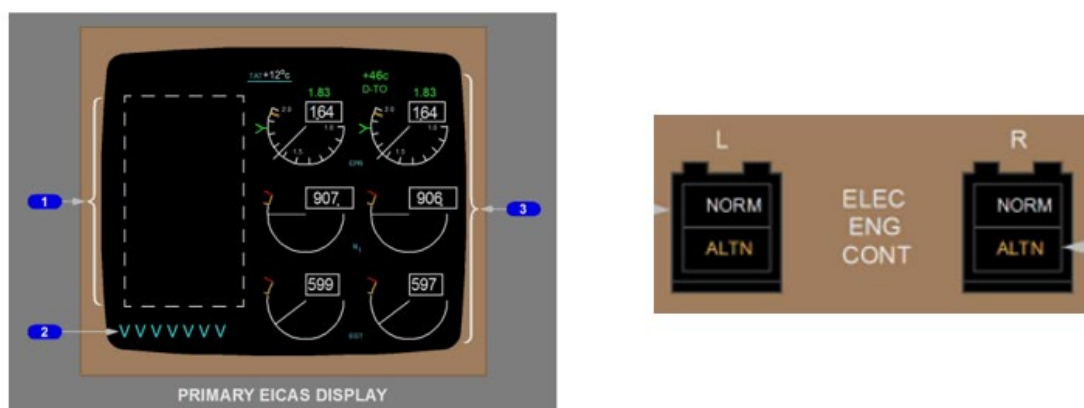
Figure 1

Soon after the flight crew set climb power³, the autothrottle disconnected, the right Electronic Engine Control (EEC)⁴ alternate mode light illuminated (Figure 1 right), and the Engine Indicating and Crew Alerting System (EICAS) advisory message R ENG EEC MODE appeared⁵ (Figure 1 left). The commander announced an “OVERTEMP⁶ ON THE RIGHT SIDE”.

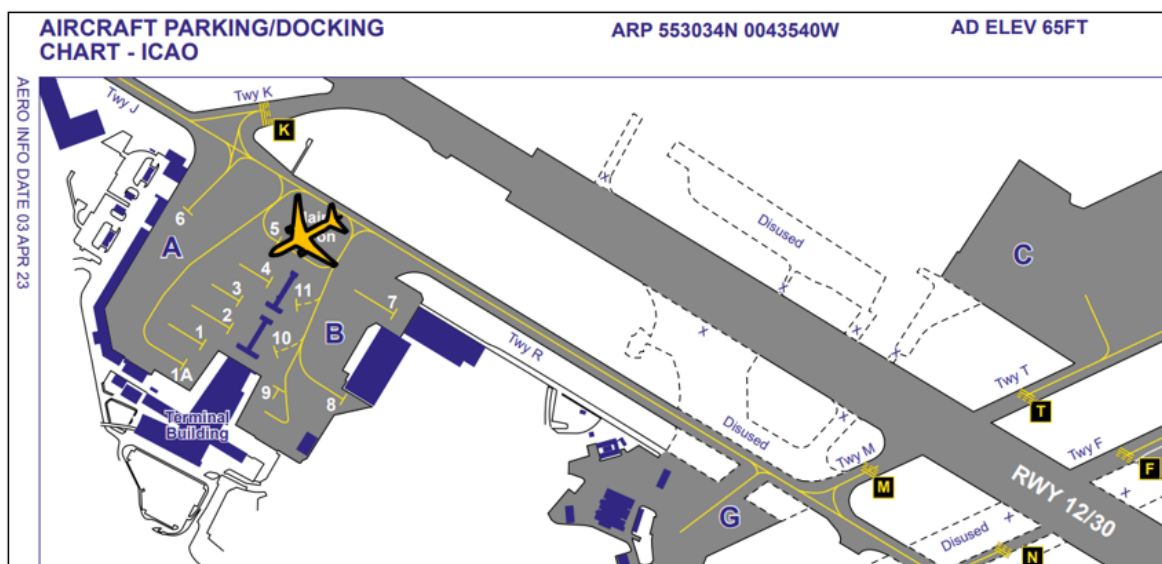
Figure 3

The aircraft landed at 1131 hrs with wind from 210° at 16 kt, and wet runway conditions. While vacating Runway 30 onto taxiway Kilo, the commander requested the AFS vehicles to follow them to Stand 5 (Figure 3). The flight crew reported noticing then that the right engine’s primary indications read zero. The commander said “LOOK... I THINK THE RIGHT ENGINE FAILED WHEN WE LANDED”, before selecting its fuel control switch to CUT OFF and requesting the ‘*After landing checklist*’.

Aircraft location (aircraft not to scale)

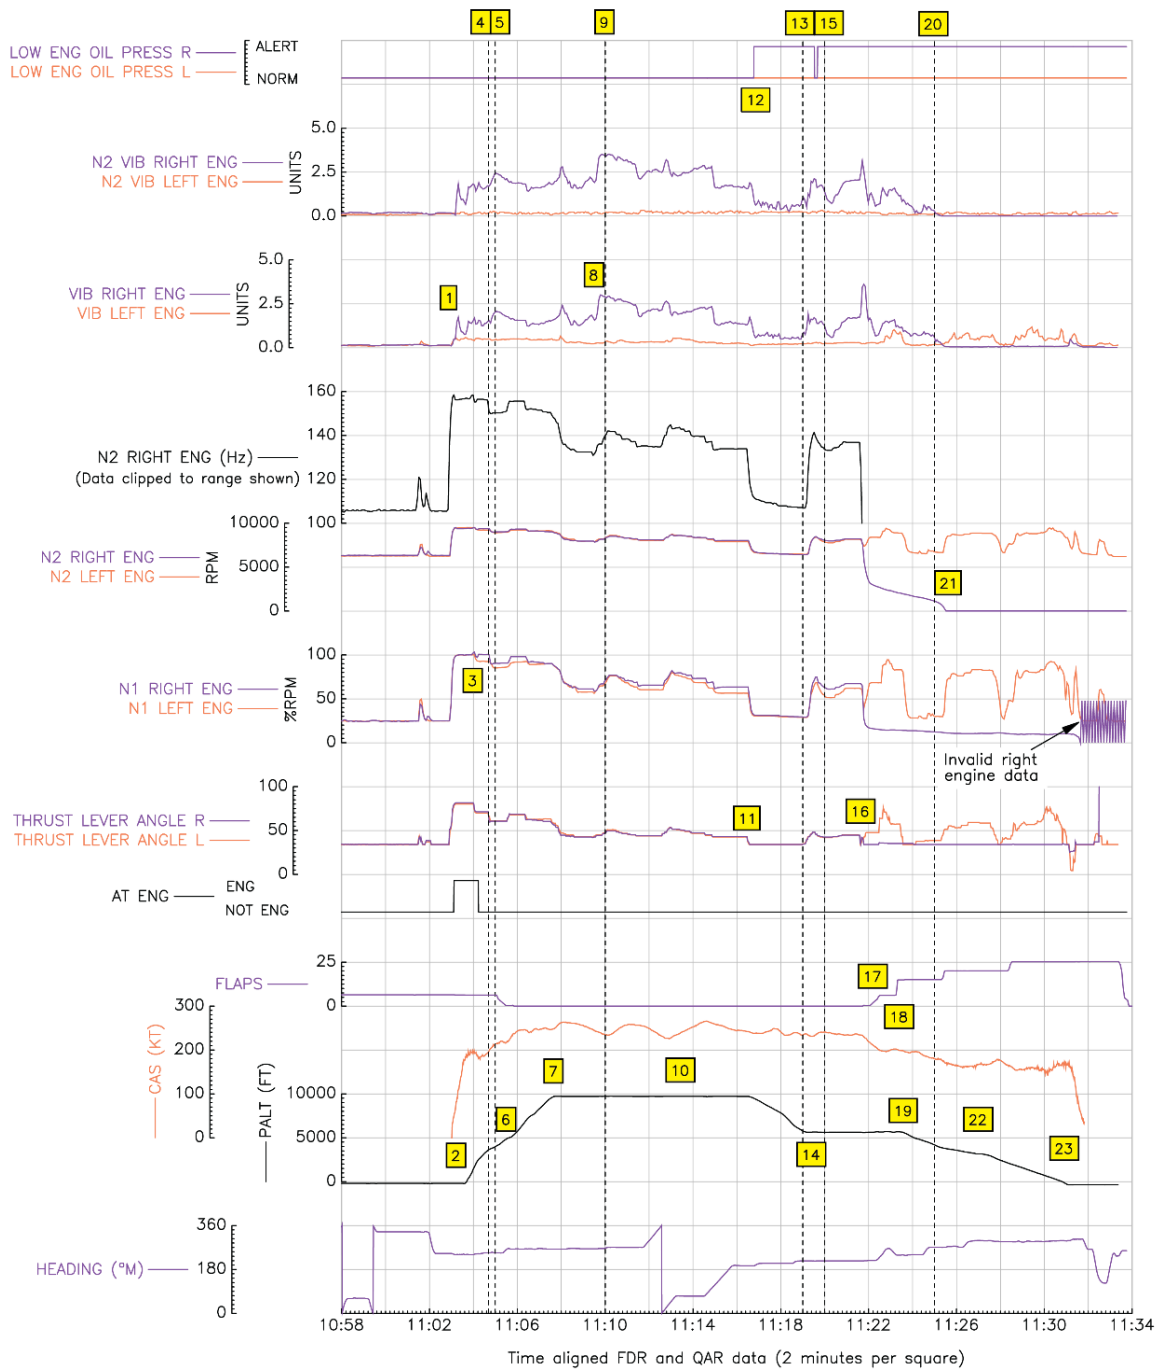
Figure 5

Selected data from the FDR, QAR and ACARS are shown in Figures 5 and 6. The aircraft engines were throttled up for takeoff from Edinburgh at 1102 hrs on 10 February 2023. There was a step increase in the recorded N2 vibration parameter soon after the engines reached their peak speed for the takeoff, indicating a level of damage was present at that time.

Selected FDR and QAR parameters, ACARS message timings, and marked events (see report text)

12. Right engine oil pressure dropped and an associated alert was generated.
13. The same ACARS maintenance messages were sent.
14. Aircraft levelled at 6,000 ft amsl.
15. An additional ACARS maintenance message was sent relating to the EEC control of the air/oil heat exchanger valve.
16. Right engine throttled back.
17. Flap deployment sequence started.
18. Approximate location of passenger video showing flames.
19. Start of descent from 6,000 ft amsl.
20. ACARS messages were generated. One related to a degraded EEC channel capability, but with sufficient control for time-limited dispatch. Another related to the air/oil heat exchanger and a further two related to a temperature probe.
21. Right engine N2 stopped.
22. Gear down.
23. Landing.

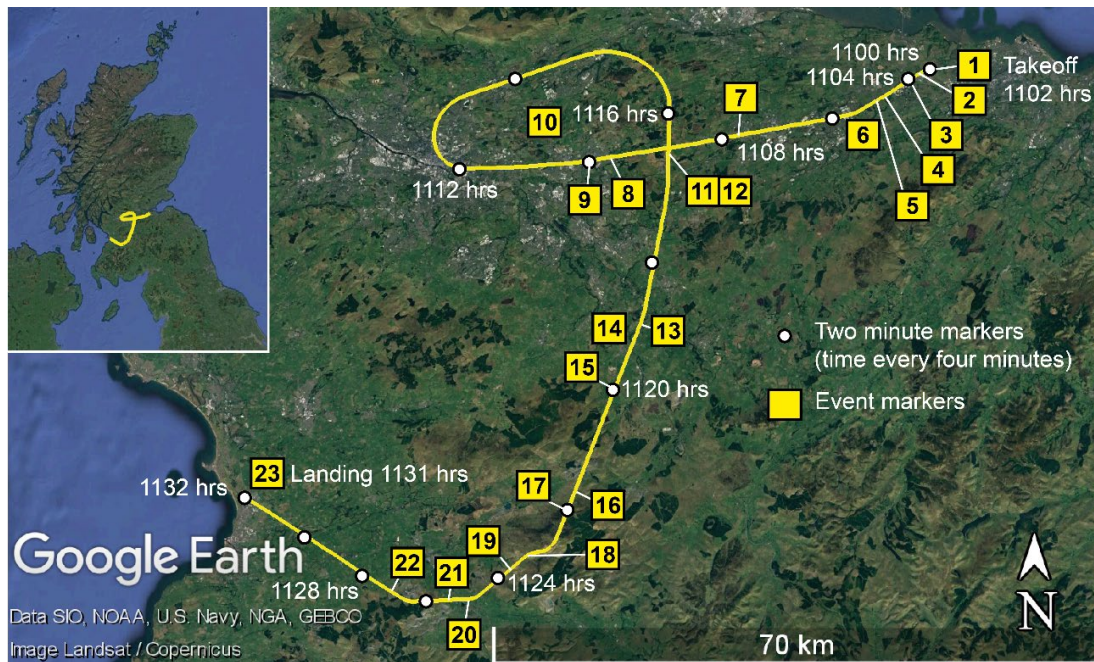
Figure 6

While the aircraft was maintaining 6,000 ft amsl on a long right base leg, the commander throttled back the right engine, which reduced some vibration he had started to notice (Figure 6, point 16). They selected FLAPS 1 (Figure 6, point 17) which briefly generated an abnormal noise on the CVR. The commander commented “THAT’S A BIG VIBRATION”, then requested selection of FLAPS 5. ATC instructed them to turn right onto a heading of 240°, with 21 miles to touchdown. Around this time a passenger videoed what looked like flames coming from under the right wing (Figure 2 and Figure 6, point 18). The commander briefly considered changing to landing FLAPS 20, asking the co-pilot for the associated V_{REF} .

Flight path with marked events (see report text)

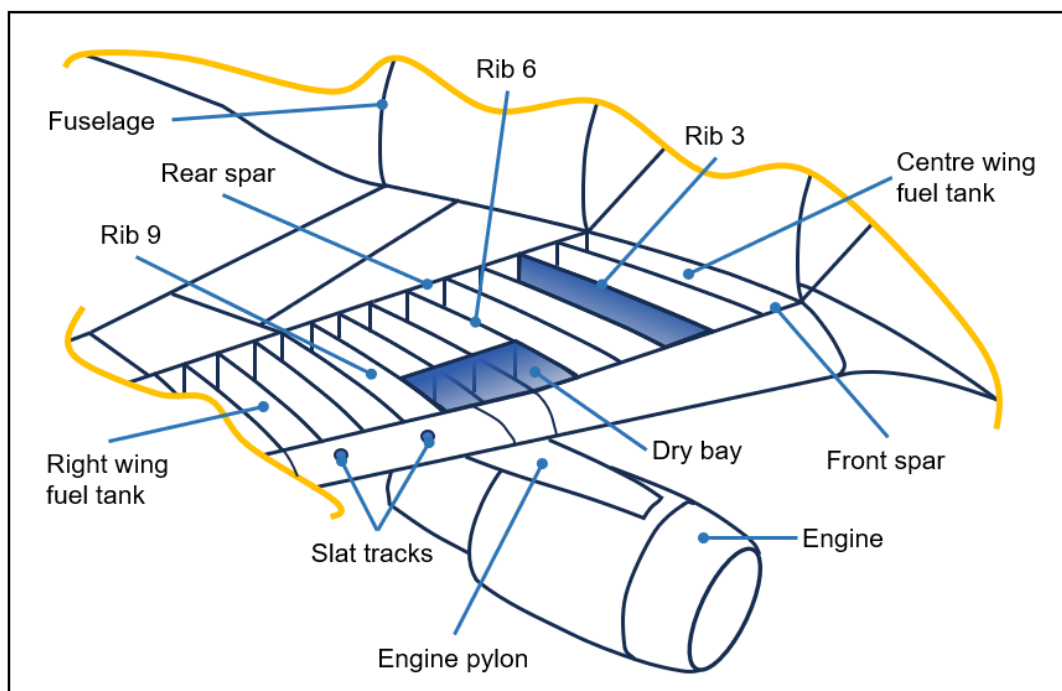
Figure 9

The internal wing structure forms three aircraft fuel tanks: a left and right wing tank with a capacity of 40,000 lbs each and a centre wing tank of 80,000 lbs. The wing fuel tank boundaries are the front and rear spar, upper and lower wing surfaces, and Rib 3 (Figure 9). Located above the engine pylon within the fuel tank boundary is a separate zone called the dry bay, which is sealed and does not contain fuel. It spans from Rib 6 to Rib 9 and is a safety feature in case of an uncontained engine rotor failure. Analysis has identified that high energy engine fragments could penetrate the wing in this area and therefore it is kept free of fuel to prevent a fuel leak. It has a drain hole at the lowest point to remove any condensation or other fluids that may collect in the bay and a removal access panel to facilitate inspections (Figure 10).

Wing scheme showing dry bay location.
(Upper and lower wing surfaces not shown for clarity)

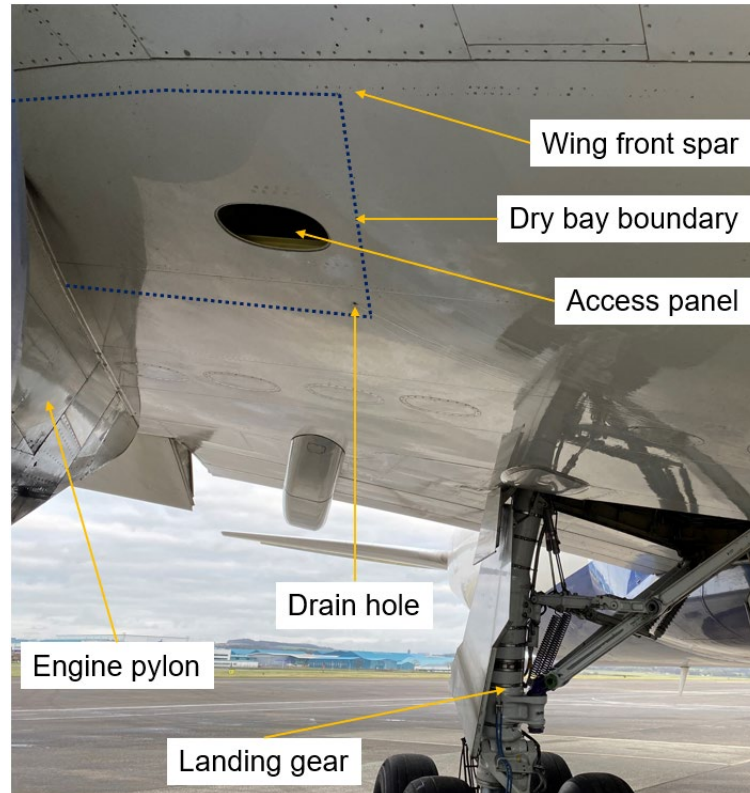
Figure 10

Dry bay viewed from outside the aircraft looking aft
(Note: Access panel removed after flight)

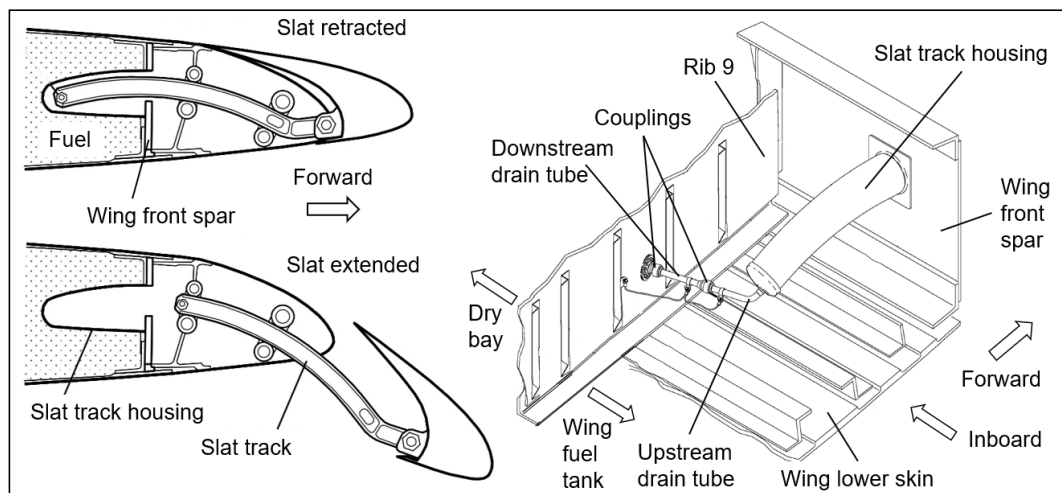
Figure 11

The wing leading edge slats extend and retract on tracks supported on rollers (Figure 11). In the retracted position the slat track protrudes through the front spar into the fuel tank. To maintain the fuel tank boundary, a slat track housing is attached to the inside of the front spar into which the track retracts. It is fitted with a drain tube to allow any fluids from the environment to drain out of the housing. If water were allowed to accumulate in the bottom of the housing and then freeze, there is a risk that the slat tracks could damage the housing, resulting in a fuel leak.

Generic slat track function (left) and the B767 inboard slat track housing (right)

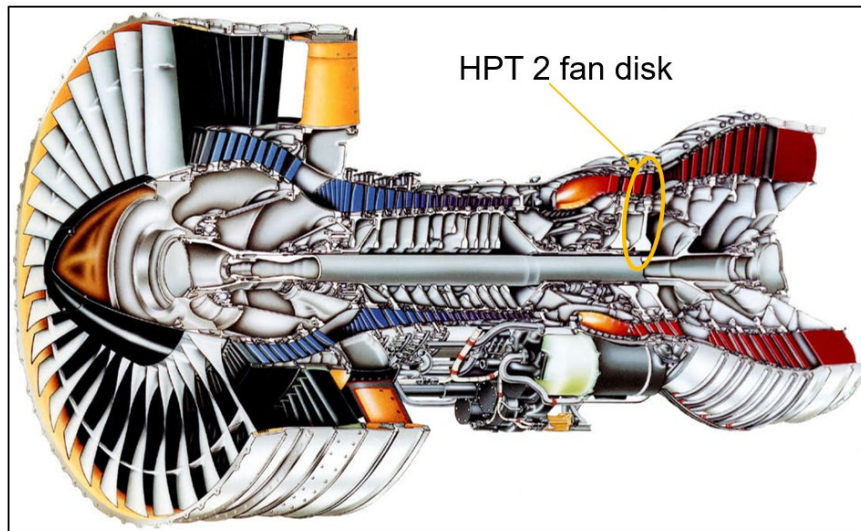
Figure 12

N197DN was fitted with two Pratt & Whitney PW4060 turbofan engines, and the engine installed on the right wing was serial number ESN 724314. It had accumulated a total of 90,814 hours and 15,560 cycles in operation with 1,862 hours and 331 cycles since its last maintenance shop visit. It is a conventional two shaft turbofan with a two-stage high-pressure turbine (HPT) section (Figure 12). The second stage HPT disk (HPT 2) has 82 blades and a 100% rotation speed of 9,900 rpm.

Section view of PW4060 engine showing HPT 2 disk (used with permission)

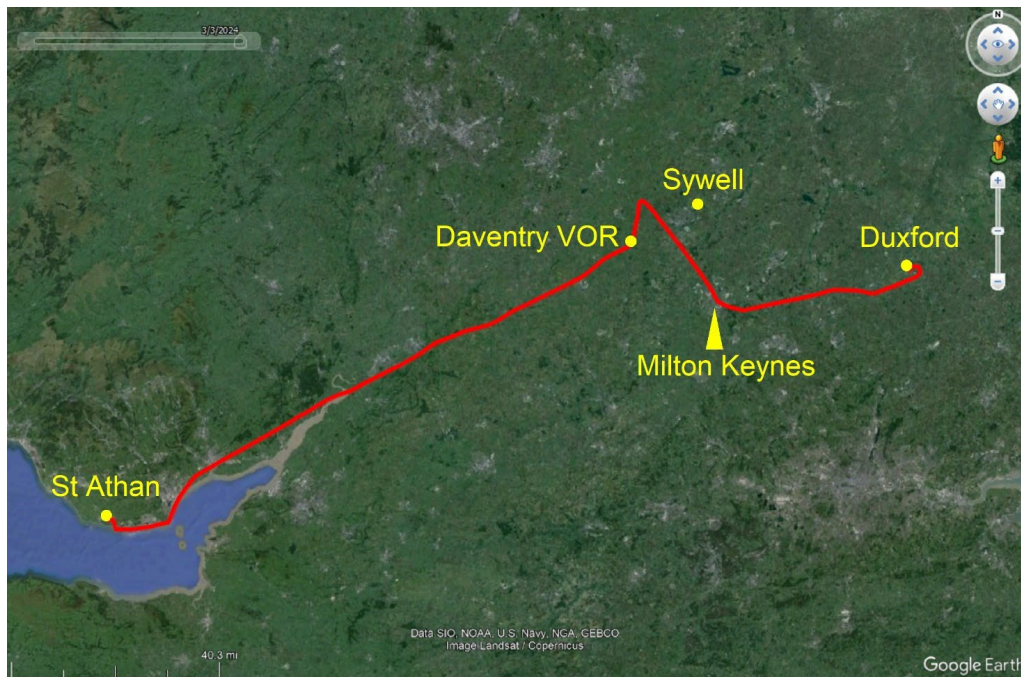
G-AZCZ commenced taxiing at 1100 hrs and took off 13 minutes later. Figure 1 provides the track of the aircraft during the flight. The aircraft climbed to 5,000 ft amsl and, as it approached Cravens Gorse hang glider site located to the east of Gloucestershire Airport, it climbed to 5,500 ft amsl. After passing Cravens Gorse, the aircraft descended to 3,800 ft and levelled off. When it was overhead the Daventry VOR the pilot altered course towards the north and contacted Sywell. The weather had not improved as anticipated and the pilot subsequently altered course towards the south, flying over Milton Keynes before turning east to Duxford, where it landed at 1248 hrs. The flight time was 1 hour 35 minutes, and the flight distance was 170 nm. During the flight the pilot stated that he had leaned the engine mixture and alternated regularly between the left and right fuel tanks; he did not operate the aircraft with the tanks set to both.

GNSS flight track from St Athan to Duxford
(©SIO NOAA U.S Navy, NGA GEBCO, Image Landsat / Copernicus)
