Rail Accident Investigation Branch

Rail Accident Report

Overspeed at Spital Junction, Peterborough 4 May 2023

Report 10/2024
September 2024

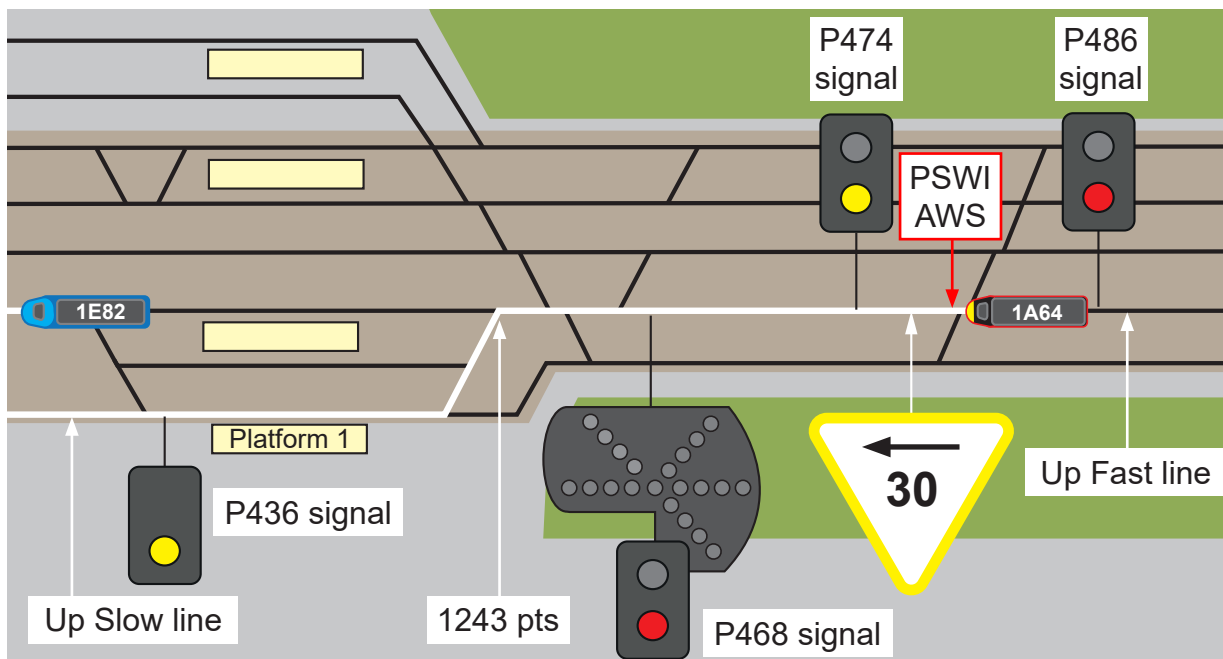
58 At 12:57:00 hrs, train 1A64 reached the inhibition point for flashing aspects (paragraph 38), meaning that the signalling control for P468 signal reverted to being approach released from red (figure 14).

Figure 14: Train 1A64 reaches the inhibition point for flashing aspects at 12:57:00 hrs. The signaller then requested the route for train 1A64 from P468 signal 16 seconds later.

- 95 However, displaying flashing yellow aspects is conditional upon the location of the train approaching the signals and the status of the route set beyond P468 signal (paragraph 37). Because of the proximity of train 1A64 to P468 signal, and because the route beyond the signal had not at that time been set (paragraph 58), the signalling was configured approach released from red. In this state, flashing aspects on P486 and P474 signals were inhibited and no flashing aspects were shown to the driver of train 1A64 as they approached the diverging route.

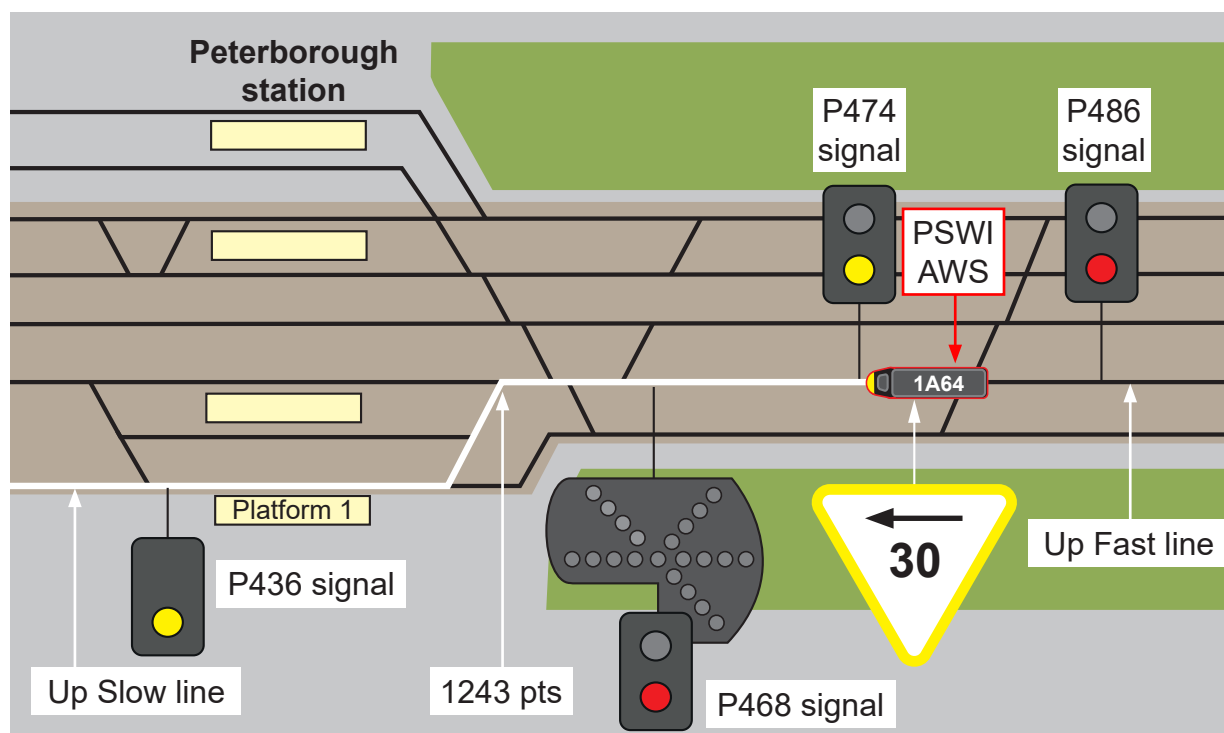
Figure 15: Train 1A64 passes the AWS magnet for the PSWI indicating the maximum permissible speed for the junction to the Up Slow line at 12:57:41 hrs.

- 100 This warning was given to, and acknowledged by, the driver of train 1A64. However, a warning from this AWS magnet is not solely given for a route set, or subsequently set, for the divergence to the Up Slow lines. It is also given to all trains approaching P468 signal, except when a through route on the Up Fast line has been set and other conditions are in place at the time a train reaches the AWS magnet (paragraph 42).

- 101 Therefore, while this AWS warning provided additional information to drivers on the speed of the diverging junction, it is not only given for the diverging route and can be legitimately disregarded by drivers in many operational conditions. This would have been the case on all the driver's previous journeys approaching P468 signal when it was displaying a cautionary or red aspect, as the route beyond had not been set.

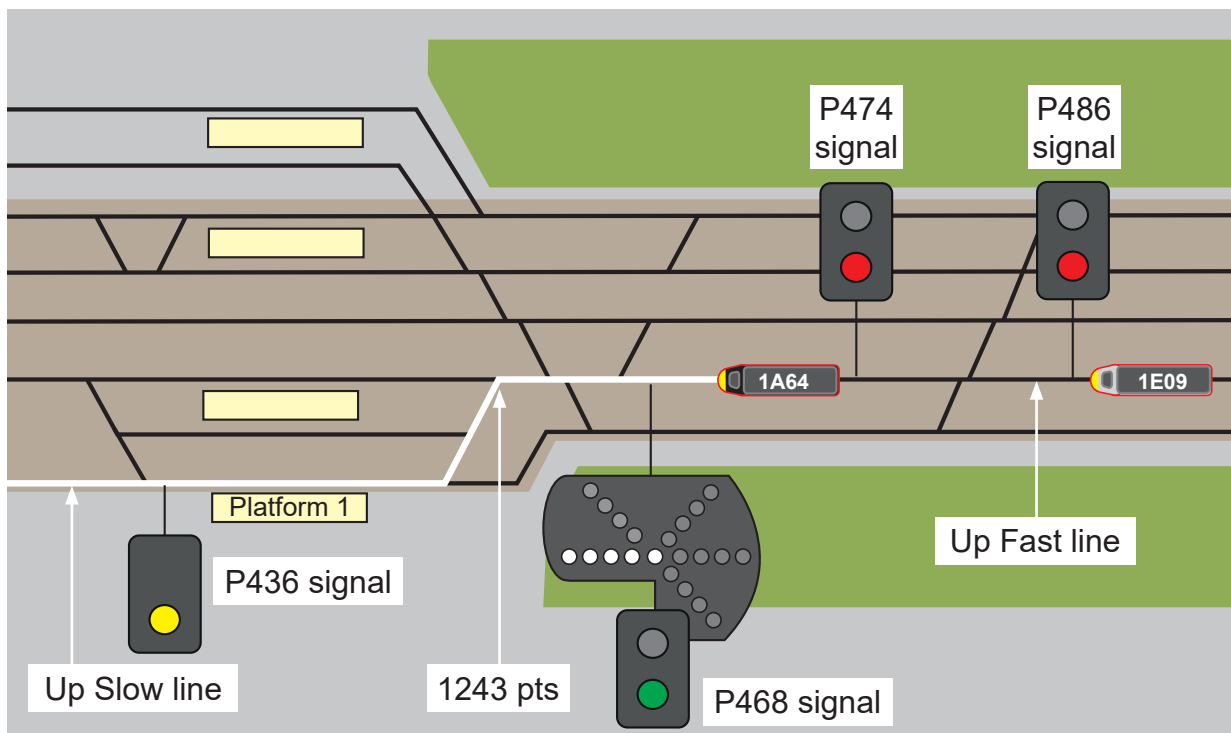
Figure 17: P468 signal is released from a red to a green main aspect with illuminated JI for the Up Slow line, platform 1 at 12:59:08 hrs.

- 81 The incident occurred due to a combination of the following causal factors:
- The driver did not react appropriately to the JI at P468 signal (paragraph 82).
 - The control of speed at this diverging junction is reliant on drivers correctly observing and responding to all signal information at up to 800 metres from P468 signal (paragraph 110).
 - The conspicuity of the signal's JI, and its level of association with the main aspect, may have reduced the likelihood of the driver observing it (paragraph 127).
 - The distance between the location at which the driver observed the main aspect and the diverging junction was sufficient for the driver to accelerate the train to an unsafe speed (paragraph 152).

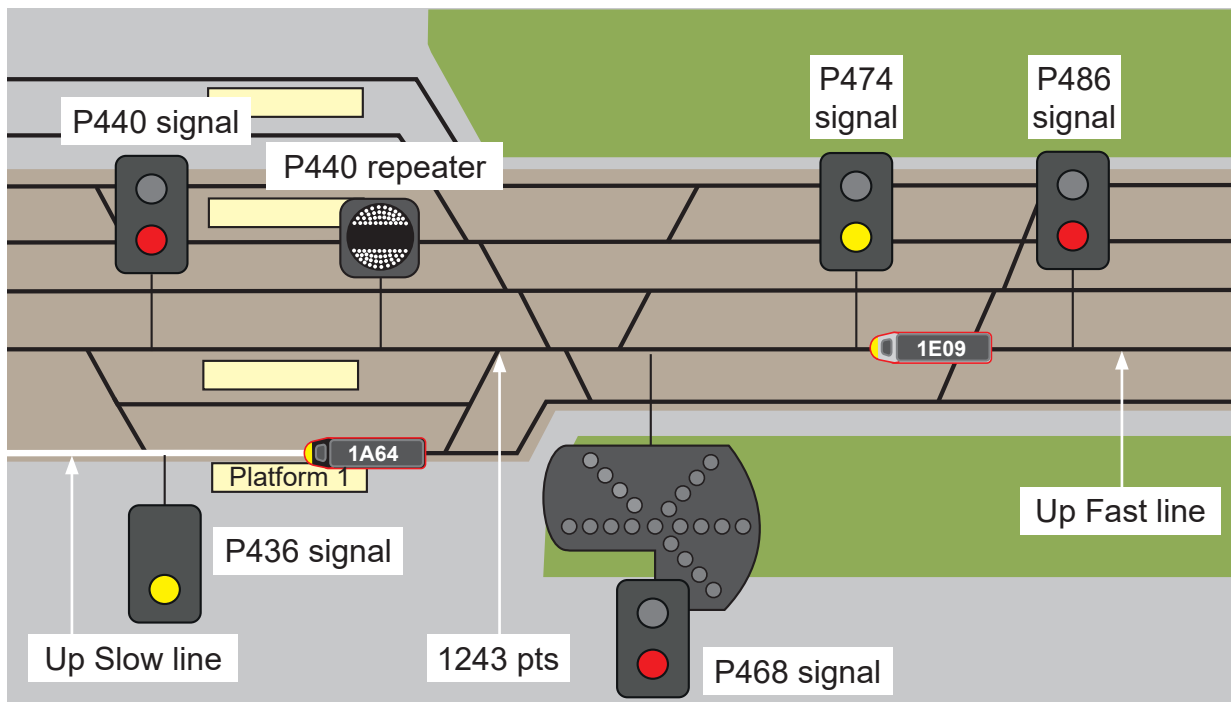
67 The train entered platform 1 travelling at 56 mph (90 km/h), still under emergency braking (figure 21).

Figure 21: Train 1A64 enters platform 1 at 56 mph (90 km/h) under emergency braking.

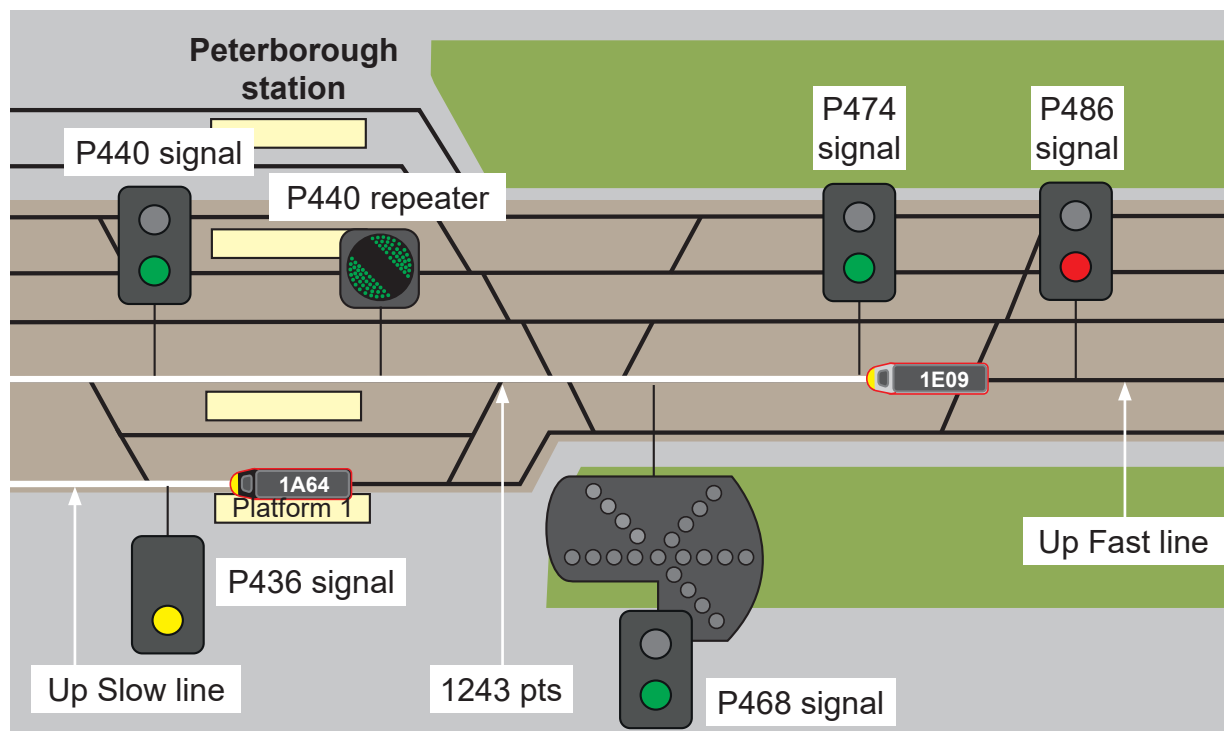
- 68 Train 1A64 came to a stop at 13:00:49 hrs within the limits of platform 1 (figure 22).

Figure 22: Train 1A64 stopped in platform 1.

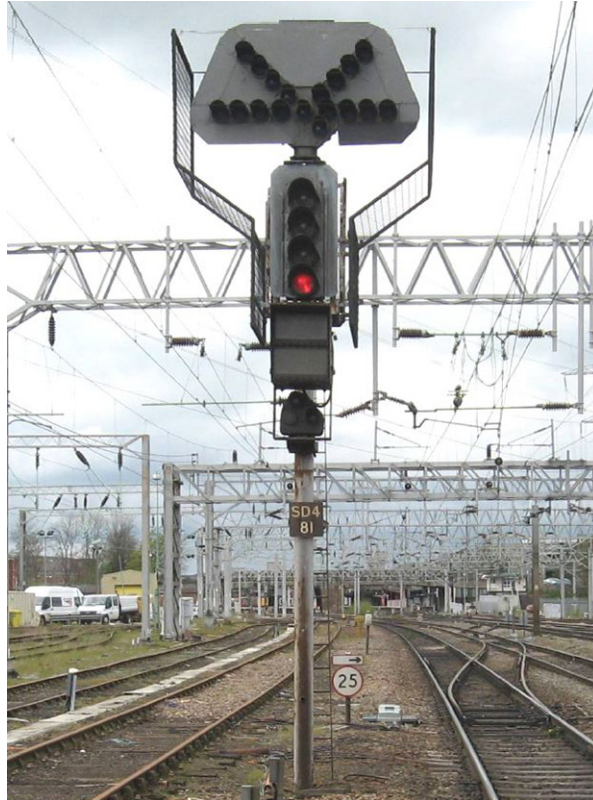
Testing and analysis by RAIB also found that the junction indicator element of the signal may not have been as conspicuous as the main aspect of the signal at the point the driver observed and reacted to the signal. This is a possible factor.

- 134 Filament bulb JIs use four individual light modules meeting BRS SE 156/1 for each route to be indicated. These are arranged around a similar light module, known as the pivot light, which illuminates with all indication positions to give five white lights (figure 23). The Unipart Dorman Mk1 LED JI is similar in design with a pivot light and four LED modules forming each indication. Both types of JI use a cast metal frame to house the light modules and a large backboard to improve contrast to the white light output.

Figure 23: Example of a JI.

The third recommendation is for RSSB to review the standards specifying the relative brightness of main aspects and junction indicators on signals to understand the effects on conspicuity of the complete signal up to the maximum distance at which a signal is required to be readable, to minimise the risk of drivers not correctly reading signals.

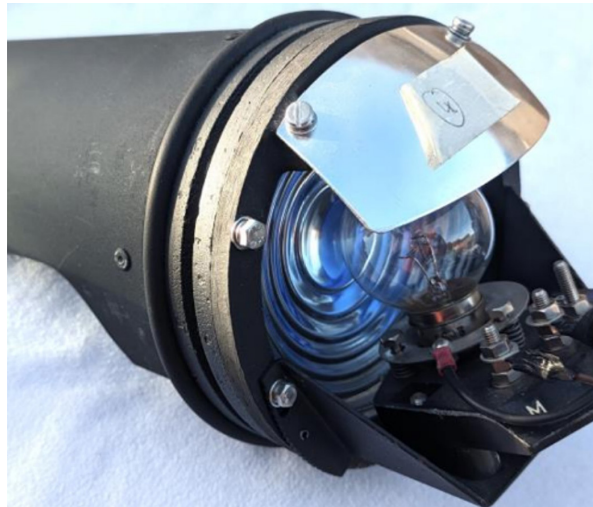
- 135 The BRS SE 156/1 light module uses a traditional filament bulb and glass lens arrangement to focus the light output towards the driver (figure 24). This produces a focused beam, but because of the long thin horizontally aligned filament used in the SL18 bulb, the intensity of the light output is greater in the horizontal axis than it is in the vertical axis when viewed from the front (figure 26a). In contrast, the Unipart Dorman Mk 1 LED light module uses an array of LEDs mounted at the end of a short tube. This provides improved visibility and reduces problems originating from sunlight reflecting directly on the LED (figure 25). The absence of a filament allows the LED light module to emit light equally in both the horizontal and vertical axis (figure 26b).

Figure 24: Bulb and lens module used in filament JIs.

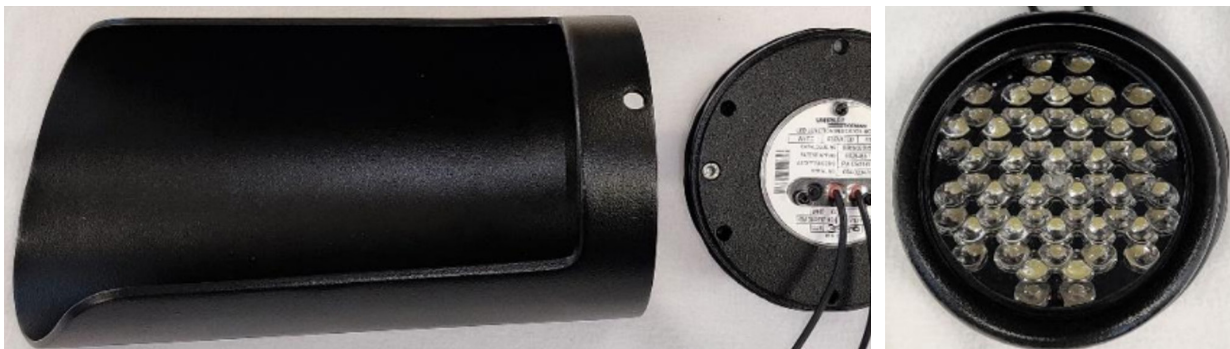
Figure 25: Unipart Dorman Mk1 LED JI module.

- 136 The LED JI light modules were found to be at different alignments within the JI housing, ranging between -0.4 and -2.7 degrees error relative to the designed position within the housing. The pivot light was also found to be installed upside down. These issues are likely to be a consequence of the sample JI having been supplied from one of Network Rail's training centres and is unlikely to be representative of the LED JIs in use. To account for the misalignment, the luminous intensity of all modules was tested 'on-axis' and relative to the light module itself, and not to its position within its housing.

- 137 During testing, the LED JI modules were found to emit a greater luminous intensity when initially illuminated. The luminous intensity reduced as the modules became warmer. Although it is unlikely that the LED JI modules fitted to P468 signal would create sufficient heat to affect the light output during the time they were illuminated for an approaching train, it was necessary to allow the modules to stabilise to enable the testing to take place. When tested, the LED JI pivot light module produced the highest output of 591 cd¹³ initially, which reduced to 403 cd once it had stabilised after 40 minutes (figure 28). The other LED JI light modules produced a light output of between 255 cd and 314 cd when stabilised.

- 138 The measured on-axis luminous intensity of the LED JI modules was significantly lower than the output measured for the BRS SE 156/1 filament bulb module, which was approximately 1,450 cd (figure 27). Although the product acceptance testing verified that an LED JI was readable at the required distance of 800 metres, the testing shows that the output of the LED JI module is significantly lower than the output of the example filament JI module it was intended to replace.

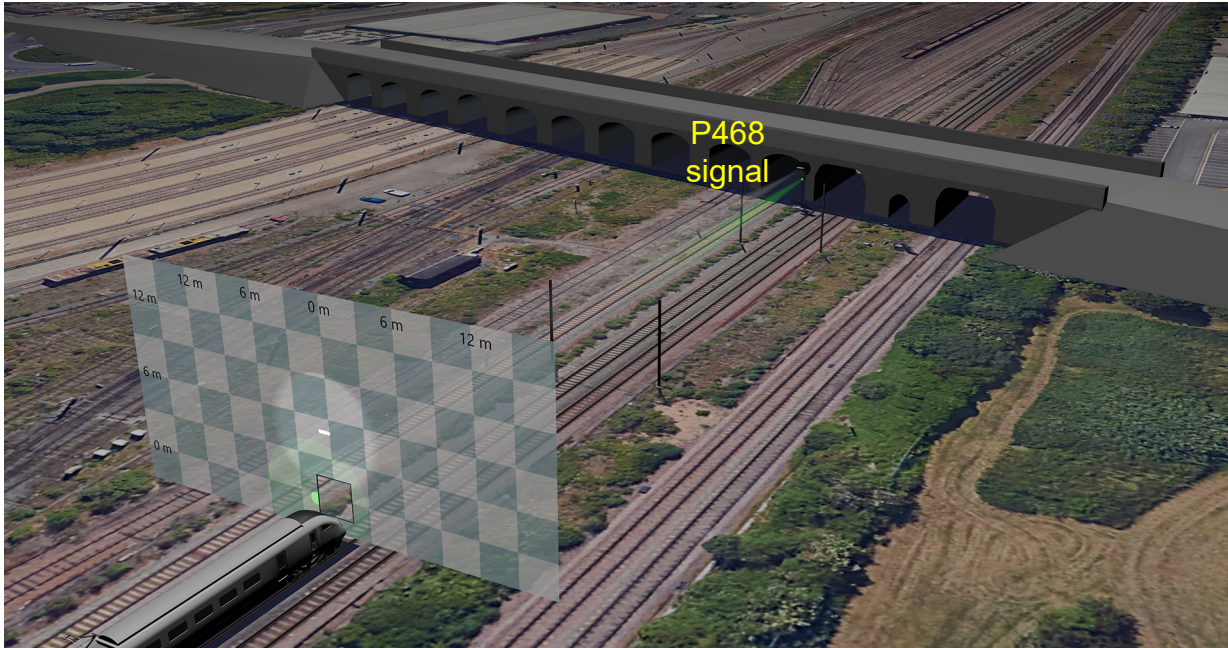
- 142 When a beam drawn from the green aspect and JI of P468 signal is overlaid on the topographical survey of the Up Fast line, the centre line of the green main aspect was found to be pointing down towards the track, and the JI pointing upwards (figure 29). This downwards alignment of the main aspect is in line with signal sighting guidance to aim the main signal towards driver's eye level at the AWS magnet associated with the signal. Figure 30 places an approaching train at 100 metres (110 yards) from P468 signal. At this distance, the centre of the green aspect beam is to the left and at a height approximating that of a driver's eye line. In contrast, the top of the windscreen of an approaching train is approximately 5 degrees below the centre of the beam projected by the JI.

Figure 30: Illustration of beams projected from green aspect and JI onto a virtual grid of 3x3 metre squares positioned 100 metres from P468 signal.
