Near miss between a train and heavy goods vehicle near Craven Arms, Shropshire, 22 July 2024

Summary of the incident

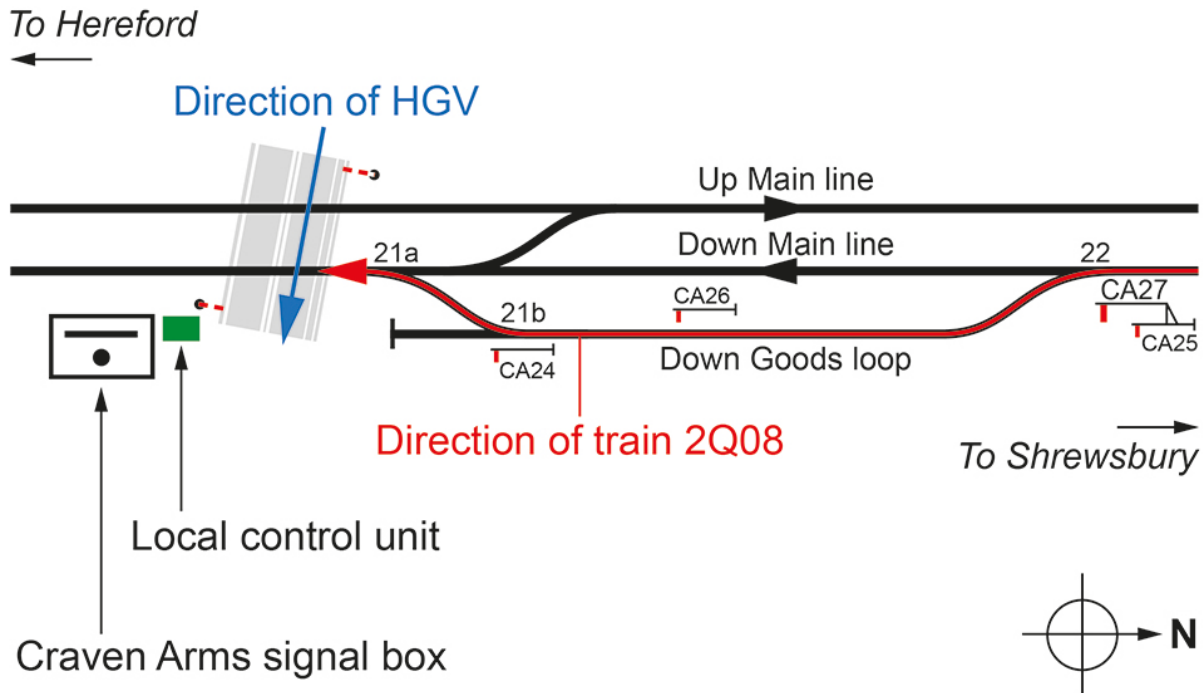
Signal CA27 is located on the approach to Craven Arms from the north at a set of points which allows trains to use either the Down Main line or the Down Goods loop.

Track layout on the approach to Craven Arms level crossing from the north; not to scale and not all features shown. The level crossing barriers are shown in the raised position.

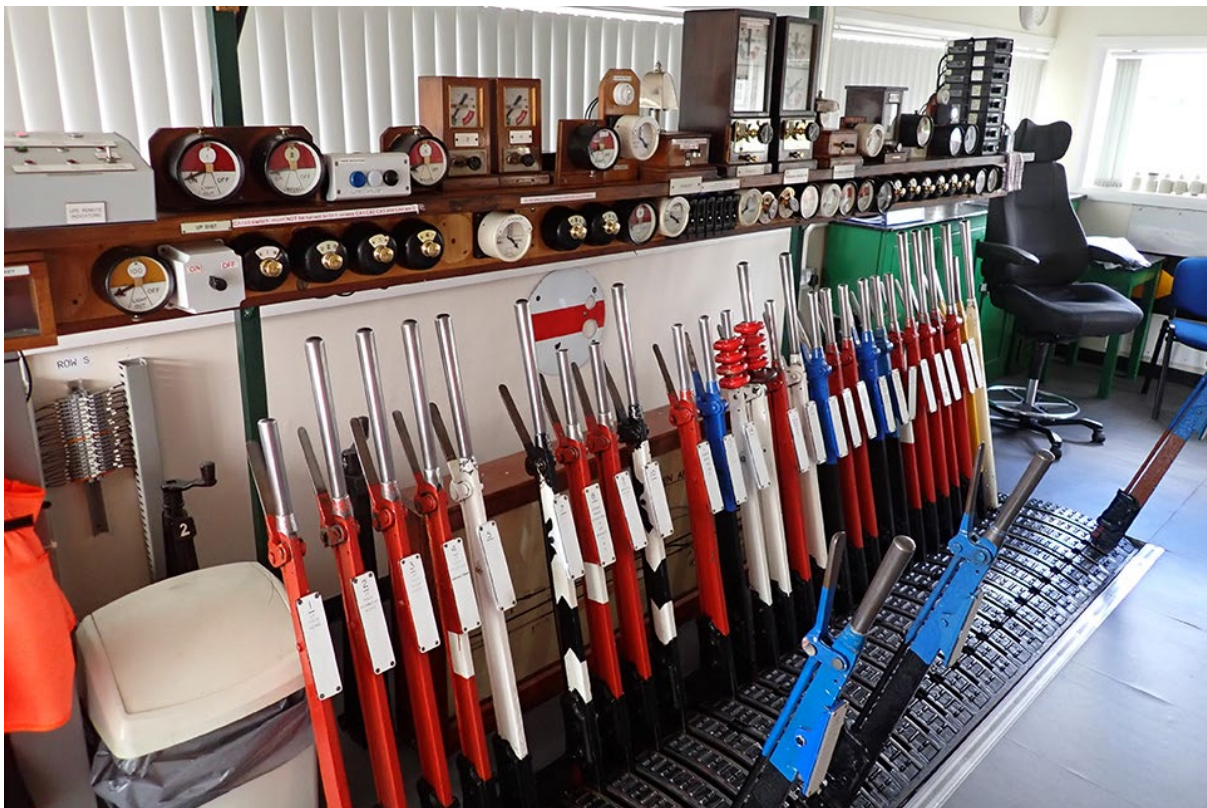
Craven Arms signal box lever frame. For illustrative purposes the red levers are 'in the frame' in their normal positions. If they were to be pulled 'out of the frame' to their reverse positions they would be on the right-hand side of the image, similar to the blue levers.

After reopening the crossing using the LCU, the signaller then went back inside the signal box and made several unsuccessful attempts to return the lever for signal CA27 fully into the frame, although by this time it should no longer have had a timeout preventing this from occurring. The data logger at Craven Arms signal box does not record the position of the lever or operation of the plunger and post-incident testing found no reason why the lever would not return to the normal position after the 70-second timer had elapsed provided the associated plunger was pressed. This means that RAIB cannot be certain why the lever would not return to the normal position during the incident.

The signaller then made further attempts to replace the lever controlling signal CA27 into the signal frame before going back outside and raising the barriers, again using the LCU to do this. The signaller then returned to the operating floor of the signal box and was able to return the lever controlling signal CA27 to the frame.
