# Collision between a train and an object left on the track at Kings Langley, Hertfordshire, 25 April 2024

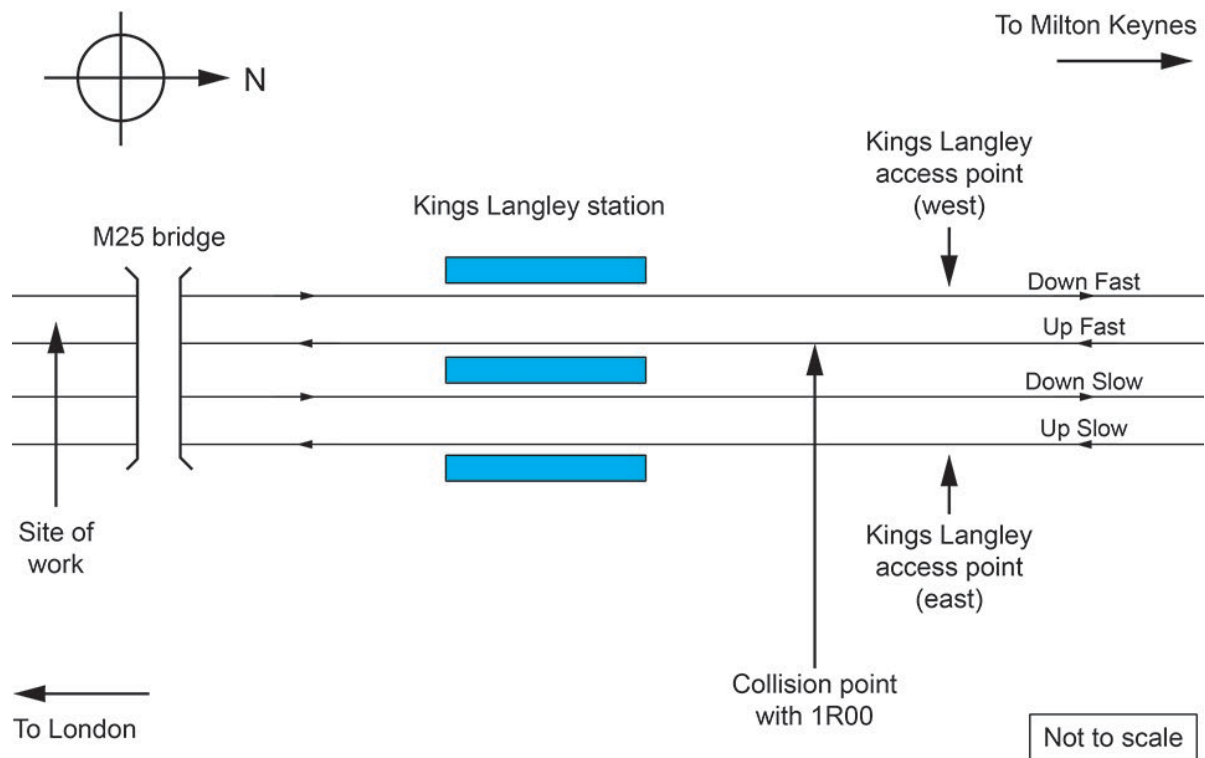
#### Line map of the access point and site of work.

The Down and Up Fast lines at Kings Langley were under possession between 22:30 hrs on 24 April to 06:00 hrs on 25 April. Additional protection was to be provided by a possession of the Down Slow line from 00:45 hrs to 05:20 hrs on 25 April. No work was to take place on the Down Slow line, but the blockage of that line would give road-rail vehicles additional room to manoeuvre when on-tracking onto the adjacent Up Fast line. The Up Slow line remained open throughout, with a site warden being appointed to prevent track workers getting too close to the open line.

The rectification work needed the use of two road-rail vehicles known as mobile elevated work platforms (MEWPs) which were required to operate side by side. The MEWPs were to access the track at Kings Langley access point at the northern end of the site of work. This access point has access gates on both the eastern and western sides of the railway. On this occasion, only the western access gate was useable due to the Up Slow line remaining open throughout the possession.

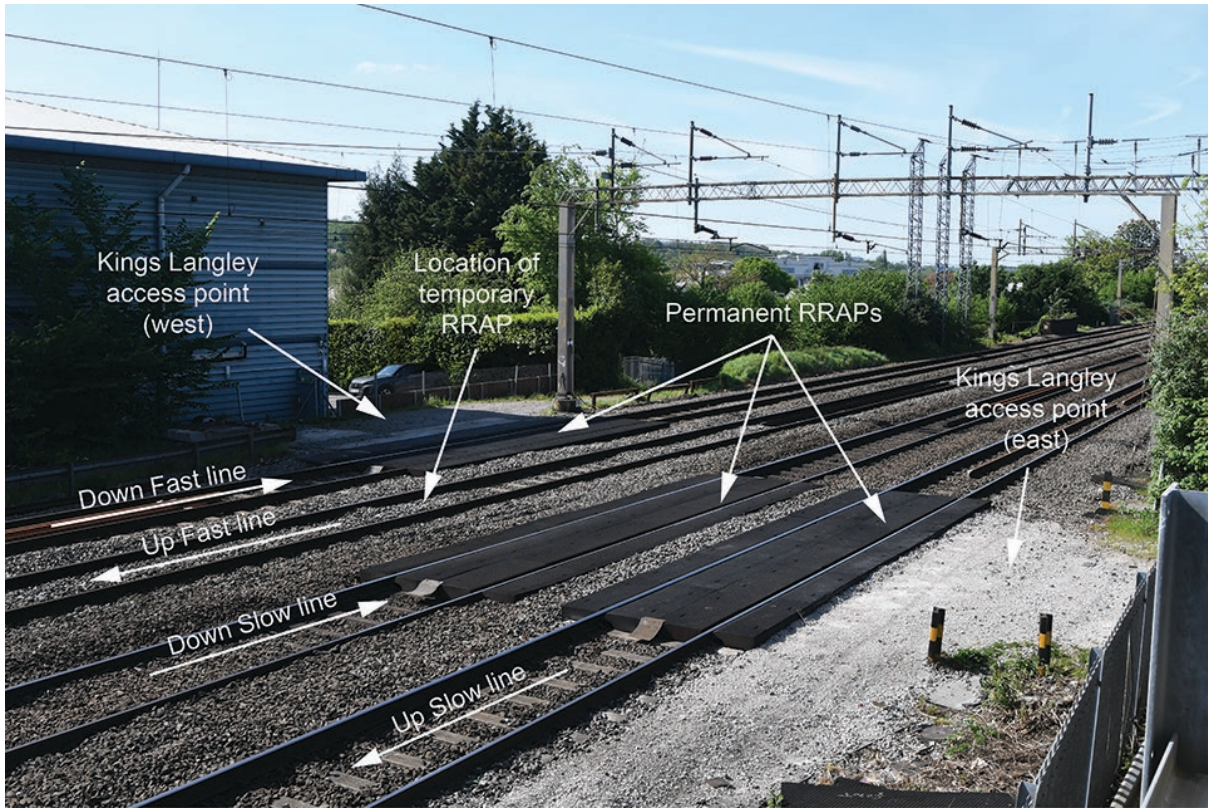
Kings Langley access point has a permanent RRAP on three of the four running lines. The permanent RRAP from the Up Fast line had been previously removed and stored near to the eastern access gate. The first MEWP was to be on-tracked using the permanent RRAP on the Down Fast line, accessed from the western gate. The second MEWP was to be on-tracked on the Up Fast line, which was also accessed from the western gate. The 'on track plant' work plan identified the missing RRAP and stated that a temporary RRAP was to be installed on the Up Fast line. The plan did not specify what type of temporary RRAP was to be used, how it was to be used, any restrictions which would apply to its use, or identify any risks associated with its use.

**Kings Langley access point from the eastern access side.**
