Near miss with a track worker, Littlehempston, Devon, 13 March 2024

Summary of the incident

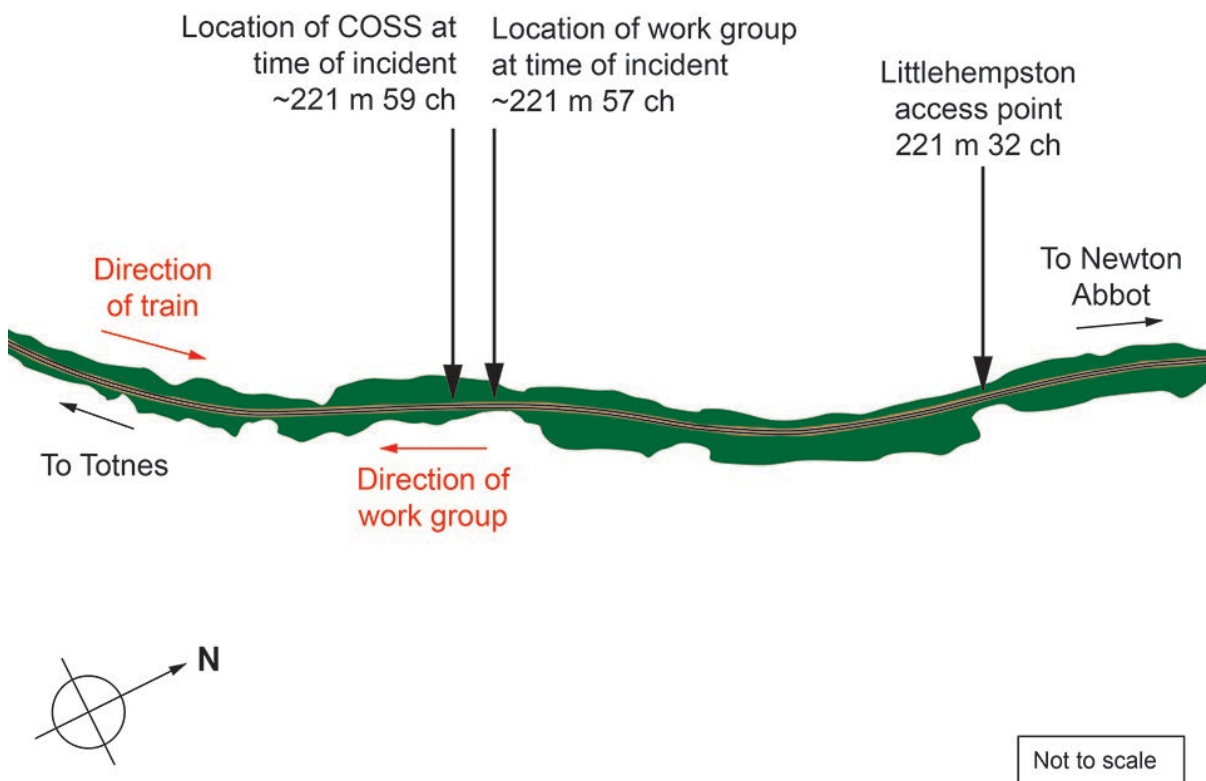
The site location given in the SWPs covered multiple access and egress points and a linear distance of around 5 miles (8 km). It did not specifically define the limits of the site of work.

Simplified diagram showing approximate location of the incident.
