Rail Accident Investigation Branch

# Rail Accident Report

**Train overspeeding at Spital Junction,  
Peterborough  
17 April 2022**

Report 06/2023  
v2 August 2024

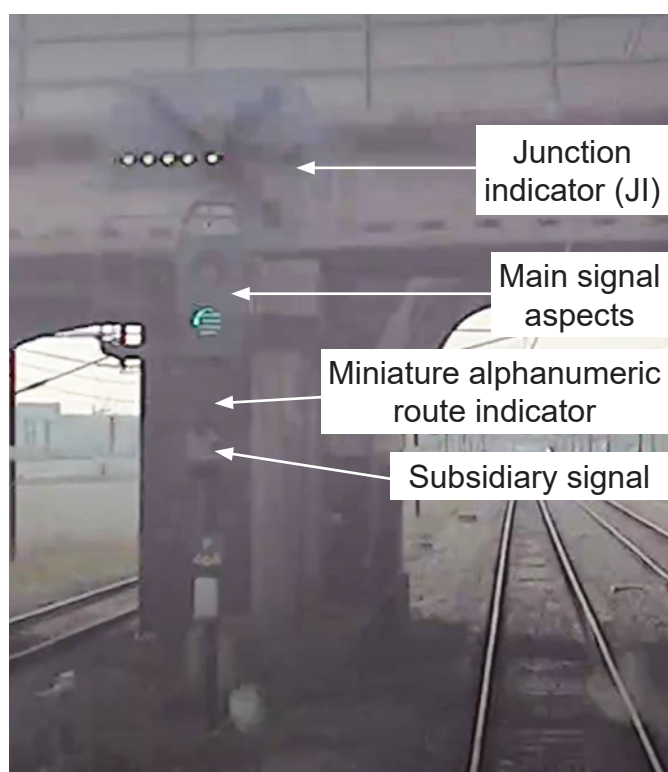
Figure 5: Annotated image of P468 signal.

74 At 10:19:09 hrs, the JI for the Up Slow line to platform 1 illuminated, followed within a second by the main aspect of P468 signal changing from red to green (figure 5). The train was travelling at around 25 mph (40 km/h) and was approximately 790 metres from the signal when the aspect changed. Three seconds later and with the train approximately 760 metres from P468 signal, the driver applied full traction power to accelerate the train (figure 16). The train passed P468 signal travelling at around 64 mph (103 km/h) and was still accelerating.

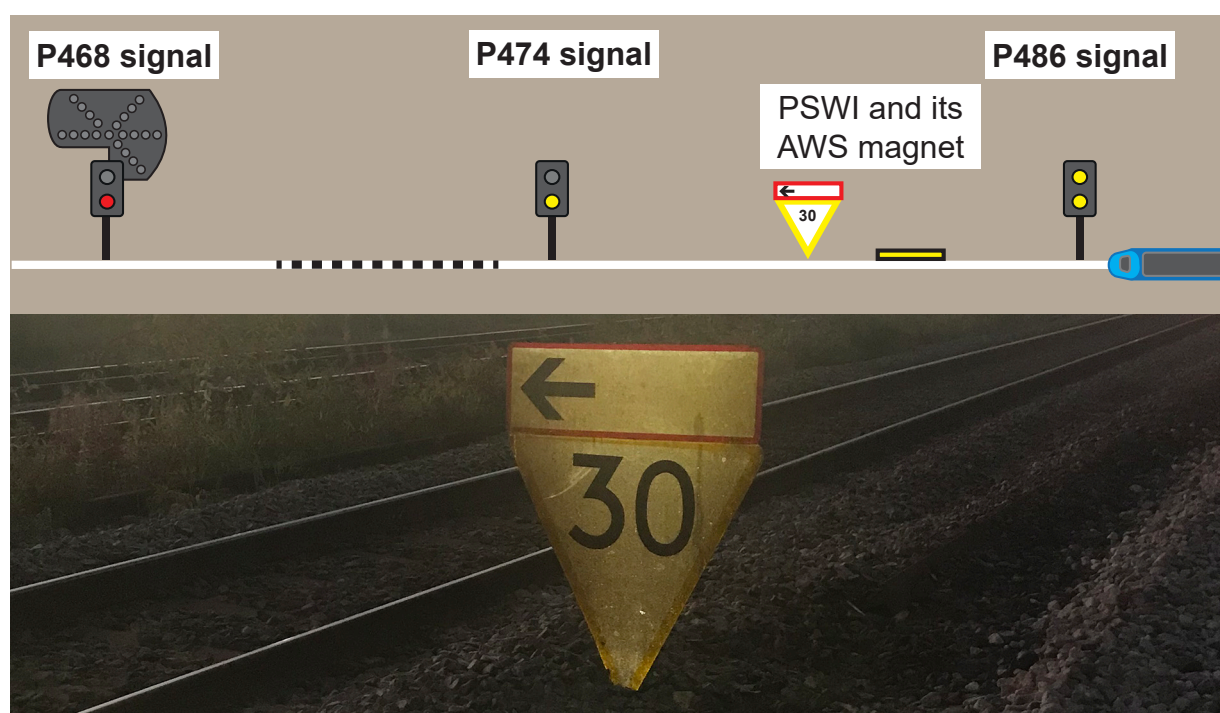
Figure 10: The location of the PSWI in relation to the other signalling equipment and an image of it (courtesy of Network Rail).

- 42 The PSWI is placed at the required deceleration distance of 2058 metres from the point of divergence, which is the distance needed for a train travelling at the permissible speed of 125 mph (201 km/h) to slow to 30 mph (48 km/h) for the divergence. This distance placed the PSWI between P486 and P474 signals. This PSWI, which is located between signals, is provided with its own automatic warning system (AWS) magnet situated about 180 metres on the approach to the PSWI sign. When a train passes over the magnet, it causes an audible warning in the cab which the driver must acknowledge within a specified time, or an emergency brake application will occur. The aim of this AWS warning is to alert the driver to the PSWI, which in turn aims to remind the driver about the slower speed divergence that is ahead.

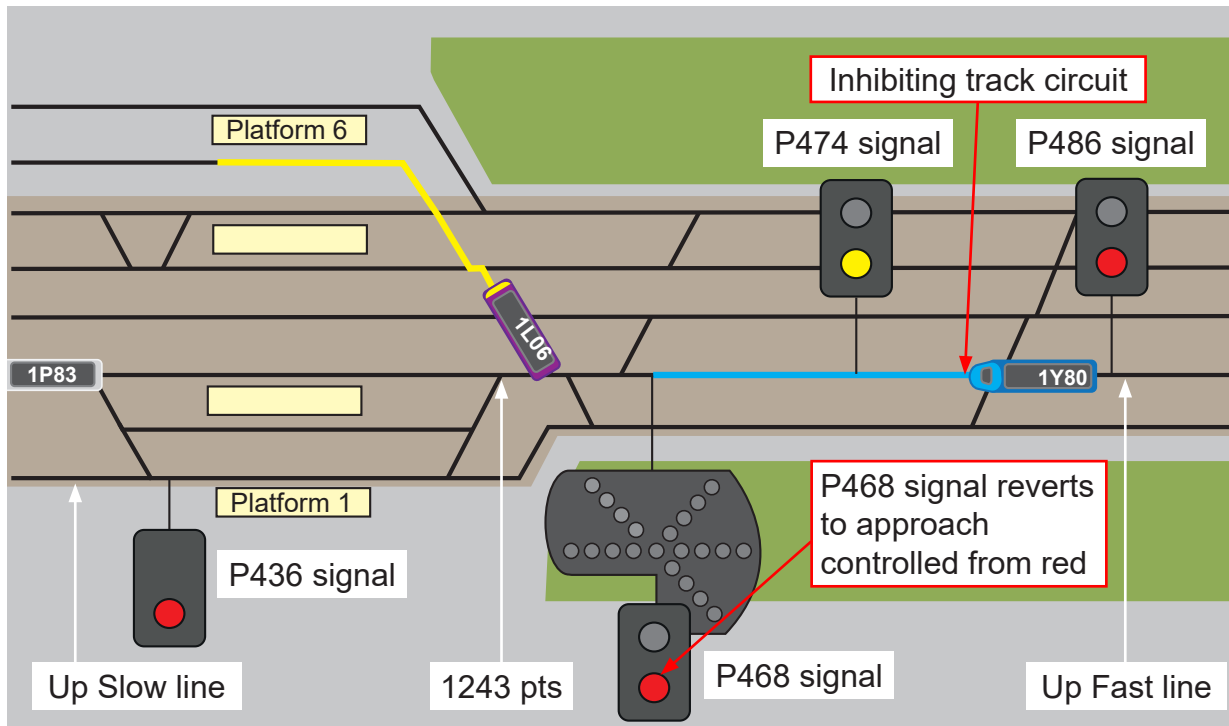
69 At 10:17:02 hrs, with train 1L06 still occupying the Up Fast line, train 1Y80 was travelling at around 32 mph (51 km/h) and slowing down as it approached and passed P486 signal displaying a single yellow aspect. Train 1Y80 then occupied track circuit T7726 which inhibited P474 signal from showing a single flashing yellow aspect (paragraph 40). At this time, P474 signal was not visible to the driver of train 1Y80. Because of the proximity of train 1Y80 to P468 signal, it was prevented from using flashing yellow control, and was approach released from a red aspect (figure 13).

Figure 13: The position of trains 1P83, 1L06, and 1Y80 at 10:17:02 hrs.

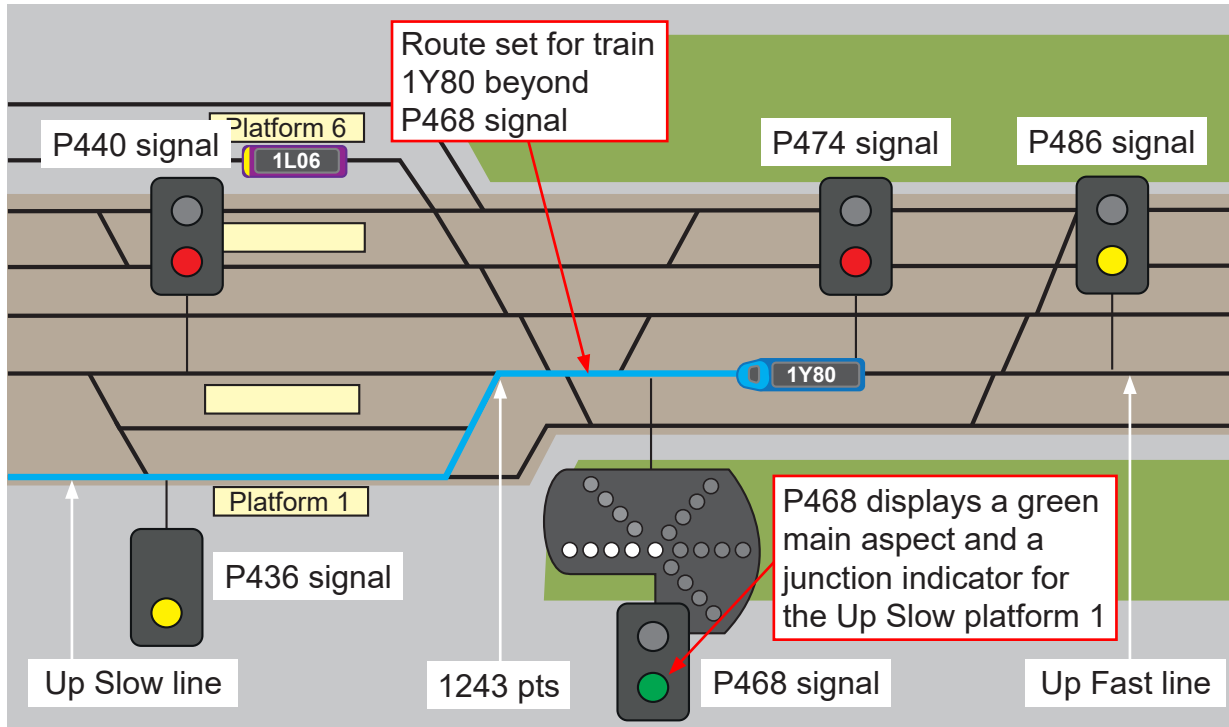
Figure 16: The position of train 1Y80 at 10:19:09 hrs.

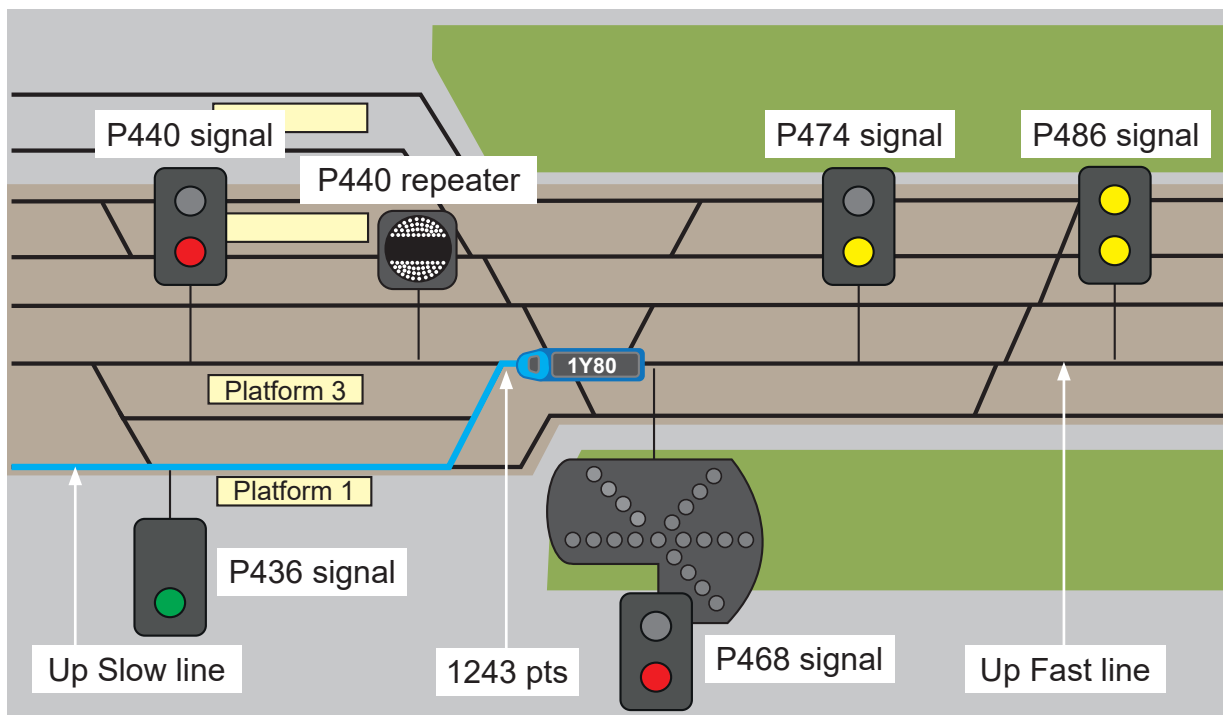
75 At 10:20:08 hrs, the train was approximately 160 metres from 1243 points and had reached around 77 mph (123 km/h). The driver stated that they saw the platform banner repeater signal at the north end of platform 3 was 'on', indicating that the route for the Up Fast line through platform 3 was not set. They reacted by applying a full service brake (figure 17).

Figure 17: The position of train 1Y80 at 10:20:08 hrs.

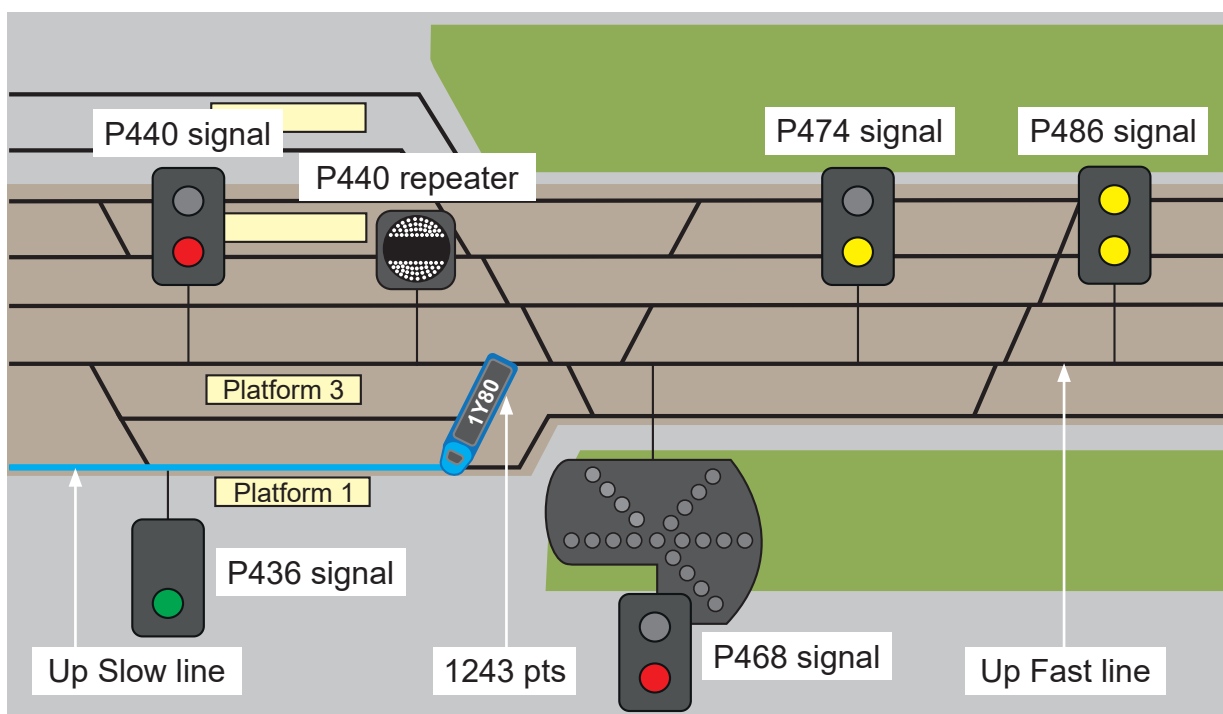
76 At 10:20:11 hrs, the train reached 1243 points at the junction while it was still travelling at around 76 mph (122 km/h) (figure 18). The driver made an emergency brake application around nine seconds later, after the train had passed over all of the points and while it was travelling at around 60 mph (97 km/h).

Figure 18: The position of train 1Y80 at 10:20:11 hrs.

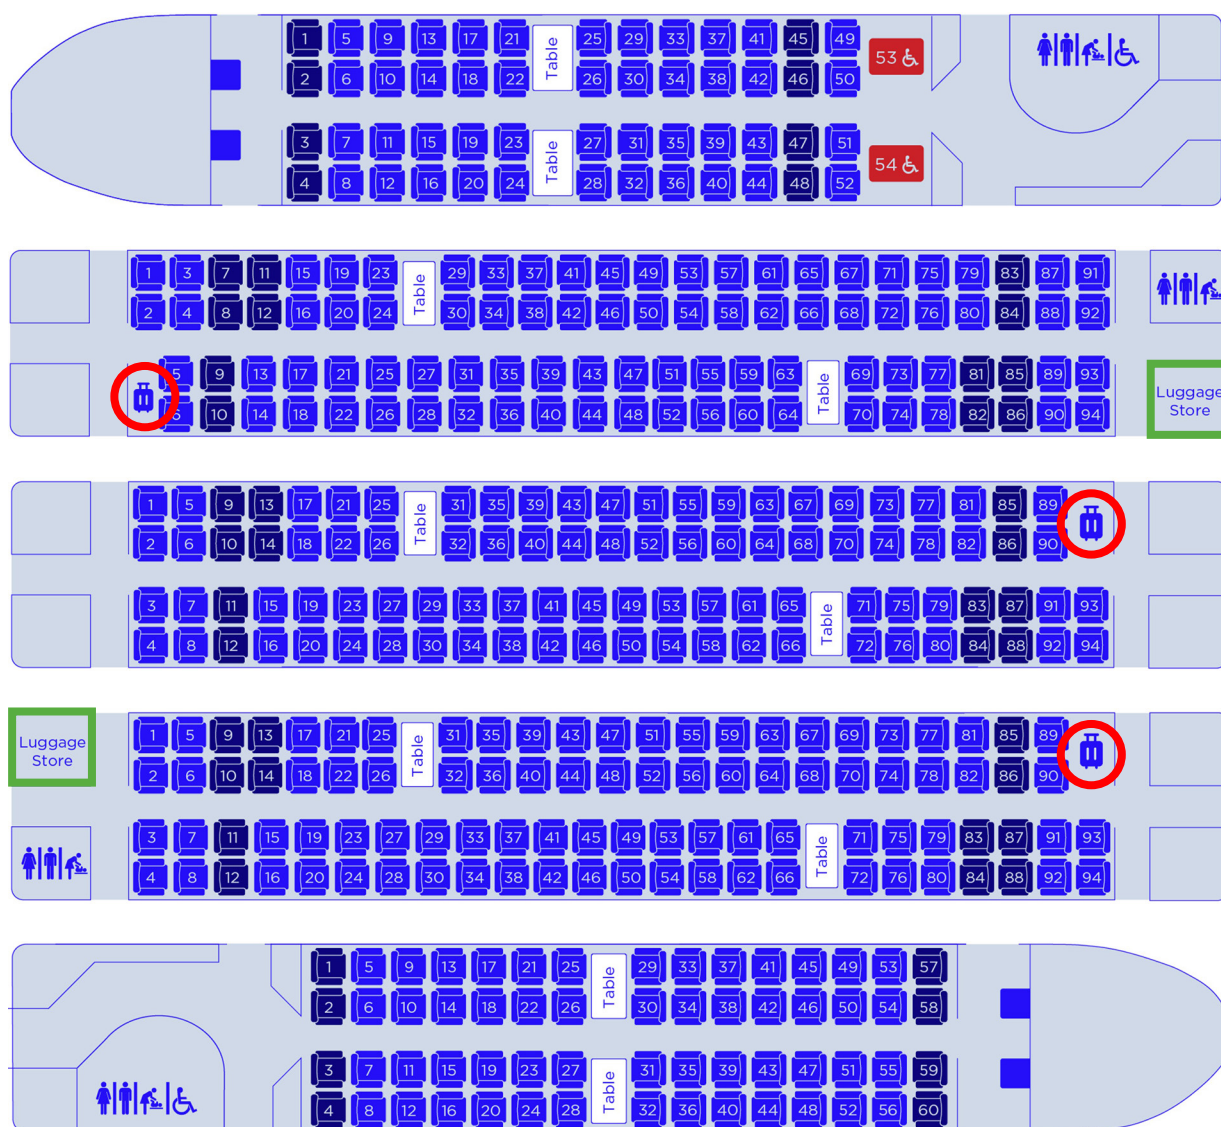
180 Lumo trains have three luggage stacks (figure 21) on a five-car train, whereas there are eight luggage stacks on a five-car LNER/GWR train. In common with LNER/GWR, Lumo trains also have two storage areas for either one or two bicycles or larger luggage. Lumo advised RAIB that it had repurposed the two bicycle storage areas in its trains to be bulk luggage storage areas by December 2021. All fleets of Hitachi AT300 trains are fitted with the same design of overhead luggage racks above passenger seats.

Figure 21: Luggage storage stacks and storage areas on Lumo's trains.

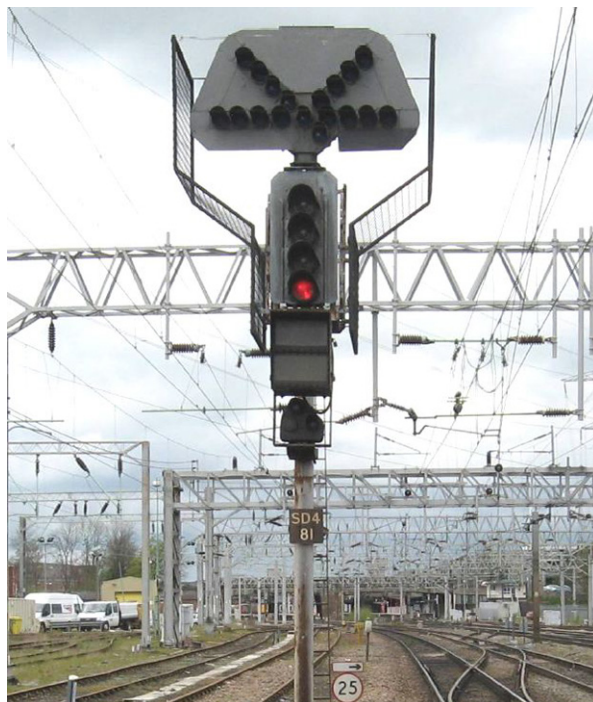
Figure E1: Example of a junction indicator

- E11. Filament bulb JIs use four individual light modules meeting BRS SE 156/1 for each route to be indicated. These are arranged around a similar light module, known as the pivot light, which illuminates with all indication positions to give five white lights (figure E1). The Unipart Dorman Mk1 LED JI is similar in design with a pivot light and four LED modules forming each indication. Both types of JI use a cast metal frame to house the light modules and a large backboard to improve contrast to the white light output.

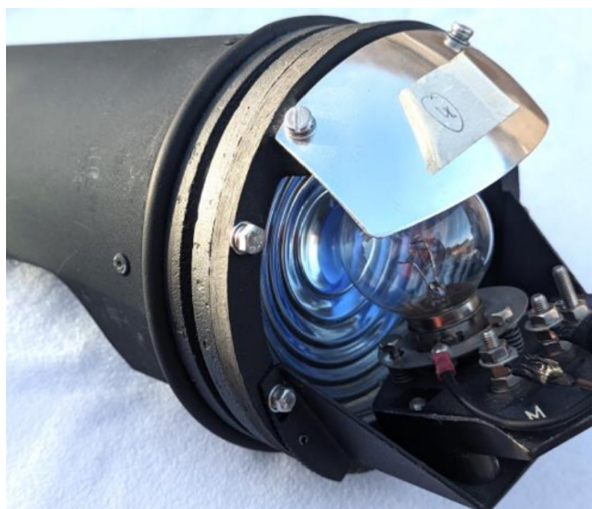
Figure E2: Bulb and lens module used in filament junction indicators.

E12. The BRS SE 156/1 light module utilises a traditional filament bulb and glass lens arrangement to focus the light output towards the driver (figure E2). This produces a focused beam, but because of the long thin horizontally aligned filament used in the SL18 bulb, the intensity of the light output is greater in the horizontal axis than it is in the vertical axis when viewed from the front (figure E4a). In contrast, the Unipart Dorman Mk 1 LED light module uses an array of LEDs mounted at the end of a short tube. This provides improved visibility and reduces problems originating from sunlight reflecting directly on the LED (figure E3). The absence of a filament allows the LED light module to emit light equally in both the horizontal and vertical axis (figure E4b).

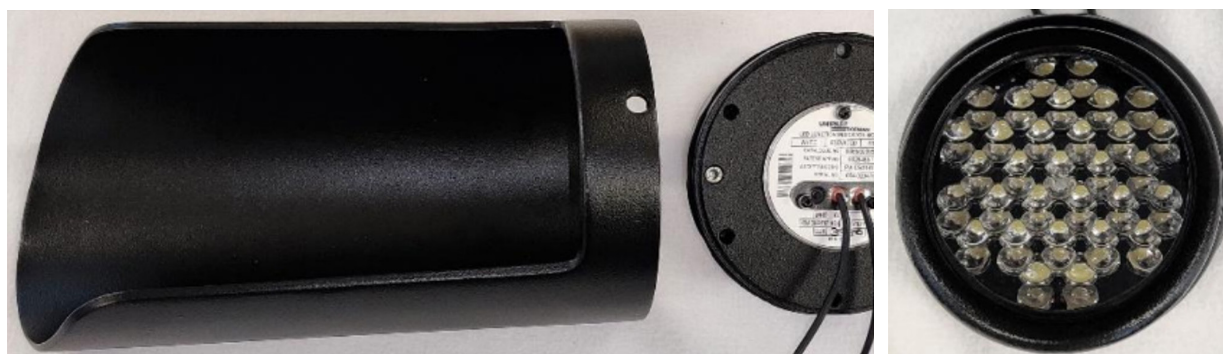
Figure E3: Unipart Dorman Mk1 LED junction indicator module.

E13. The LED JI light modules were found to be at different alignments within the JI housing, ranging between  $-0.4$  and  $-2.7$  degrees error relative to the designed position within the housing. The pivot light was also found to be installed upside down. These issues are likely to be a consequence of the sample JI having been supplied from one of Network Rail's training centres and is unlikely to be representative of the LED JIs in use. To account for the misalignment, the luminous intensity of all modules was tested 'on-axis' and relative to the light module itself, and not to its position within its housing.

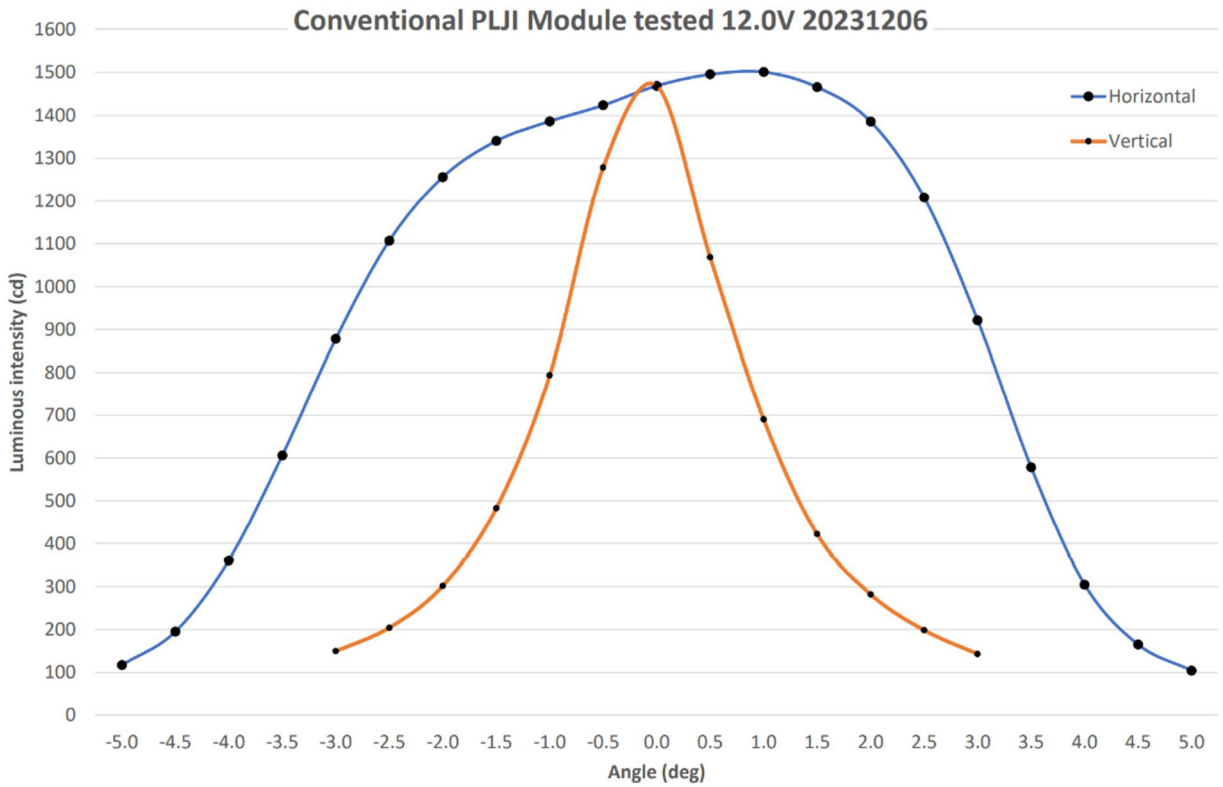
Figure E5: Measured luminous intensity from a filament junction indicator module.

E15. The measured on-axis luminous intensity of the LED JI modules was significantly lower than the output measured for the BRS SE 156/1 filament bulb module, which was approximately 1,450 cd (figure E5). Although the product acceptance testing verified that an LED JI was readable at the required distance of 800 metres, the testing shows that the output of the LED JI module is significantly lower than the output of the example filament JI module it was intended to replace.

- E18. Testing of the filament and LED JI modules found that the filament module produced a higher peak luminous intensity (paragraphs E14 to E16). This was significantly reduced as the viewing angle increased, especially in the vertical axis. In contrast, LED modules produced a much lower peak luminous intensity output but were less sensitive to viewing angle. This meant they produced an output much closer to the peak luminous intensity as the viewing angle increases away from the projected beam axis.

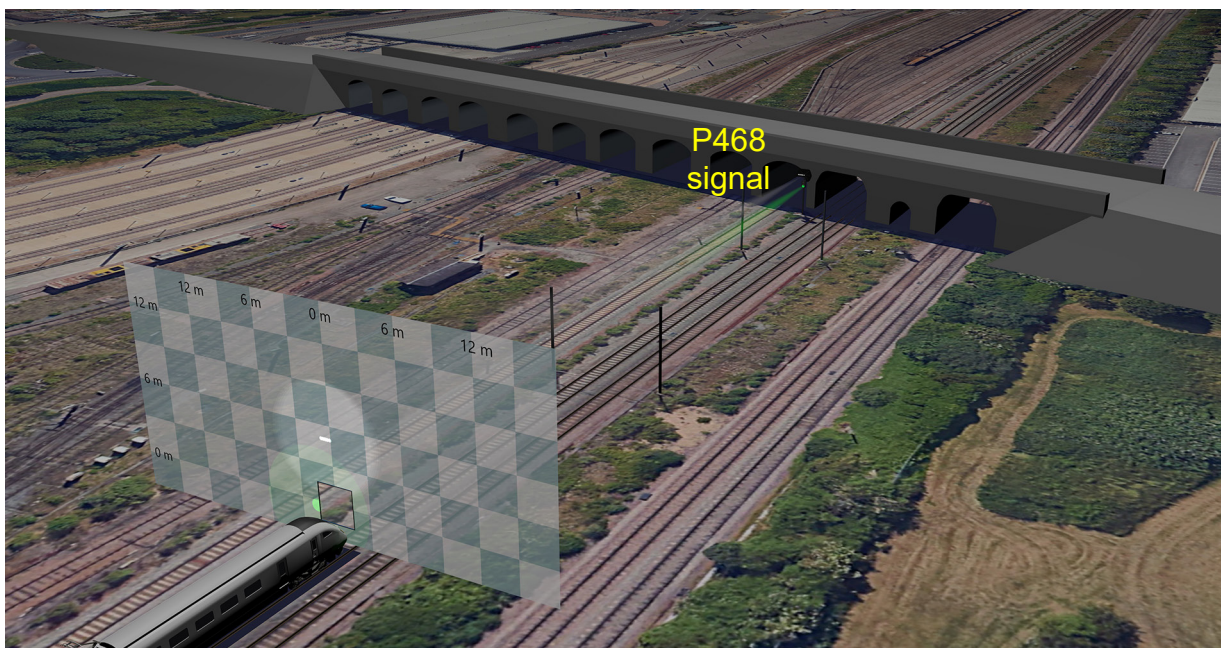
Figure E8: Illustration of beam projected onto virtual 3x3m square grid 100 metres from P468 signal.

- E19. When a beam drawn from the green aspect and JI of P468 signal is overlaid on the topographical survey of the Up Fast line, the centre line of the green main aspect was found to be pointing down towards the track, and the JI pointing upwards (figure E7). This downwards alignment of the main aspect is in line with the signal sighting guidance to aim the main signal towards driver's eye level at the AWS magnet associated with the signal. Figure E8 places an approaching train at 100 metres (110 yards) from P468 signal. At this distance, the centre of the green aspect beam is to the left and at a height approximating that of a driver's eye line. In contrast, the top of the windscreen of an approaching train is approximately 5 degrees below the centre of the beam projected by the JI.

- E20. When these beams are projected to 800 metres (875 yards) from P468 signal, the centre of the green aspect beam remains closer to the driver's eye line, although below the windscreen level of an approaching train. However, the centre of the JI is much further from the driver's eye line (figure E9).
