Rail Accident Investigation Branch

Rail Accident Report

Overspeed at Spital Junction, Peterborough 4 May 2023

Report 10/2024
September 2024

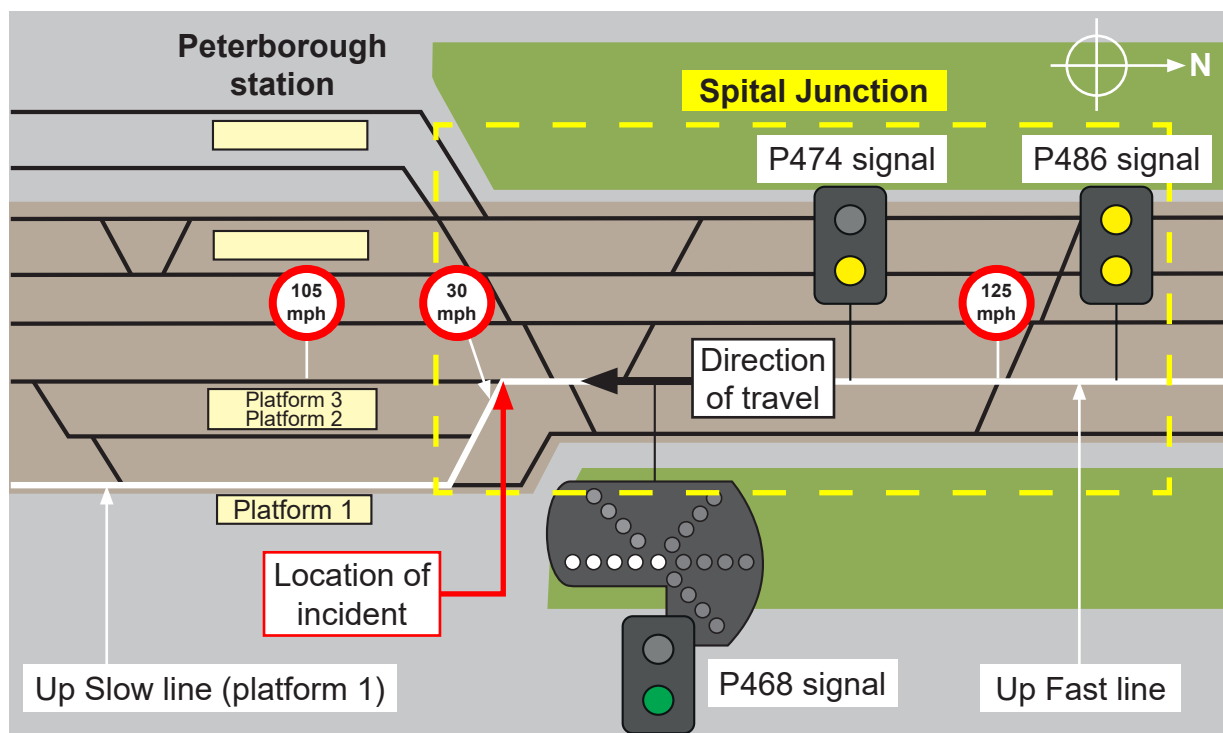
- 5 The driver of train 1A64 did not observe this junction indicator and reacted only to the main aspect of the signal by applying full power to the train when it had changed from showing a red aspect (danger) to a green aspect (proceed).
- 6 The train did not derail and no damage was caused to the train or track. However, the train's speed over the junction resulted in sudden sideways movements of the coaches. This led to some passengers being thrown from their seats, with some receiving minor injuries as a result.

Figure 2: Location of the incident and a schematic diagram of the main features on the north approach to Peterborough station.

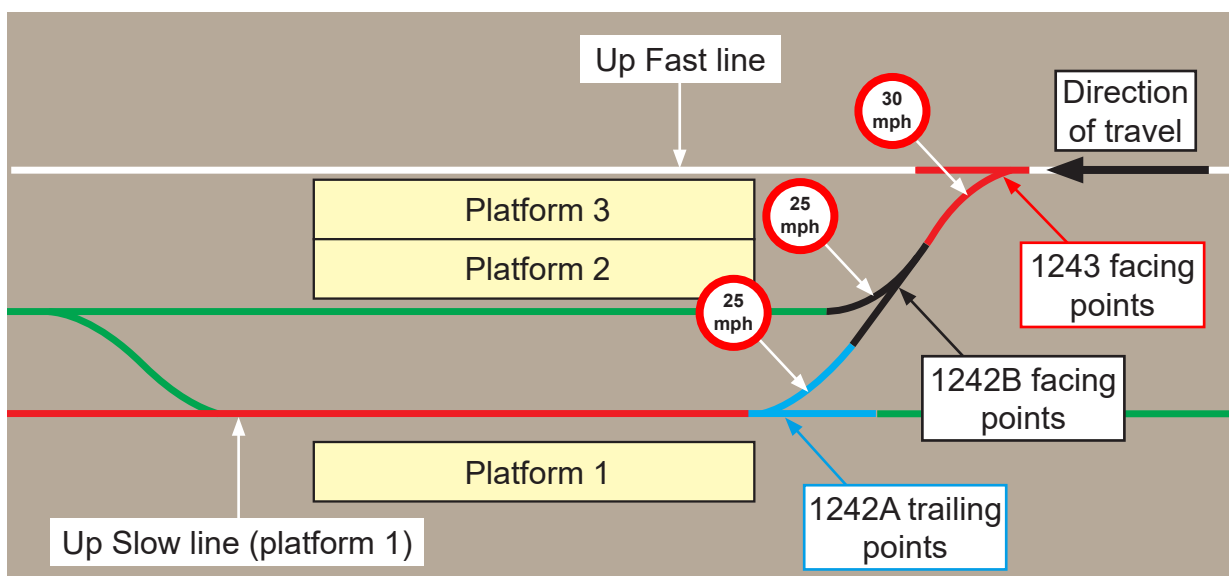
- 13 The diverging route at the junction over which the train passed, comprises three turnouts² (figure 4). The first turnout of the junction, which includes 1243 points, has a maximum permitted speed of 30 mph (48 km/h). The remaining two turnouts have maximum permitted speeds of 25 mph (40 km/h). When viewed in the direction of the train's travel, the first and second sets of points are facing points while the third are trailing points. The maximum line speed on the Up Slow line through platform 1 is 50 mph (80 km/h).

Figure 4: Details of the track layout at the diverging junction to the Up Slow lines.

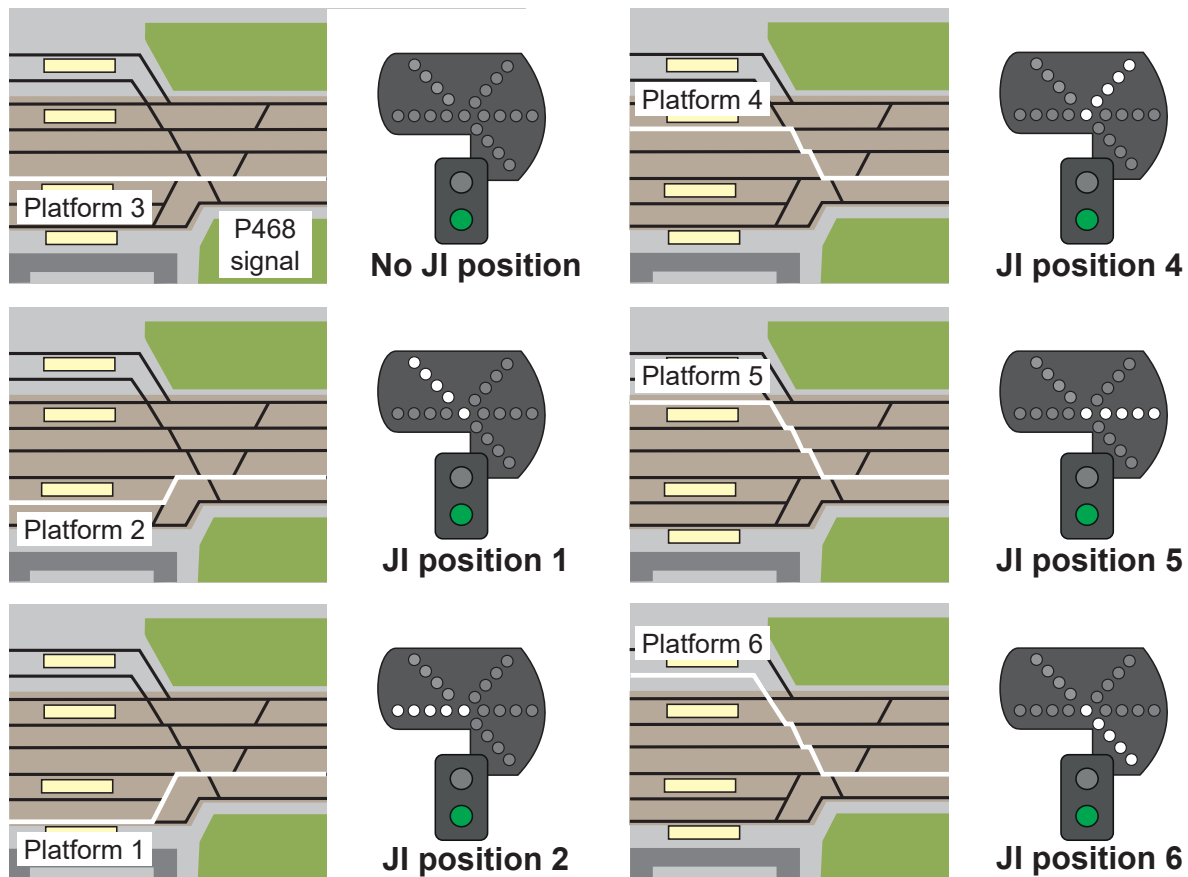
- 15 The JI on P468 signal can show five different indications, meaning a train can be signalled to go in one of six different ways beyond the signal (the JI is not illuminated for trains going straight ahead on the Up Fast line). Figure 6 shows where a train can go to from this signal and what the associated JI indication will be for that route. The signal is also fitted with a subsidiary signal and a miniature alphanumeric route indicator. These are for occasions when a train is signalled into a platform at Peterborough station that is already occupied by another train and are not relevant to this incident.

Figure 6: Routes from P468 signal and the associated JI indication.

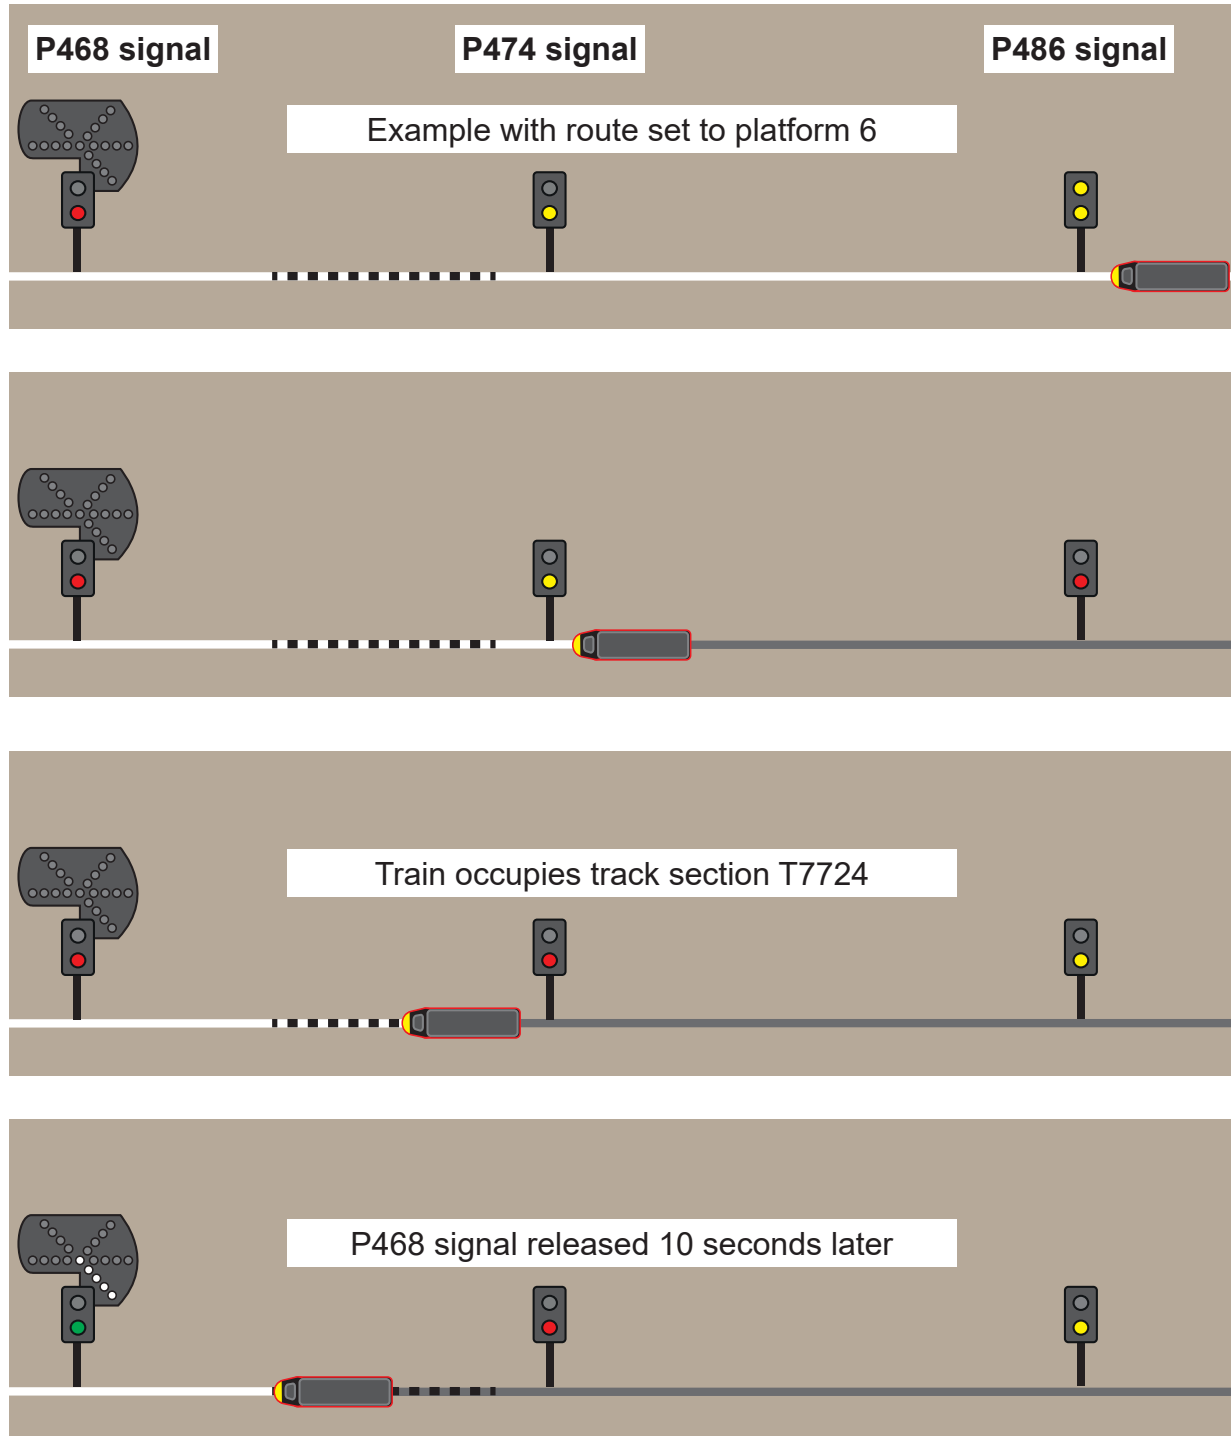
Figure 8: The aspect sequence for P468 signal when a route with approach release from red control is set.

- 31 Figure 8 shows that the sequence of aspects for P468 signal when a route towards platform 6 with approach release from red control is set (in this example figure P468 signal is shown displaying a green aspect when released, as a route is already set beyond the next signal at the end of platform 6). As the train travels towards P468 signal at red, it will occupy track section T7724, (indicated on figure 8 by a black dashed line) and start a timer. When the timer reaches 10 seconds, the interlocking releases the aspect control on P468 signal and allows it to display a proceed aspect and JI indication.

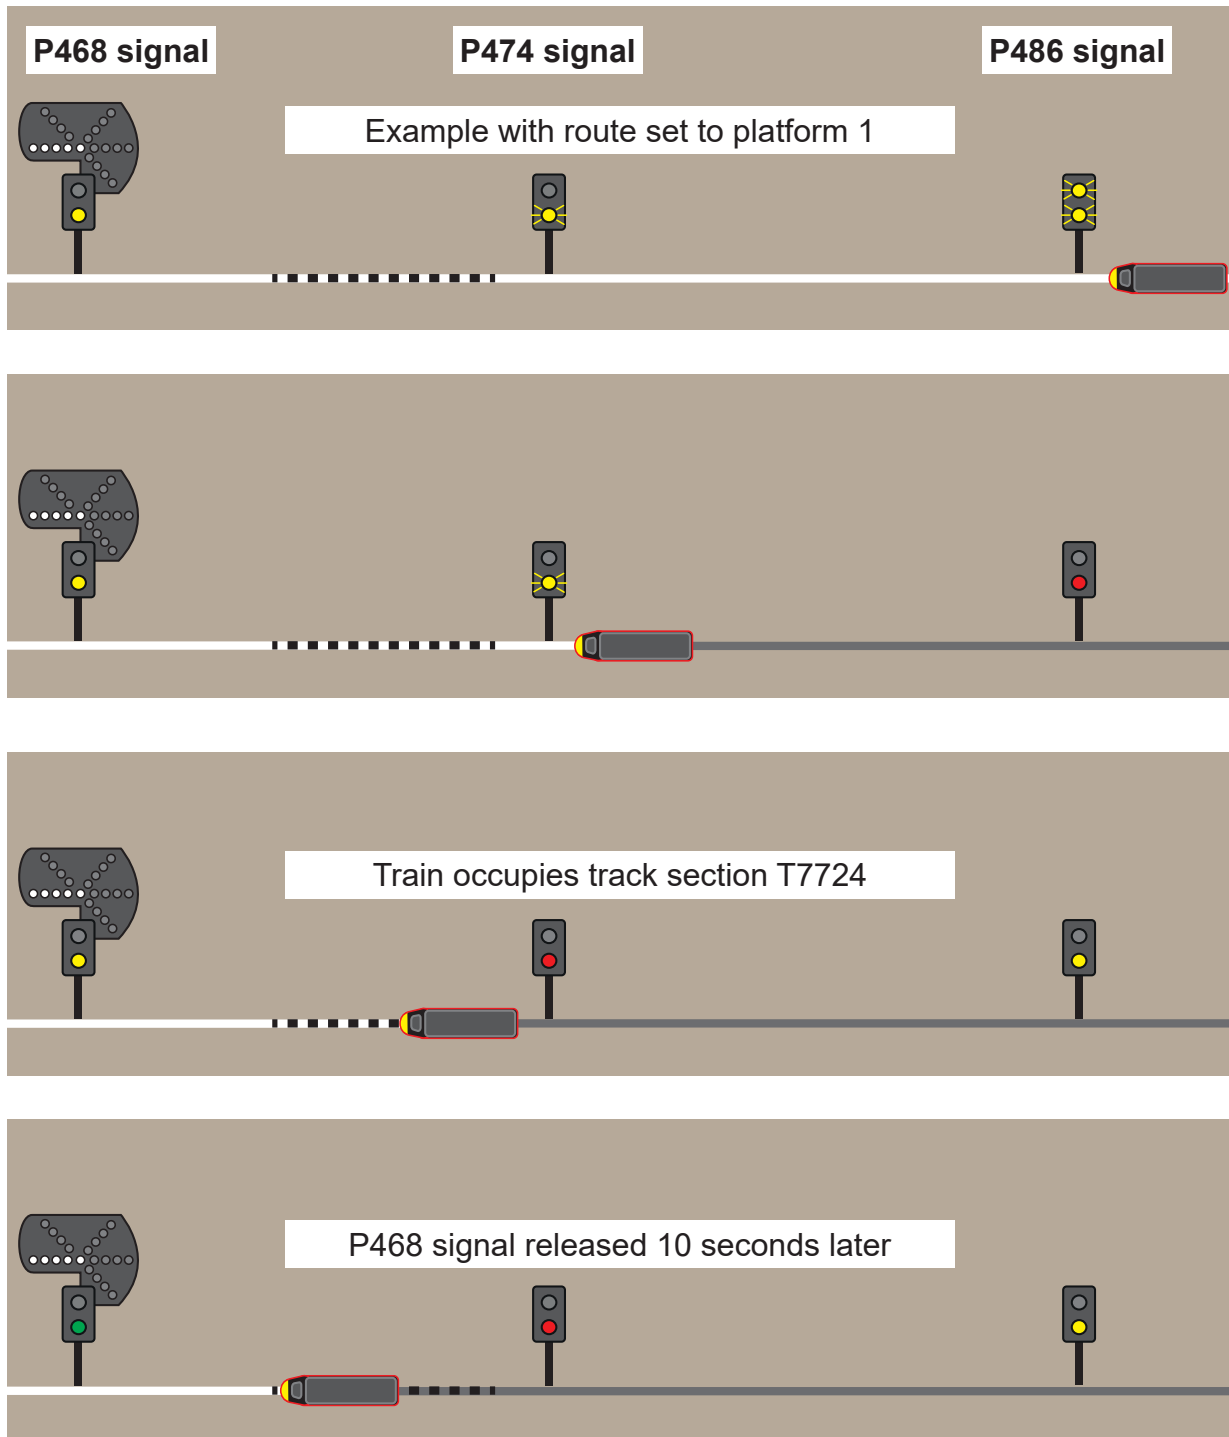
Figure 9: The aspect sequence for P468 signal when a route with flashing yellow aspect sequence control is set to platform 1.

- 36 Figure 9 shows an approaching train passing P486 signal displaying a flashing double yellow aspect and P474 signal displaying a flashing single yellow aspect. After passing P474 signal, the train will occupy track section T7724 as it continues towards P468 signal. As it was for the approach release from red control (paragraph 31), when this track section is occupied for 10 seconds, the interlocking releases the restriction on P468 signal and allows it to display a less restrictive proceed aspect as permitted by the aspect of the signal ahead.

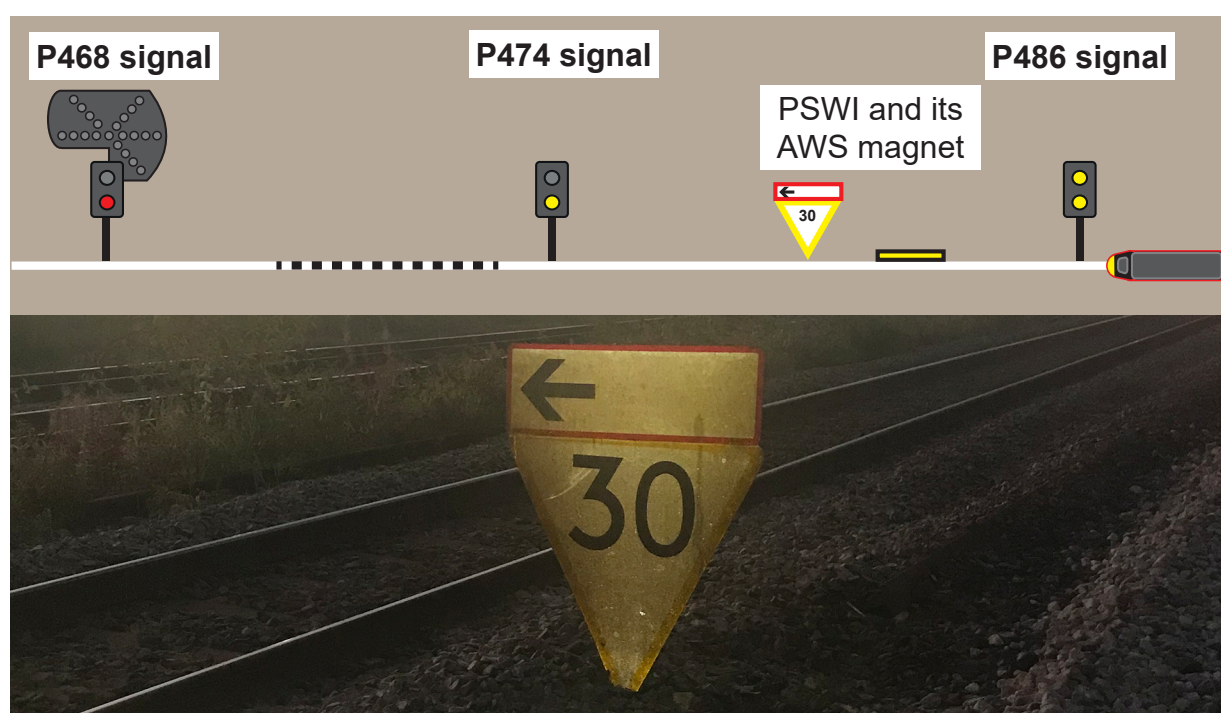
Figure 10: The location of the PSWI in relation to the other signalling equipment and an image of it (courtesy of Network Rail).

- 40 The PSWI is placed at the required deceleration distance of 2058 metres from the point of divergence, which is the distance needed for a train travelling at the permissible speed of 125 mph (201 km/h) to slow to 30 mph (48 km/h) for the divergence. This distance placed the PSWI between P486 and P474 signals. This PSWI, which is located between signals, is provided with its own automatic warning system (AWS) magnet situated about 180 metres on the approach to the PSWI sign. When a train passes over the magnet, it causes an audible warning in the cab which the driver must acknowledge within a specified time, or an emergency brake application will occur. The aim of this AWS warning is to alert the driver to the PSWI, which in turn aims to remind the driver about the slower speed divergence that is ahead.

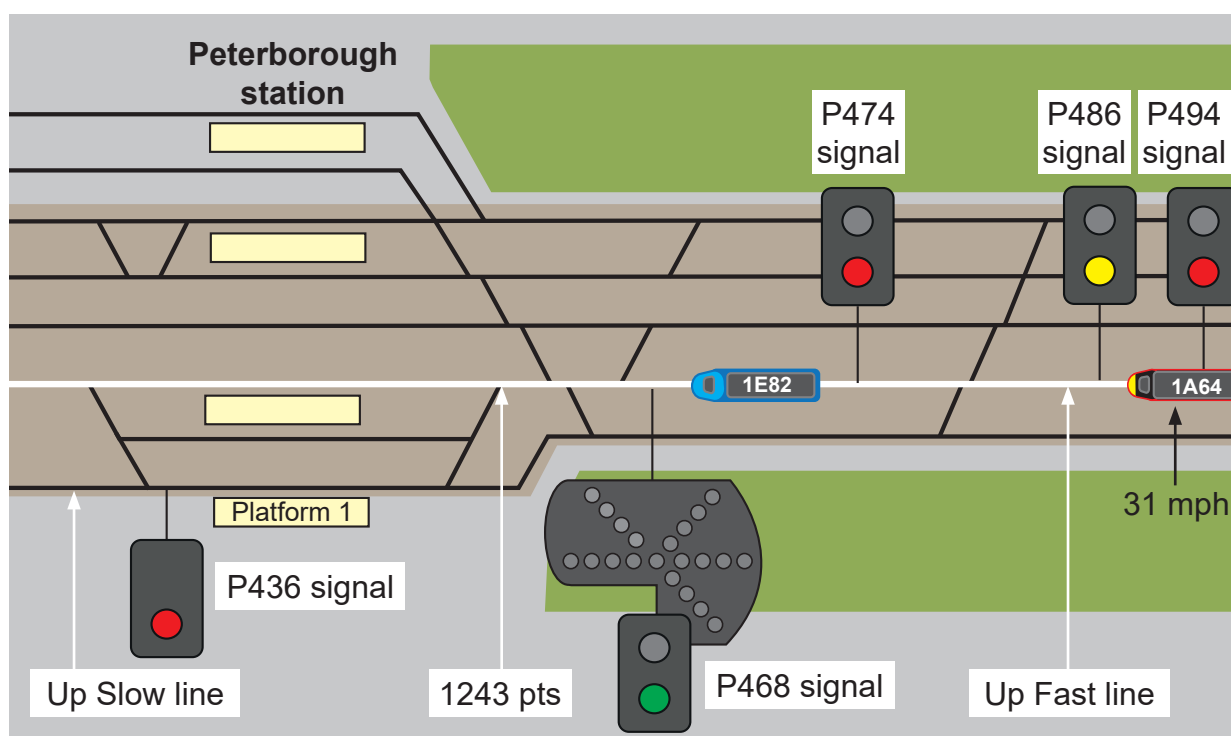
56 At 12:56:00 hrs, the signallers made a route request to set the route on the Up Slow line beyond P436 signal (situated at the end of platform 1) for train 1A64. At this time, train 1A64 was travelling at 31 mph (50 km/h) and was close to passing P494 signal, which was displaying double yellow aspects. However, the route ahead of train 1A64 could not yet be set as train 1E82 was occupying the Up Fast line approaching P468 signal (figure 12).

Figure 12: The position of train 1A64 and train 1E82 ahead of it shortly after 12:56:00 hrs..

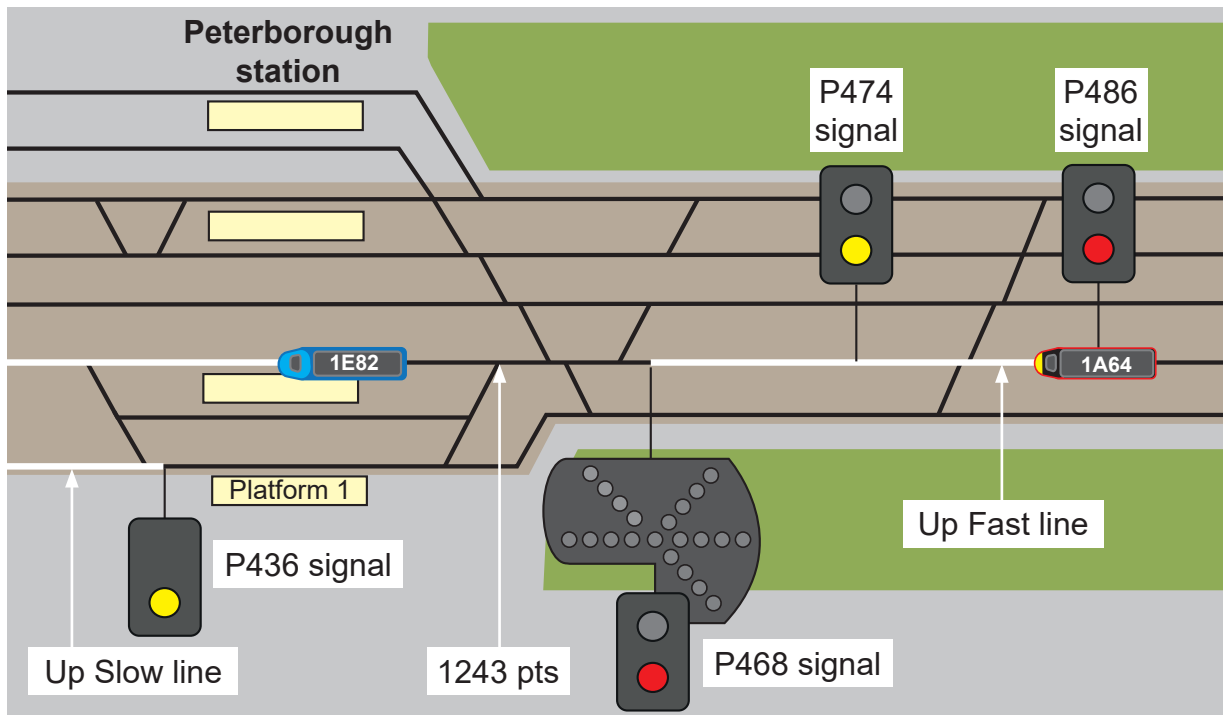
57 At 12:56:46 hrs, train 1E82 cleared the conflict point of the junction beyond P468 signal. This is the earliest time that a signaller could have set the route for train 1A64 from P468 signal to the Up Slow line. By this time, train 1A64 had passed P486 signal travelling at 31 mph (50 km/h) (figure 13).

Figure 13: Train 1E82 clears Spital Junction which is the earliest time that the signaller could have set the route to the Up Slow line for train 1A64 at 12:56:46 hrs.

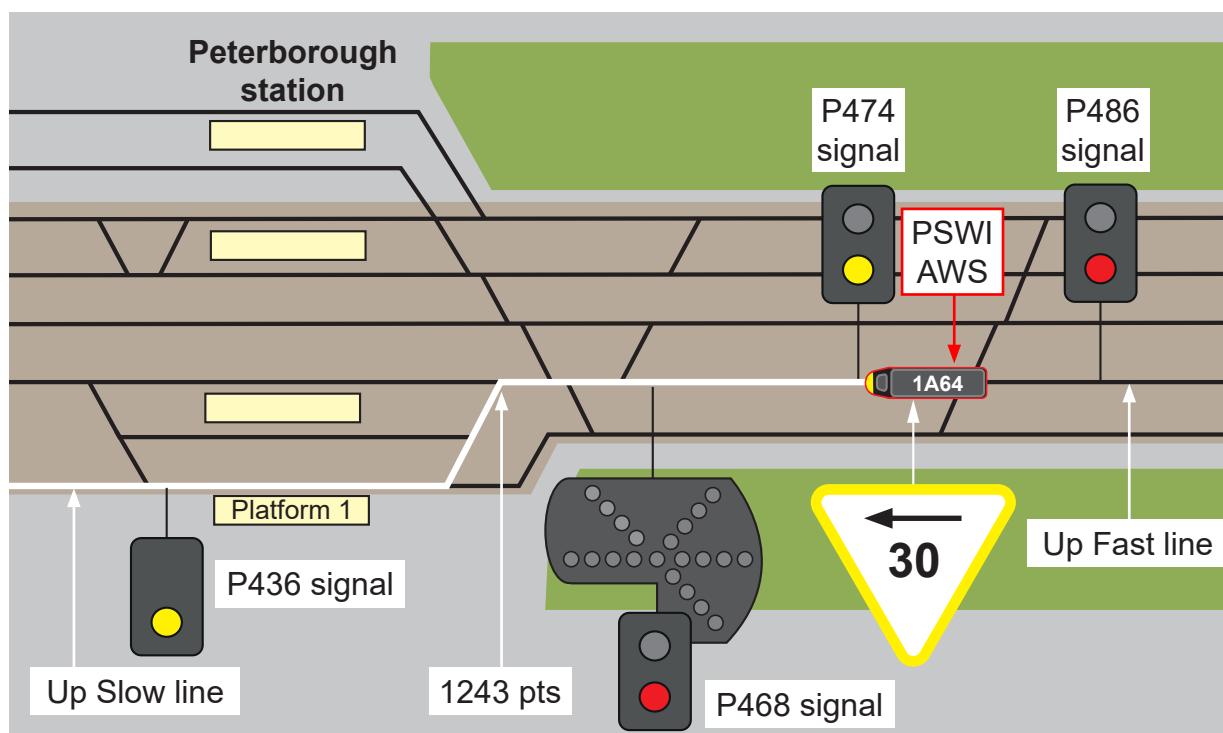
Figure 15: Train 1A64 passes the AWS magnet for the PSWI indicating the maximum permissible speed for the junction to the Up Slow line at 12:57:41 hrs.

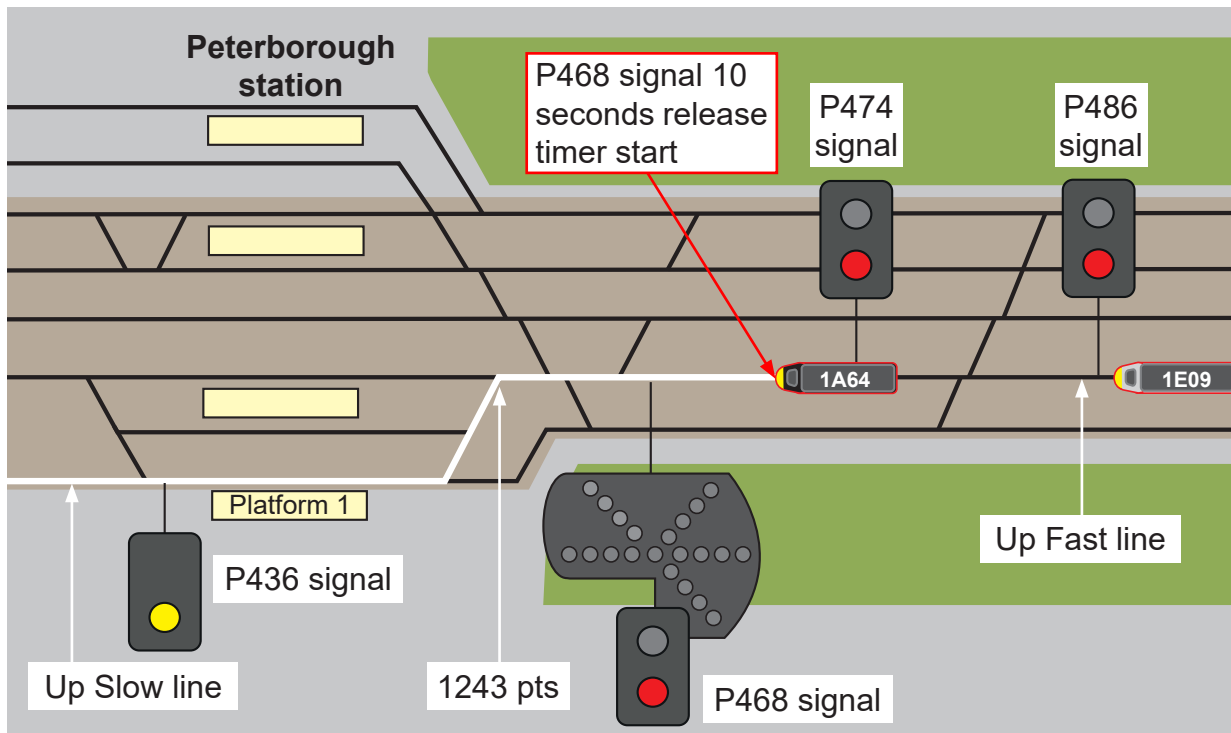
- 61 At 12:58:59 hrs, train 1A64 reached the track circuit which started the 10-second release timer of P468 signal. It was coasting at 16 mph (26 km/h). Ahead of the train, P468 signal was displaying a red aspect (figure 16).
- 62 At 12:59:08 hrs, the JI for the Up Slow line to platform 1 illuminated, followed within a second by the main aspect of P468 signal changing from red to green. Train 1A64 was at this time approximately 800 metres from the signal and coasting at 17 mph (27 km/h) (figure 17).

Figure 16: Train 1A64 reaches the start of the timer release track circuit for P468 signal at 12:58:59 hrs.

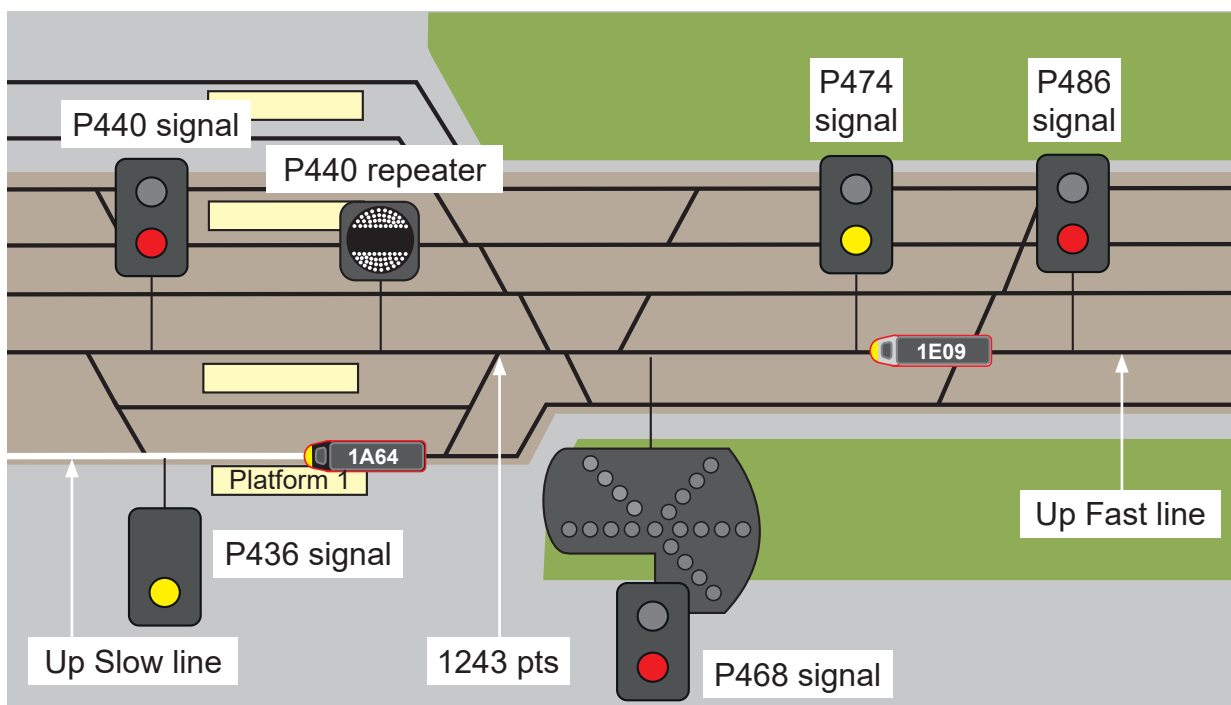
67 The train entered platform 1 travelling at 56 mph (90 km/h), still under emergency braking (figure 21).

Figure 21: Train 1A64 enters platform 1 at 56 mph (90 km/h) under emergency braking.

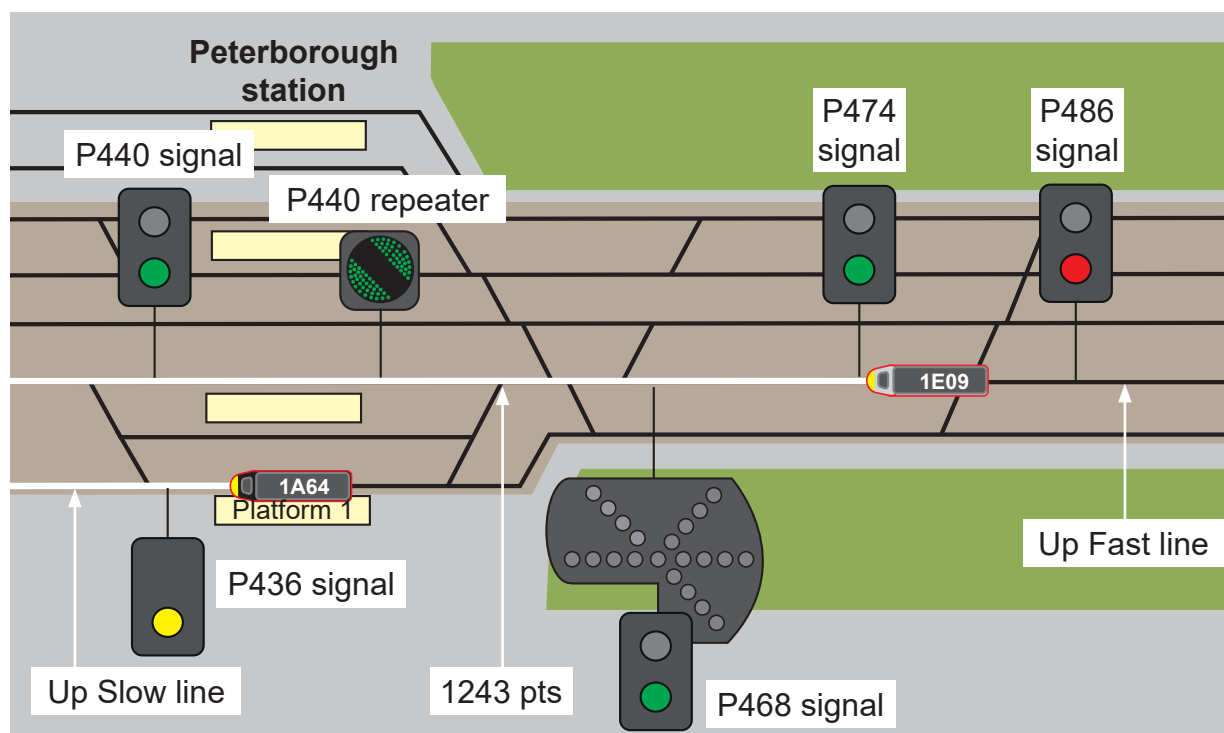
- 68 Train 1A64 came to a stop at 13:00:49 hrs within the limits of platform 1 (figure 22).

Figure 22: Train 1A64 stopped in platform 1.
