# ***AAIB Bulletin***

# ***10/2024***

<b>Aircraft Type and Registration:</b>	Vans RV-6A, G-RVSH	
<b>No &amp; Type of Engines:</b>	1 Lycoming IO-360-A1AD (Modified) piston engine	
<b>Year of Manufacture:</b>	2004 (Serial no: PFA 181A-13026)	
<b>Date &amp; Time (UTC):</b>	3 September 2023 at 1406 hrs	
<b>Location:</b>	Truro Airfield, Cornwall	
<b>Type of Flight:</b>	Private	
<b>Persons on Board:</b>	Crew - 1	Passengers - None
<b>Injuries:</b>	Crew - 1 (Fatal)	Passengers - N/A
<b>Nature of Damage:</b>	Aircraft destroyed	
<b>Commander's Licence:</b>	Private Pilot's Licence	
<b>Commander's Age:</b>	60 years	
<b>Commander's Flying Experience:</b>	261 hours (of which 115 hours were on type) Last 90 days - 6 hours Last 28 days - 3 hours	
<b>Information Source:</b>	AAIB Field Investigation

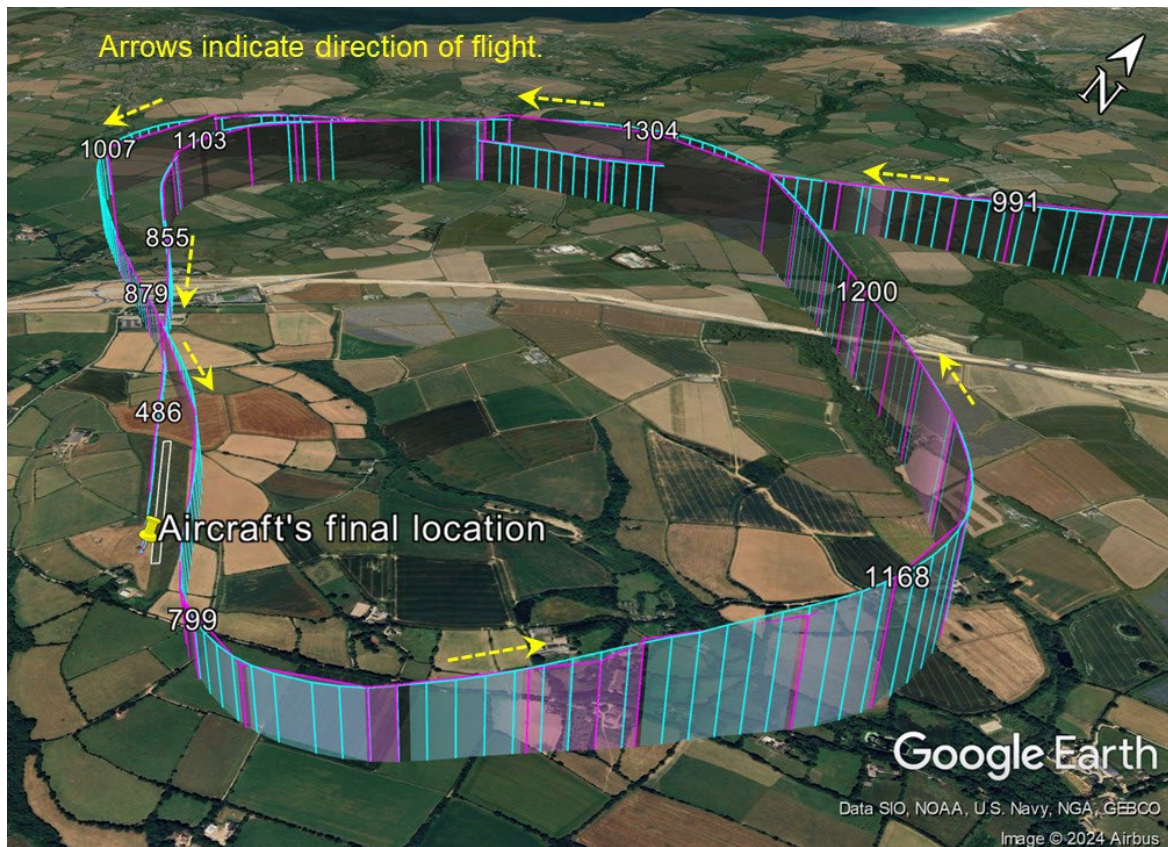
**Figure 4**

The iEFIS and EKP-V received GPS data from their own GPS antennas, which were collocated on top of the cockpit glareshield. The lateral difference between their recorded GPS positions during the final approach and landing was smaller than the typical error in GPS position measurement<sup>1</sup>, and indicated that G-RVSH was offset to the right of the Runway 14 edge by about 20 m. This is illustrated in Figure 4, which shows the flight path taken by G-RVSH before landing in the direction of Runway 14. The GPS tracks corroborated the positions of the wheel track marks found on the accident site (Figure 2).

GPS tracks from EKP-V (blue) and iEFIS (purple) recordings, with altitude amsl overlaid  
© 2024 Google, Image © Airbus

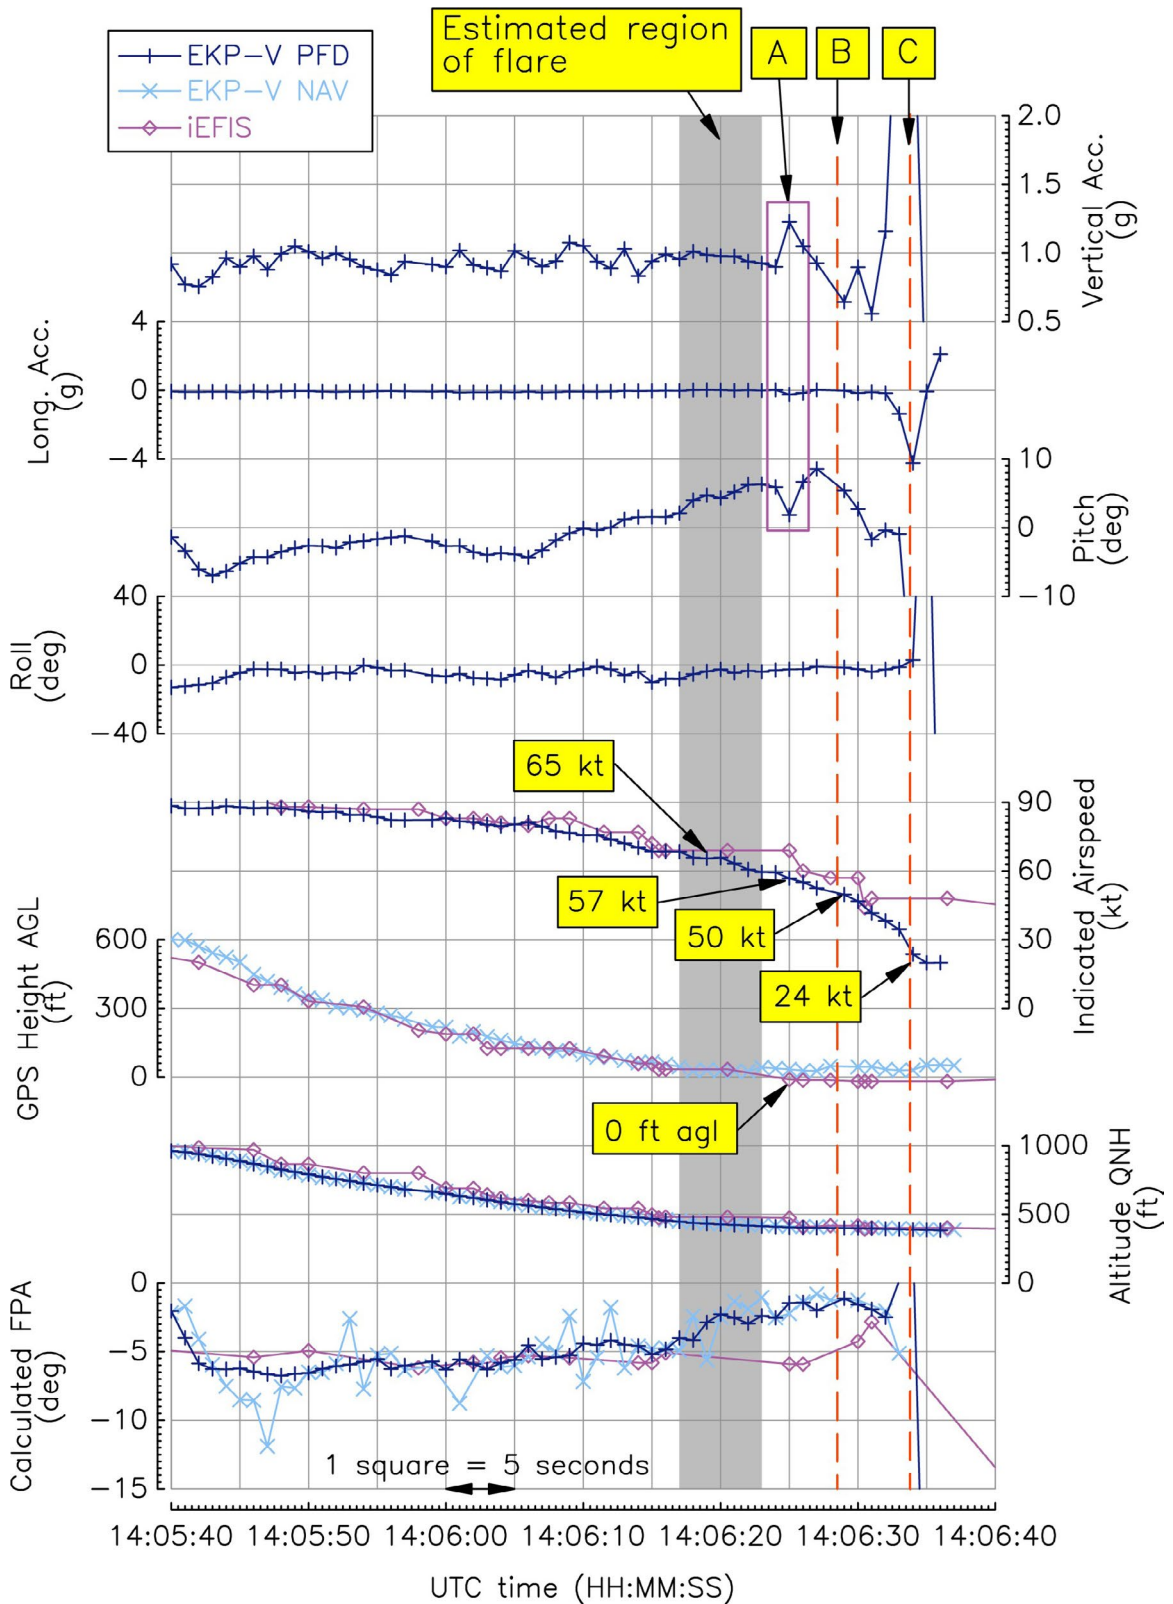
**Figure 5**  
Pertinent recorded parameters for the final 60 seconds of the flight

Figure 5 shows pertinent recorded parameters for the last 60 seconds of the flight. The Flight Path Angle (FPA) was calculated from the recorded data and indicates that the approach was flown at a FPA of between  $-5^{\circ}$  and  $-7^{\circ}$  until the flare. The accuracy of these calculations was limited by sensor measurement and calibration uncertainties, which are not known to the investigation.

The airspeed was about 90 kt at the start of the approach, gradually reducing to about 65 kt where the data indicates G-RVSH began to flare (shown as the shaded region in Figure 5). The recorded GPS position at 1406:20 hrs indicates that G-RVSH was abeam Runway 14 and about a fifth of the length along it when the flare was performed.

A change in vertical and longitudinal acceleration, and temporary reduction in pitch, were recorded shown as point A in Figure 5, and the airspeed was about 57 kt. The sample rate and precision of the altitude and vertical acceleration recordings were not sufficient to determine whether this data indicates a bounce, float or ballooning. Furthermore, similar fluctuations in the recorded vertical acceleration were observed in the data throughout the flight to Truro.

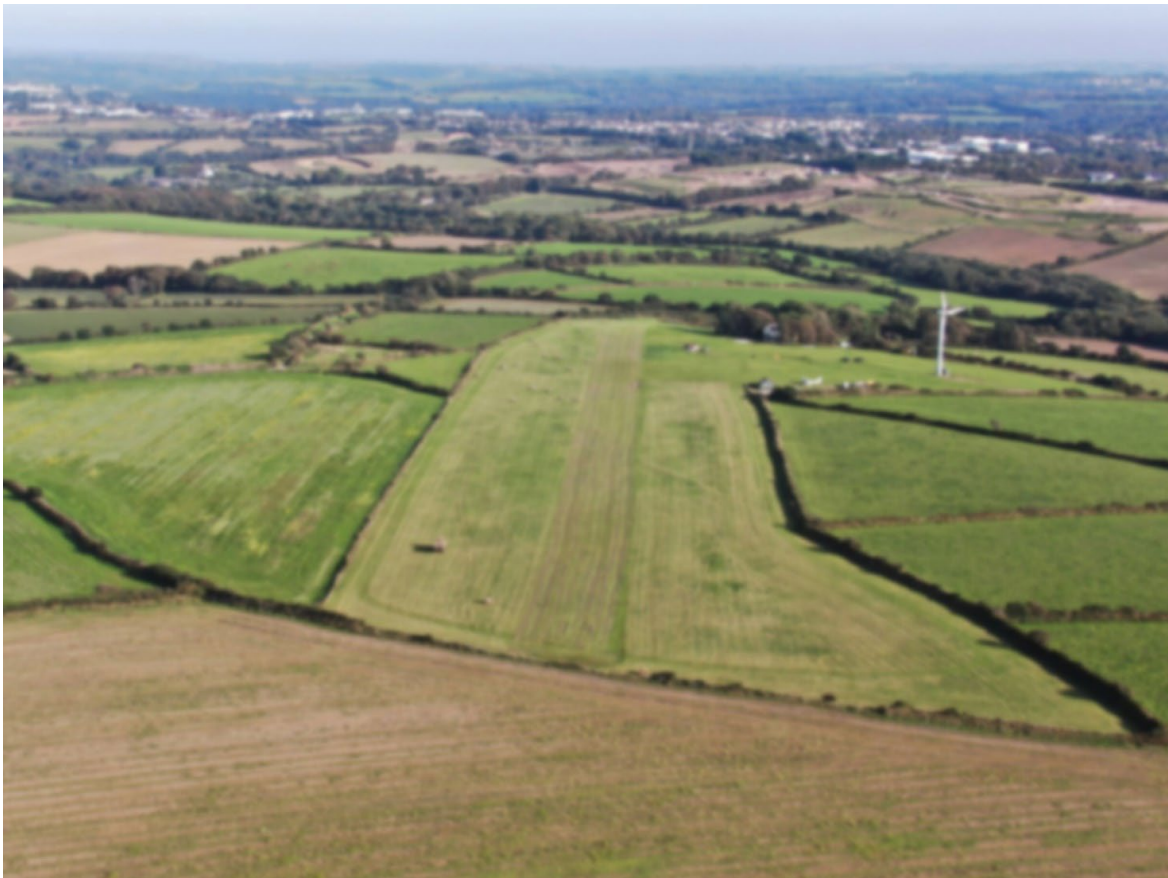
**Figure 12**

Figure 12 represents the vision of someone who had 6/9 binocular vision and illustrates the level of visual acuity and detail that the pilot was likely able to see on the approach had he not been wearing corrective glasses. A medical examiner stated that the pilot had mild short-sightedness where he "would not be able to see some small typeface on a PowerPoint presentation from the back of the lecture theatre." However, the medical examiner stated that the pilot should have been able to identify the airfield, make a circuit and approach, and see the vehicles in the field, but perhaps not any people working on them when he was at the 500 ft agl. His vision would have made identification of the threshold numbers and runway from this point difficult due to the lack of contrast.

View of airfield as per Figure 1, with image refracted to approximate the pilot's uncorrected eyesight (Note the comparison with Figure 1 might not be valid if viewed with low resolution devices or printed copies)

Figure 12 indicates that his uncorrected vision would not likely have affected his ability to discern the airfield. However, it would likely have made identification of the threshold numbers and runway difficult due to the lack of contrast seen from the 500 ft point.

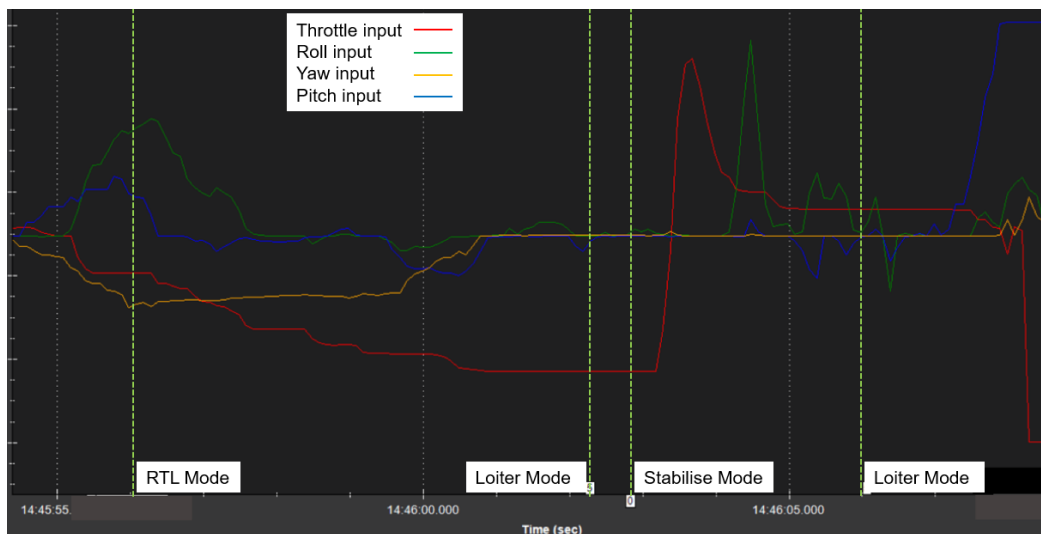
**Figure 3**

Data downloaded from the UA showed that at 1445:56 hrs (local) the aircraft entered RTL mode (Figure 3) and the throttle input was recorded as having reduced to 2.6% from an RP input; this had no effect in RTL mode. The mode then changed to LOITER for approximately 600 ms before going back to STAB where the throttle increased to 100% in less than 1 sec. A large roll input was recorded after which the mode was changed to LOITER. The aircraft deviated from normal flight attitude and was not under control. The throttle was recorded as reducing to zero. The aircraft then pitched up but as it was inverted, it struck the ground.

Pilot inputs
