Report on the investigation of
the capsizing of the recreational craft

Wheelyboat 123

with the loss of two lives
on Roadford Lake, Devon, England
on 8 June 2022

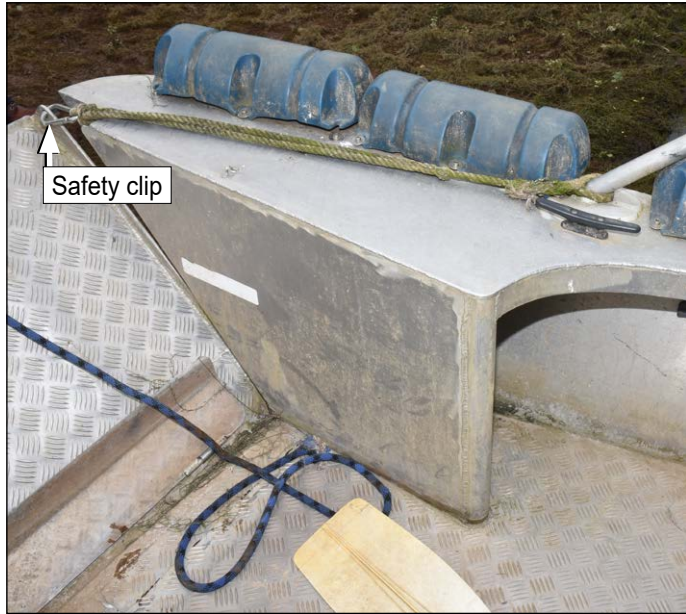
Figure 8: Bow door winch and safety clip

Observation	Figure
Safety notices and builder's plate missing from inside of bow ramp	Figure 8
Bow ramp vertical seals did not extend the full length of the bow ramp channel. A 150mm long section from the top of the channel was missing	Figure 13
Bow ramp watertight seal was degraded and deformed with small amounts of debris embedded in the seal	Annex D – E1, E2 & E3
A chalk test on the bow ramp seal indicated areas where the seal was not effective	Annex D – E3
The bow ramp seal failed a hose test allowing water to pass the seal	Annex D – E4
17 litres of water were drained from the starboard buoyancy tank	Annex D – E5
The buoyancy tanks' drain plugs were mismatched and the starboard plug was ill-fitting and lacked seals	Annex D – E6 & E7
There were small cracks in the deck	Annex D – E8
On the bow ramp, the welded hinge plate had a circumferential crack	Annex D – E9
The bow ramp hinge pins and bores were worn allowing movement of the bow ramp on the seal	Annex D – E10

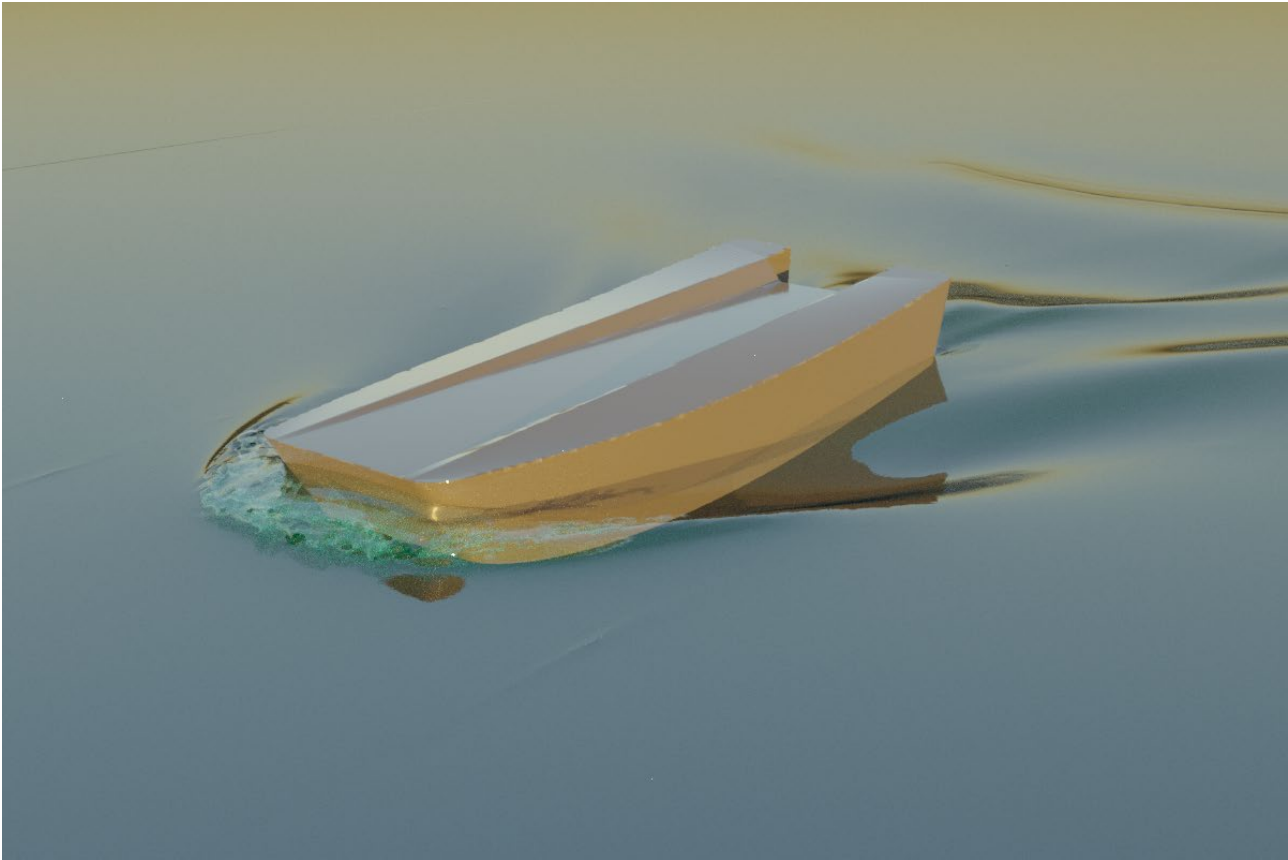
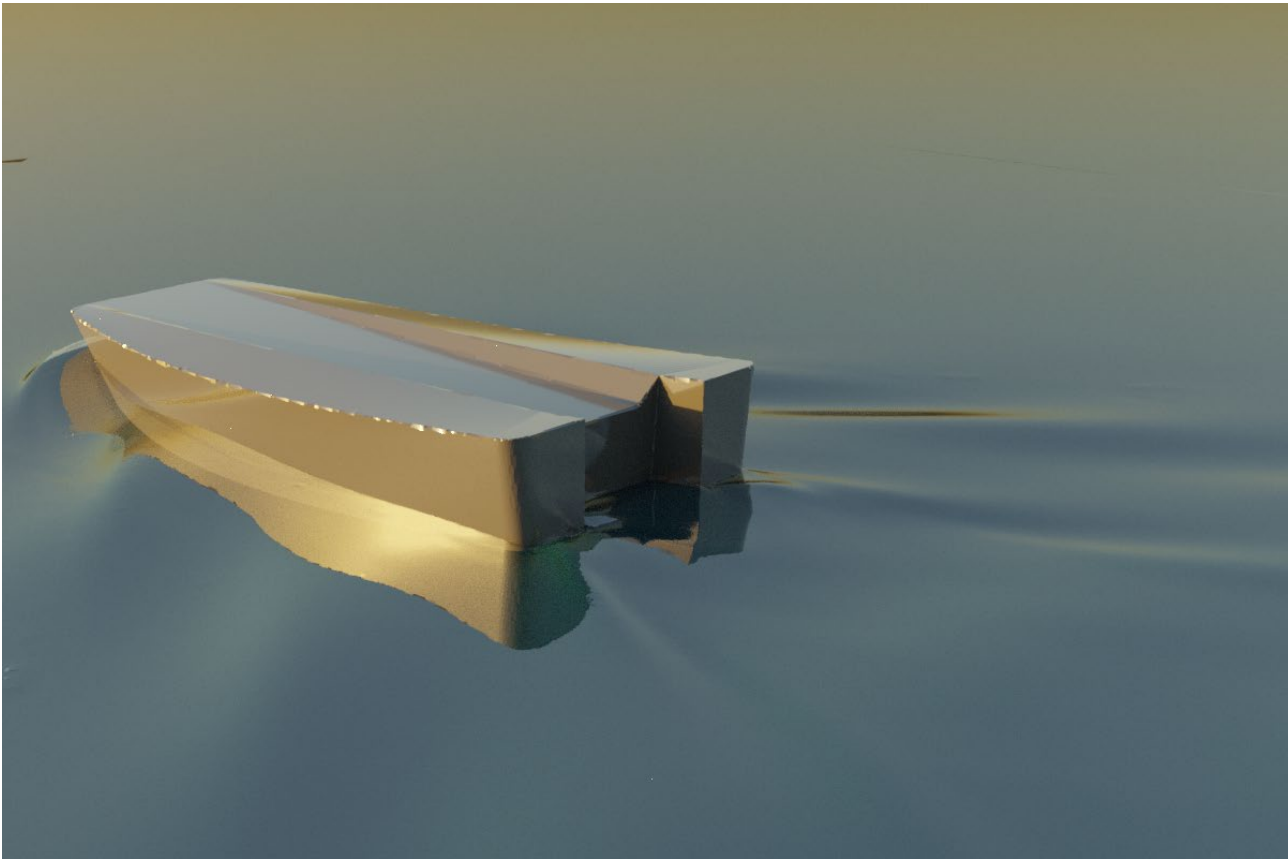
Figure 20 CFD predicted bow wave, loading condition: Pre-Turn #4, boat speed: 6 knots
2d slice through top of bow ramp seal, 475mm to port of vessel's centreline

The CFD results are presented in Table 8, renders of the wave pattern at 6 knots boat speed are shown in Figure 19 and a longitudinal contour of the bow wave in way of the port side ramp edge is shown in Figure 20.
