Rail Accident Investigation Branch

Rail Accident Report

Collision between a road-rail vehicle and a trolley near Brading, Isle of Wight 22 November 2023

Report 12/2024
October 2024

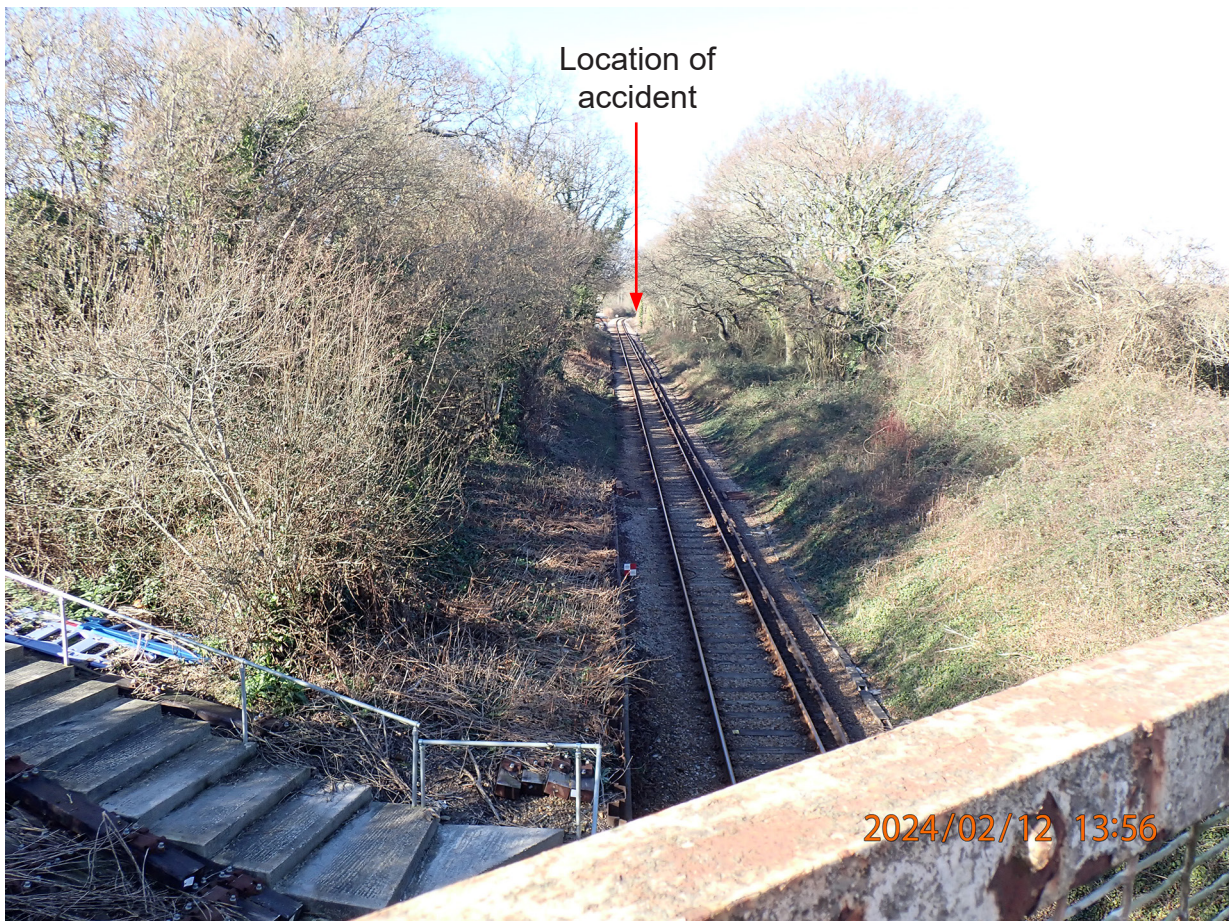
- 43 The COSS and the track repair work group then travelled by road to a track access gate at Rowborough Lane bridge (3 miles 60 chains) near the middle of their planned site of work (figure 7). The COSS phoned the ES at 00:25 to confirm they had arrived at the access gate, then briefed the work group that there would be an RRV in the area.

Figure 7: View from Rowborough Lane bridge looking north up the gradient towards location of accident.
