Rail Accident Investigation Branch

Rail Accident Report

Trap and drag accidents at Archway and Chalk Farm stations 18 February and 20 April 2023

Report 06/2024
June 2024

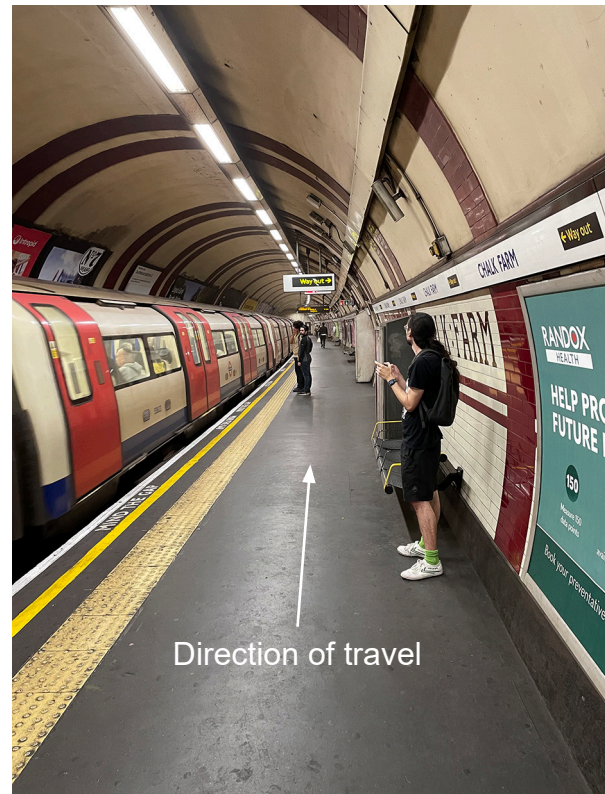
Figure 3: View southbound from the west (tailwall) end of platform 2 at Chalk Farm.

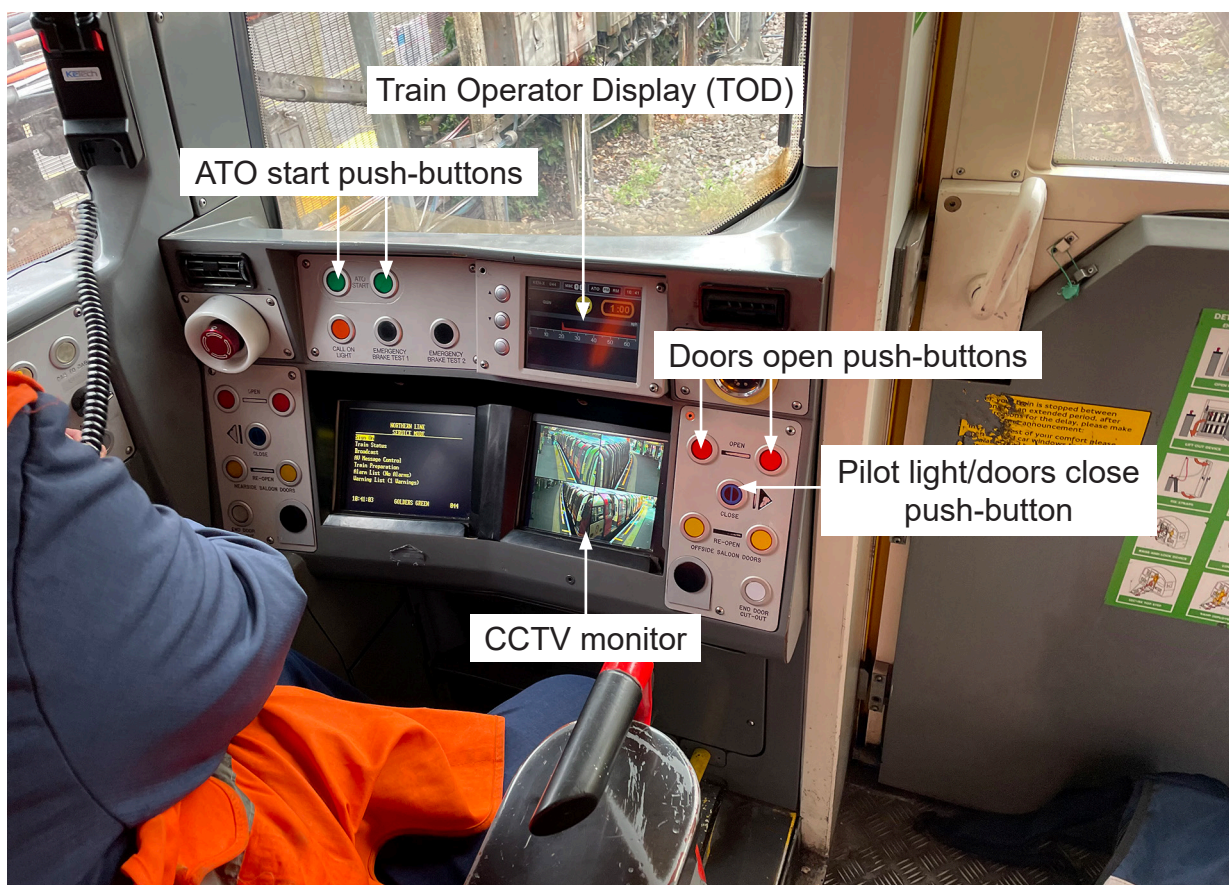
Figure 4: 1995 stock cab display and control panels. The panels to the left and right are for door operation on each side of the train. There is an LCD monitor to display platform CCTV images, and a primary display panel.

- 127 The monitor in the train cab is approximately 100 mm x 150 mm and displays images from cameras located on the platform (figure 4). The image is displayed on the monitor from just before entering a station until the last car has left the station (paragraph 11). OPO CCTV document No: S1150 issue A2 states: '*All presented images shall be either a 2-way full vertical split, 3-way vertical split or 4-way vertical split (no full captured image used).*' The split at Chalk Farm was into two images, rather than four smaller images. Although four smaller images may have given a closer view of the passenger, they might have taken more time to scan than two images.
