SB2/2024

JUNE 2024

**Fatal injury to a recreational diver  
after contact with the recreational diving support boat  
*Karin*  
in Scapa Flow, Orkney Islands, Scotland  
on 28 September 2023**

## MAIB SAFETY BULLETIN 2/2024

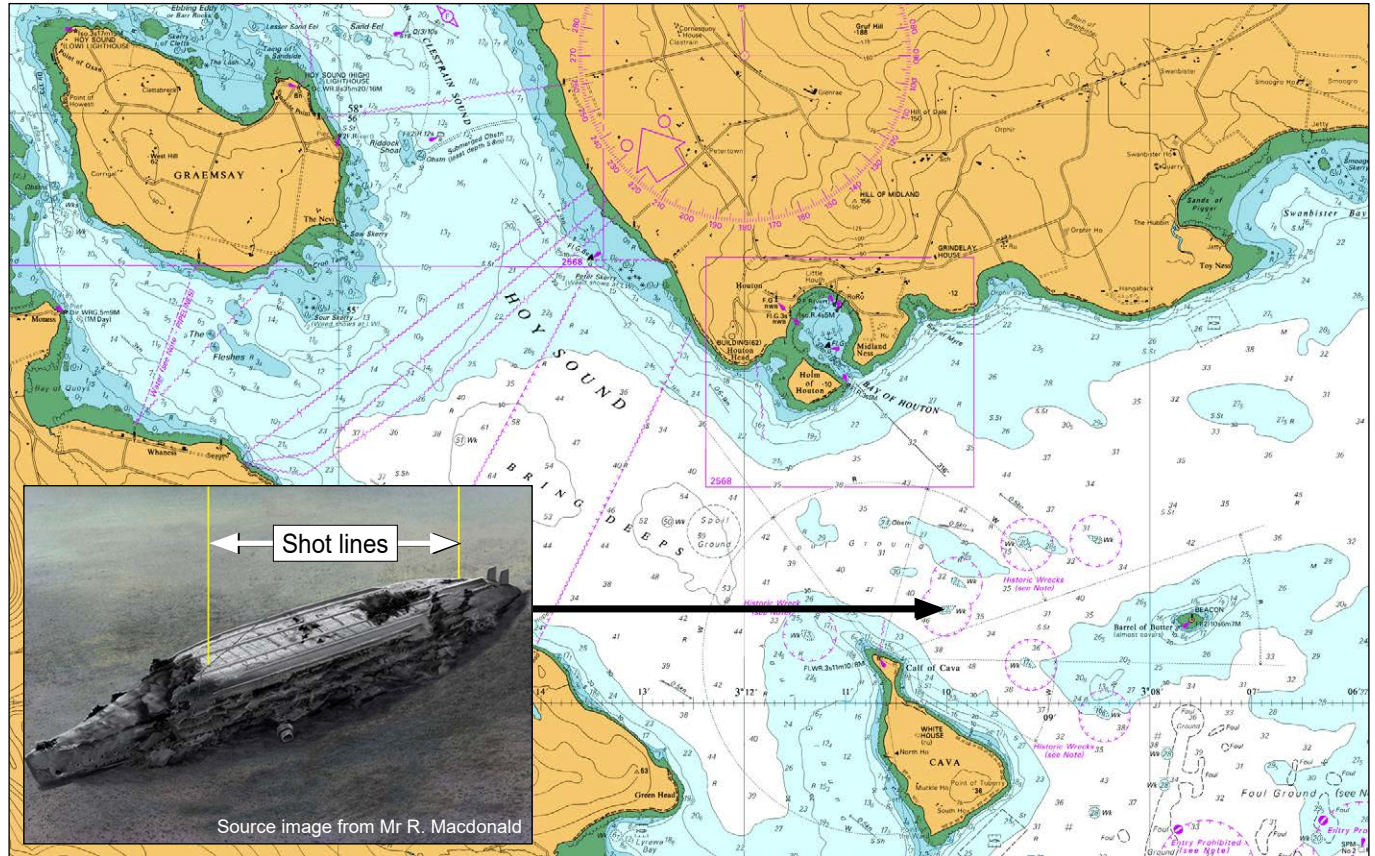
**Figure 1: SMS *Markgraf***

On the morning of 28 September 2023, a recreational diver carrying out decompression stops died, almost certainly as a result of being struck by the rotating propeller of the UK registered diving support boat *Karin*. The diver was diving from a second dive boat that was also supporting divers exploring the wreck of the German battleship SMS *Markgraf* (**Figure 1**), which was lying at a depth of 45m in Scapa Flow, Orkney Islands, Scotland.
