SB3/2024

Fatal man overboard from the fishing vessel

Kingfisher (DH110)

MAIB SAFETY BULLETIN 3/2024

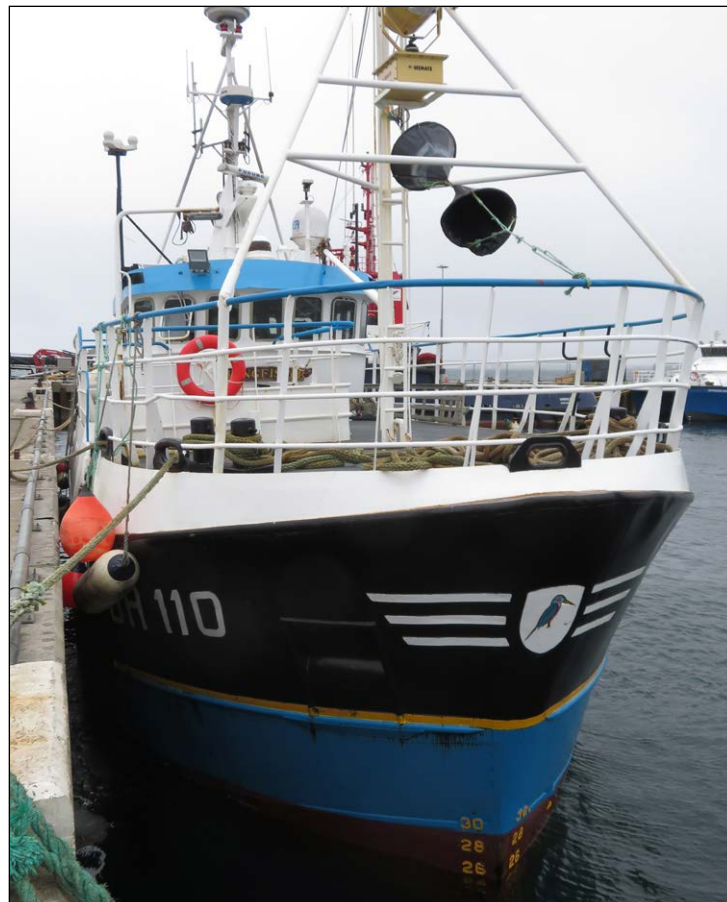
Kingfisher

The ongoing investigation has found that the vessel's risk assessment required a PFD to be worn when working on deck. The PFD worn by the deckhand was compliant with EN ISO 12402-2:2020¹ and had a red webbing lifting strop sewn onto the harness (see **figure**) that hung freely below the stole.

After the recovery of the deckhand, it was found that the leg rope of the last creel that had been shot away was threaded through the PFD's red webbing lifting strop. This had connected the deckhand to the running backrope and caused him to be pulled overboard. It is probable that the deckhand had inadvertently passed the toggle on the creel's leg rope through the red webbing strop while connecting the creel to the backrope.

Although some crew cutting the lifting strops from their PFDs removed the risk of entanglement it created another, as their PFDs no longer had the lifting strops necessary to recover them from the water if they fell overboard. Unauthorised modification of a PFD can cause damage, render it inoperable and invalidate its certification; this practice must be avoided.

The use of a PFD as PPE to mitigate the risk of MOB must not increase the risk of entanglement. The type of PFD must be appropriate to the method of fishing, correctly worn and consider factors such as inadvertent entanglement by either loose lifting strops or loose crotch straps.

- the hazards associated with shooting and recovering creels, such as the risk of entrapment in a running backrope, are fully mitigated;
- when working deck PFDs are provided, they are of the required standard and are appropriate for the work being undertaken by the deck crew; and
- when new hazards are identified, such as the risk of entanglement from loose lifting strops on PFDs, they share the information among the crew and source alternative PPE as soon as possible.
