Report on the investigation of
the fatal crush accident to a bosun during cargo
operations on board the roll-on/roll-off cargo vessel

Clipper Pennant

at Gladstone Dock, Liverpool, England

REPORT NO 16/2024

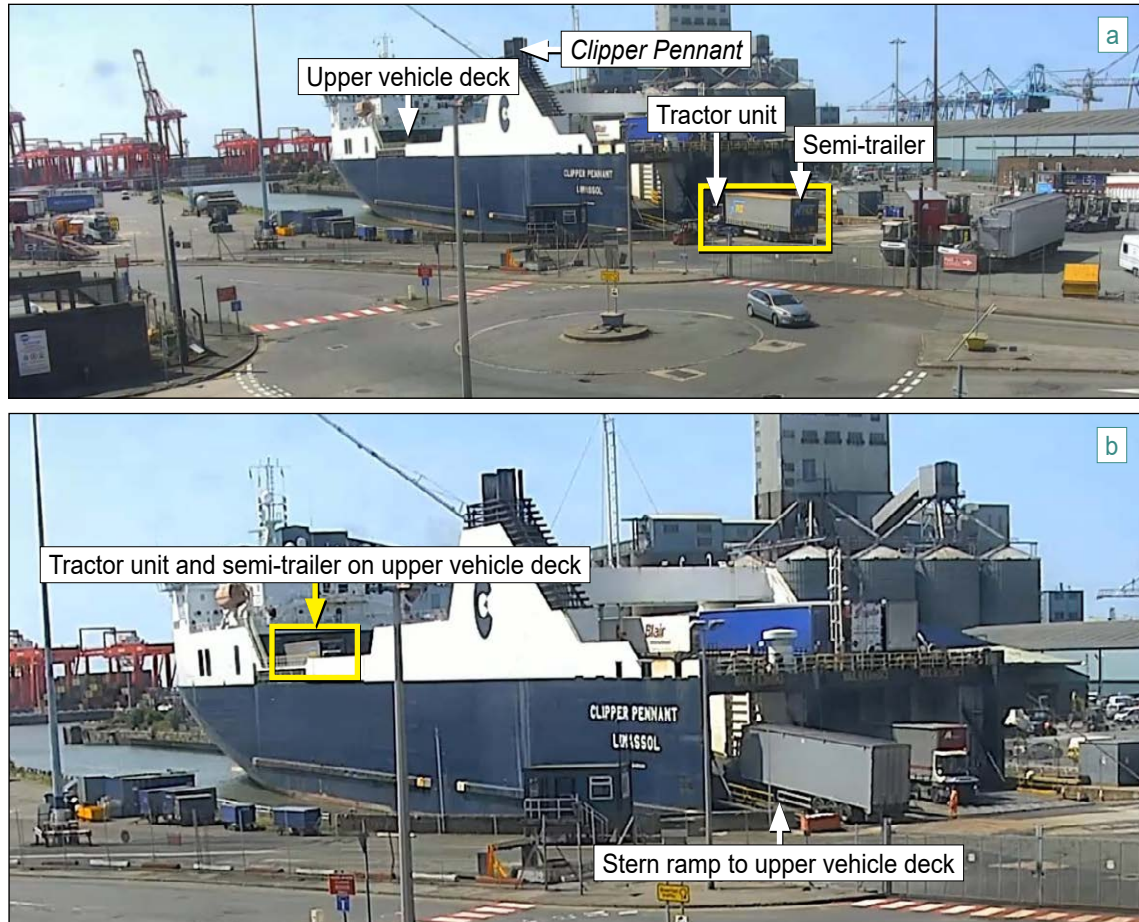
Figure 4: CCTV stills of the tractor unit and semi-trailer joining the loading queue (a) and manoeuvring into position on the upper vehicle deck (b)

At 1352, a tractor unit pulling a semi-trailer drove up the port ramp (**Figure 4a**) and onto the upper vehicle deck. In preparation to push the semi-trailer into stowage space 21, the tractor unit driver made an anticlockwise turn and aligned the semi-trailer with the appropriate lane (see **Figure 3**). The driver then applied the handbrake and rotated the seat assembly by 180° to face the semi-trailer.

The tractor unit remained stationary on the upper vehicle deck while the driver awaited further instructions from the bosun, who continued to act as banksman. The bosun was still lashing the rear chains of the adjacent semi-trailer in stowage space 20 and was not yet visible to the tractor unit driver. While waiting for the bosun to enter their line of sight the tractor unit driver removed the left side of their hearing protection to listen out for whistle signals⁴. Moments later, the bosun emerged from the rear of the adjacent semi-trailer and made his way over to the corner of the deck, where he was visible to the tractor unit driver. With the line of sight established, the bosun waved to the tractor unit driver to push the semi-trailer towards stowage space 21.

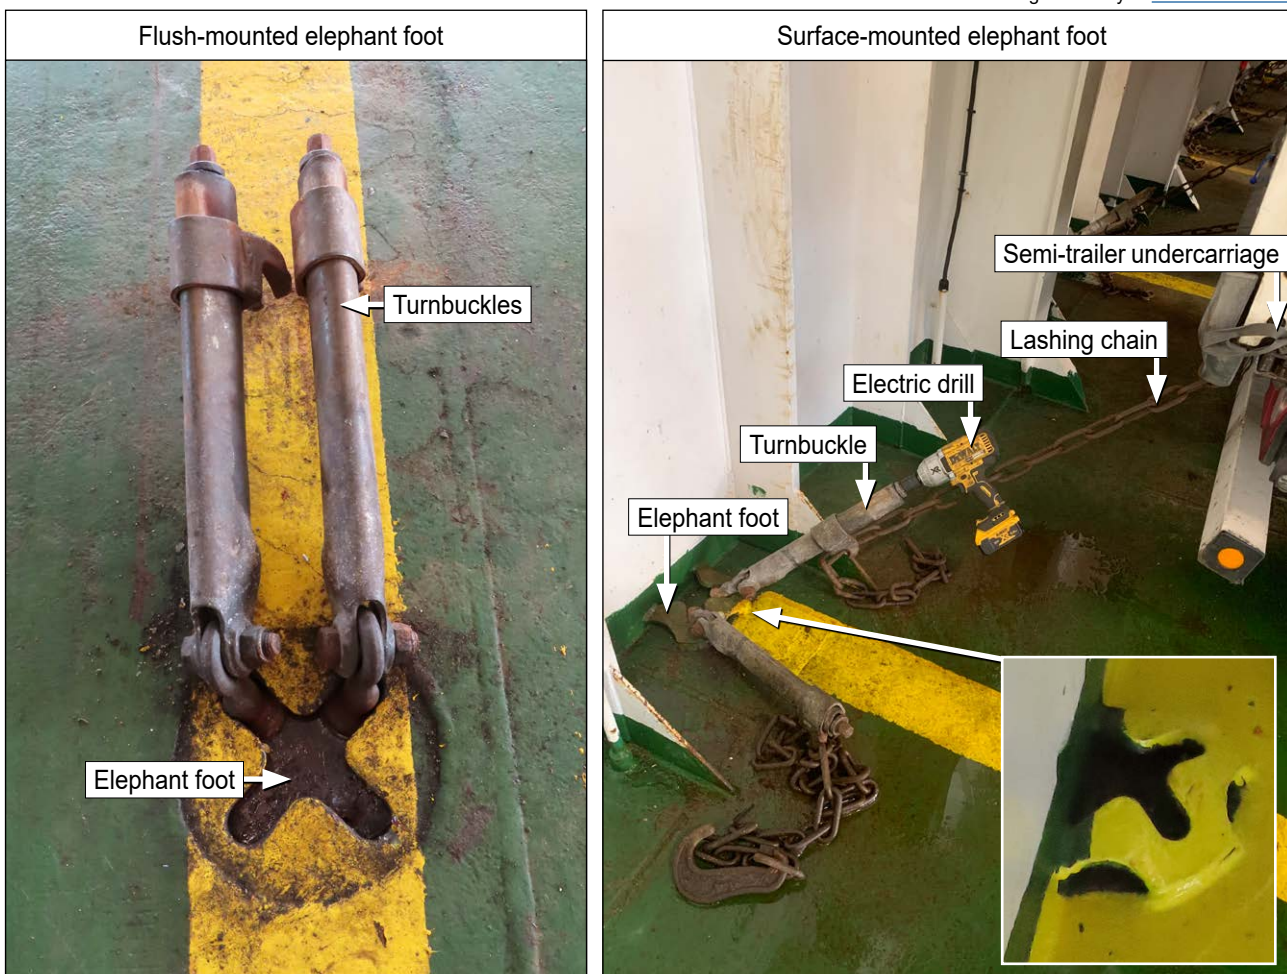
Figure 8: The elephant’s feet securing arrangement

Cargo securing points, referred to as ‘elephant’s feet’, were welded into *Clipper Pennant’s* vehicle decks and comprised cross-shaped openings used to lash a vehicle to the deck; this was a standard, industry-wide securing method. One end of the lashing chain was connected to the undercarriage of the semi-trailer and the other end was inserted into the elephant’s foot. The lashing chain turnbuckles were then tightened to avoid cargo movement when the vessel was underway (**Figure 8**).

The elephant’s feet were spaced evenly across *Clipper Pennant’s* vehicle decks, longitudinally and athwartships, to enable various vehicle loading configurations. Two types of elephant’s feet were installed: flush-mounted, allowing semi-trailers to be stowed either side of the elephant’s feet, which were fitted flush to the deck and measured 22.5cm in diameter at the deck’s surface; and surface-mounted, which protruded from the deck’s surface against bulkheads (**Figure 8**).

Yellow lines were painted through the elephant’s feet to denote the vehicle lanes. The lines provided a visual aid to help tractor unit drivers guide semi-trailers into their stowage spaces. Each painted yellow line measured around 18cm to 20cm wide and ran within the diameter of the elephant’s feet. This resulted in a lane width of 3m.

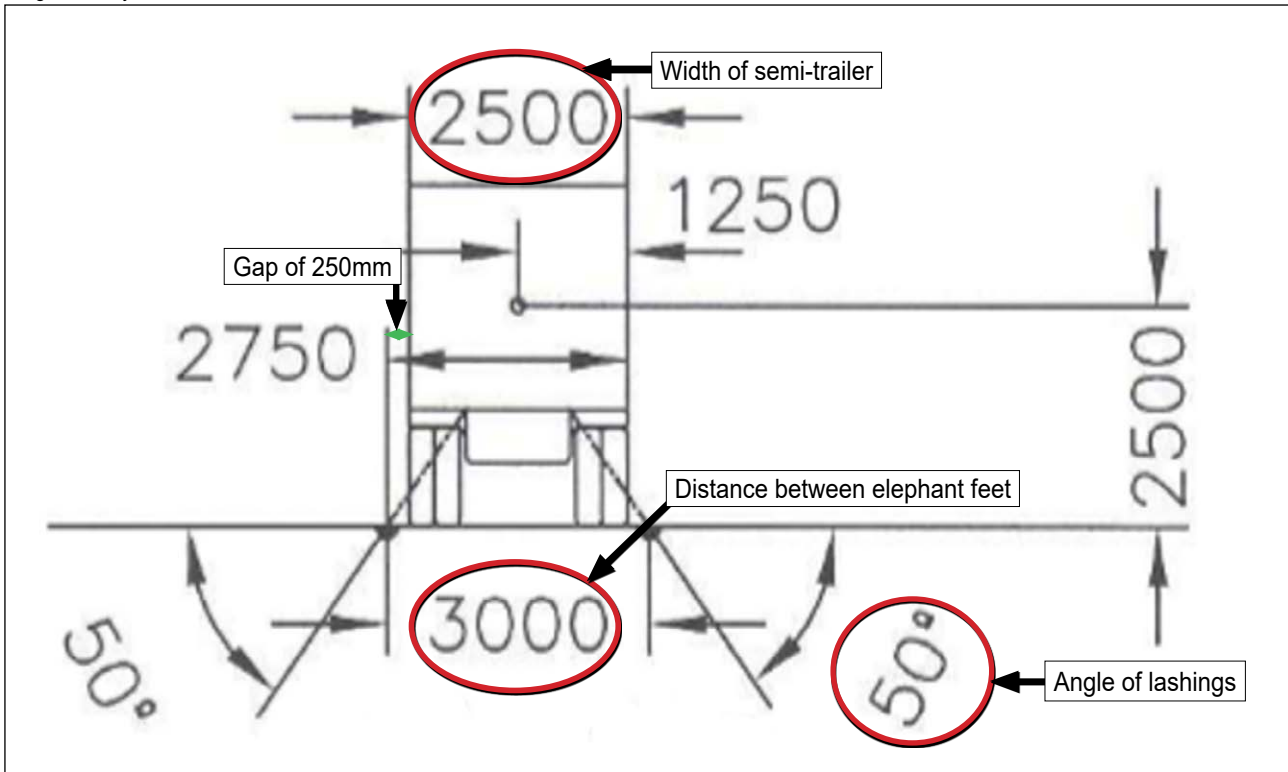
Figure 10: CSM extract, showing the semi-trailer and elephant's feet dimensions

The CSM illustrated the typical positioning of a stowed and secured semi-trailer with a width of 2500mm fitted inside an athwartships stowage space of 3000mm between elephant's feet (**Figure 10**). When the semi-trailer was positioned centrally in the stowage space there was a gap of 250mm between the side of the semi-trailer and the centre of an elephant's foot.

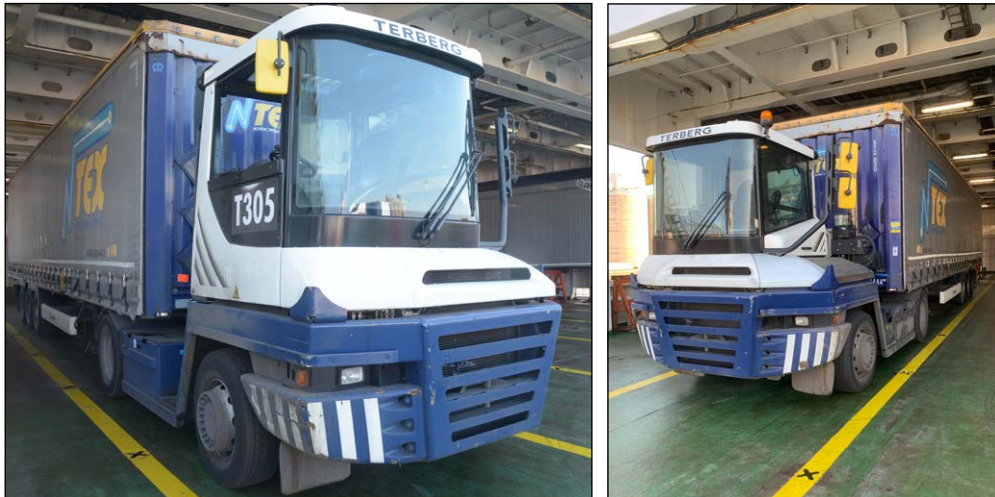
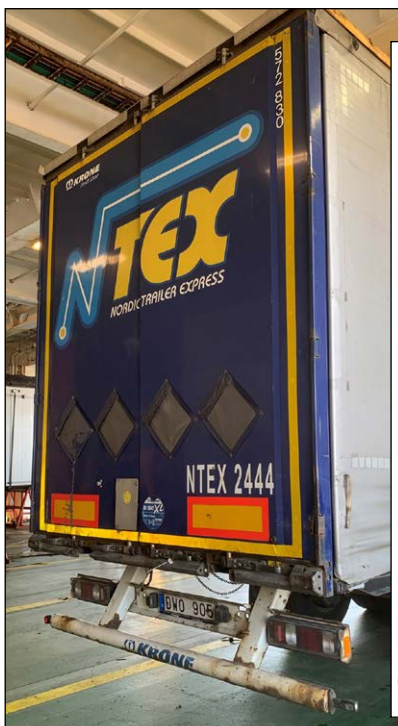
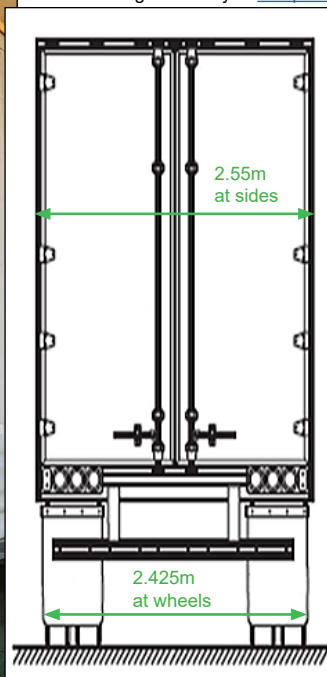
Figure 13: The Terberg RT223 tractor unit and Krone semi-trailer involved in the accident

The Terberg RT223 tractor units used to load and unload semi-trailers at Gladstone Dock were manufactured by Royal Terberg Group B.V. in the Netherlands. The units were designed for use at terminals and on board ro-ro freight ferries. Tractor units at the port were maintained by P&O staff. The tractor unit involved in the accident (**Figure 13**) had last been serviced in January 2021 and had no recorded defects that affected its drivability.

The tractor unit transported semi-trailers using a fifth wheel coupling arrangement comprised of a horseshoe-shaped device bolted onto the tractor unit's rear and a kingpin¹² that protruded from the undercarriage. Once connected, the semi-trailer rested and pivoted on the tractor unit's fifth wheel, allowing the semi-trailer to be pushed or pulled.

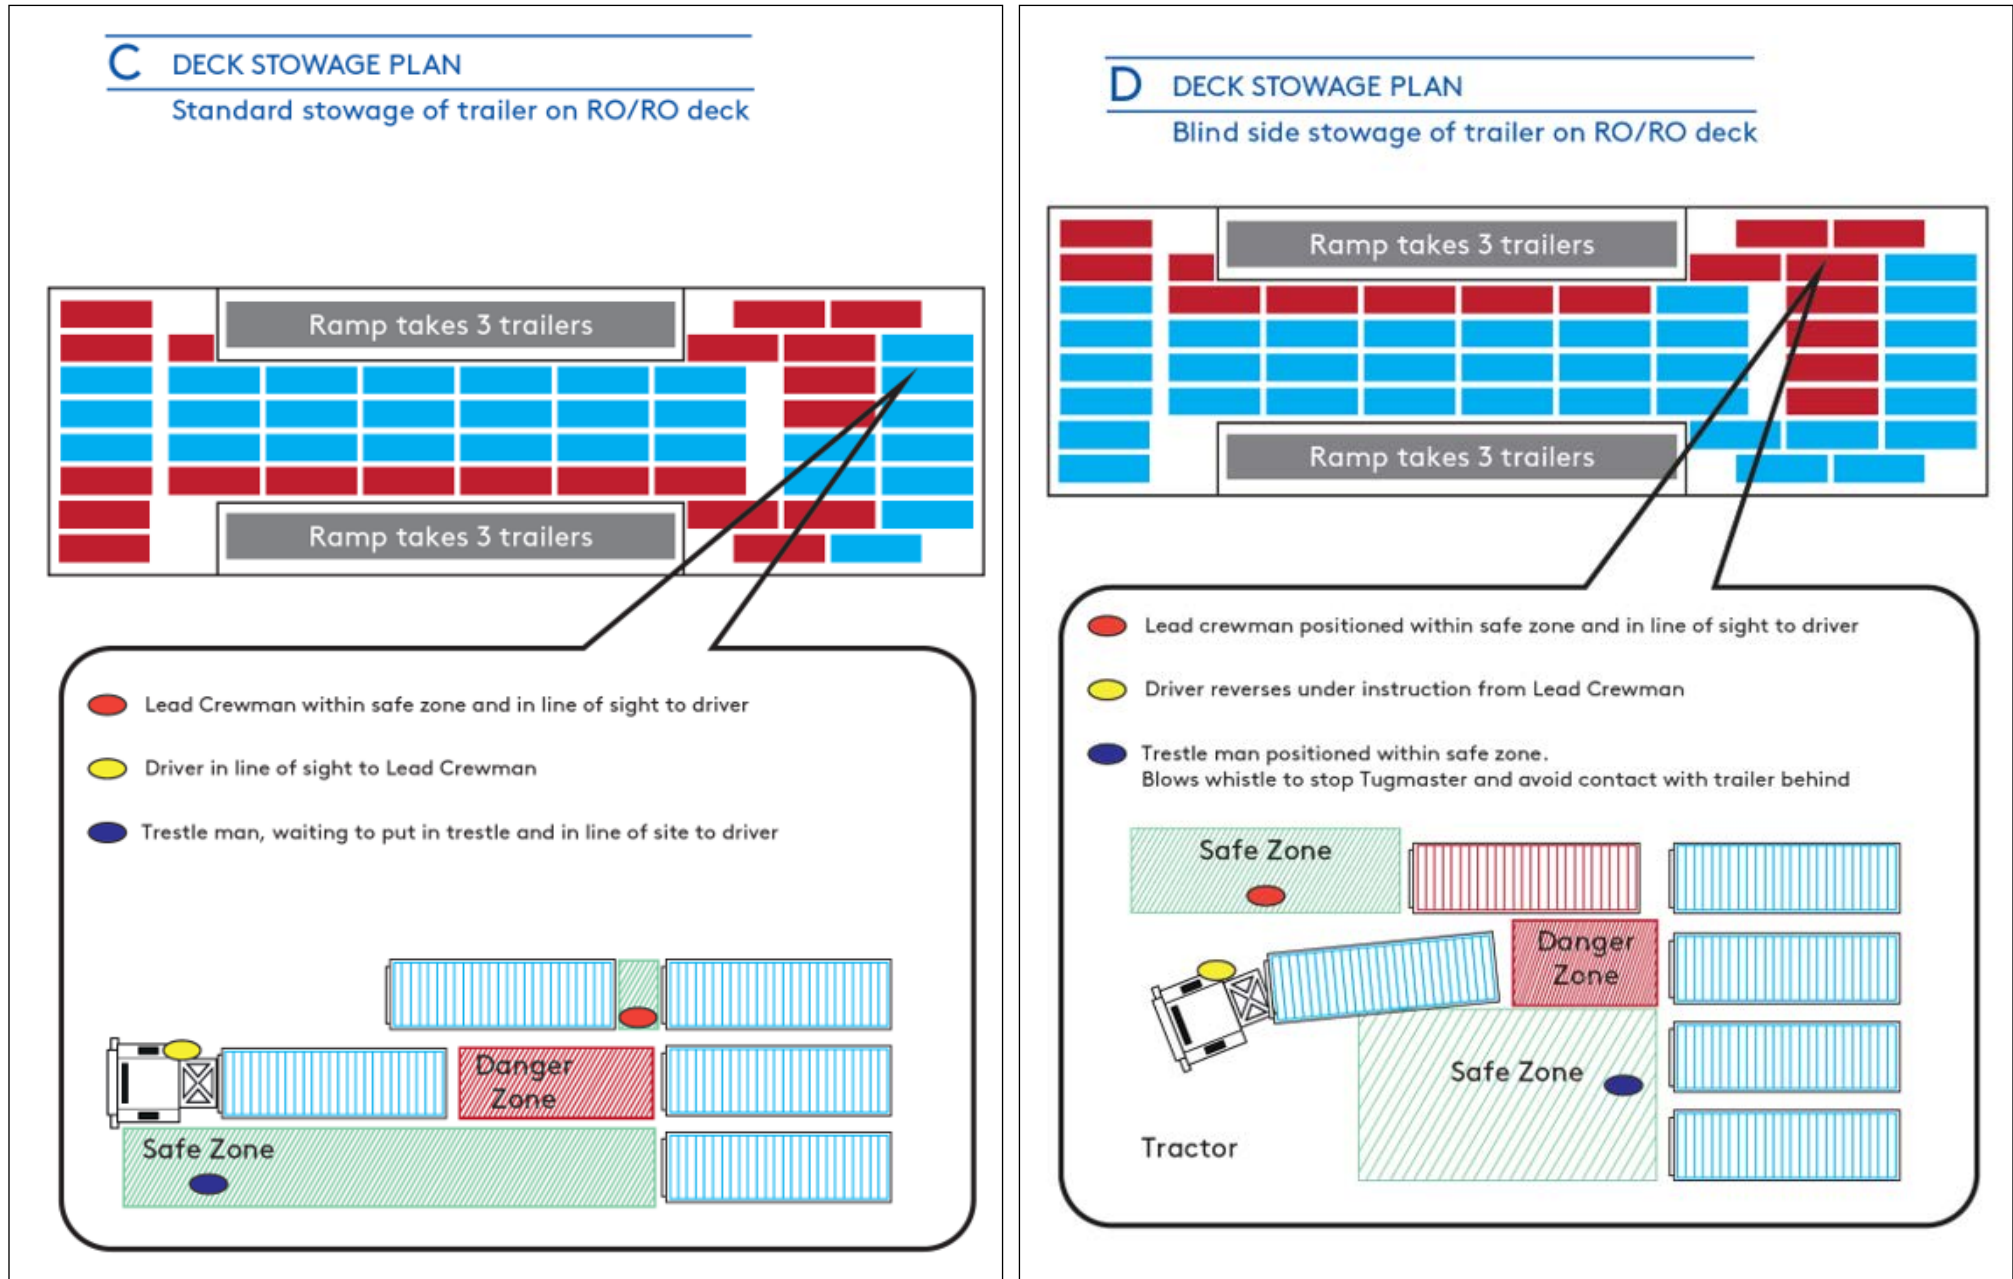
Figure 15: Extracts from P&O *Stowage of Trailers on Ro/Ro Vessel* pamphlet and P&O SSW, showing safe zones and danger zones during semi-trailer loading

The tractor unit driver carried a four-page pamphlet produced by P&O titled *Stowage of Trailers on Ro/Ro Vessel* that had been derived from the SSW (see section 1.10.1). The pamphlet contained diagrams of safe zones, danger zones (**Figure 15**), hand signals used by banksman and a table to record training, which was blank for the tractor unit driver.

SSW V28 identified safe and dangerous zones where the banksman could stand, covering scenarios where line of sight was maintained with the driver and trestle man and times when there was a blind spot (see **Figure 15**). It also detailed the various signalling methods permitted for the banksman to use. SSW V28 was accompanied by the four-page pamphlet *Stowage of Trailers on Ro/Ro Vessel* (see section 1.7.5).

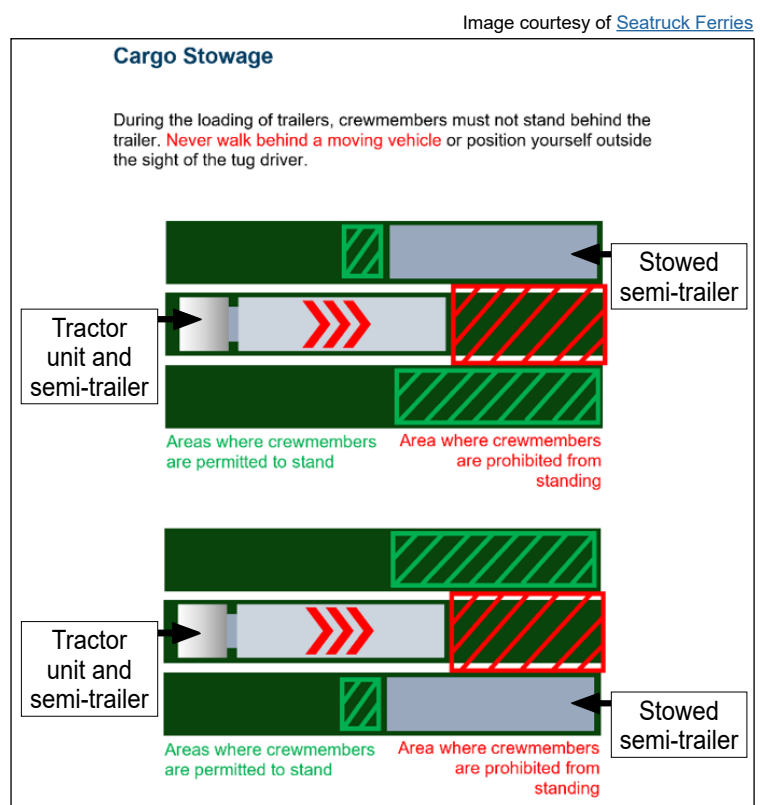
Figure 17: Extract from Seatruck's Deck and Safety Procedures Guide, showing safe and hazardous areas

The guide illustrated the safe positions for crew to stand when loading a semi-trailer and highlighted the areas deemed unsafe and prohibited (**Figure 17**). It did not contain specific information about the marking of vehicle decks, although an illustration of how to position safety barriers in the lower hold (**Figure 18**) used white lines to show lane markings and a thick yellow line to denote the walkway. The guide instructed that *Walkways must always be kept clear, position trestles and lashings so that they are not a tripping hazard.*

The bosun was aware of the guide and familiar with its content. The guide was not shared with P&O Ferries Liverpool or its tractor unit drivers.

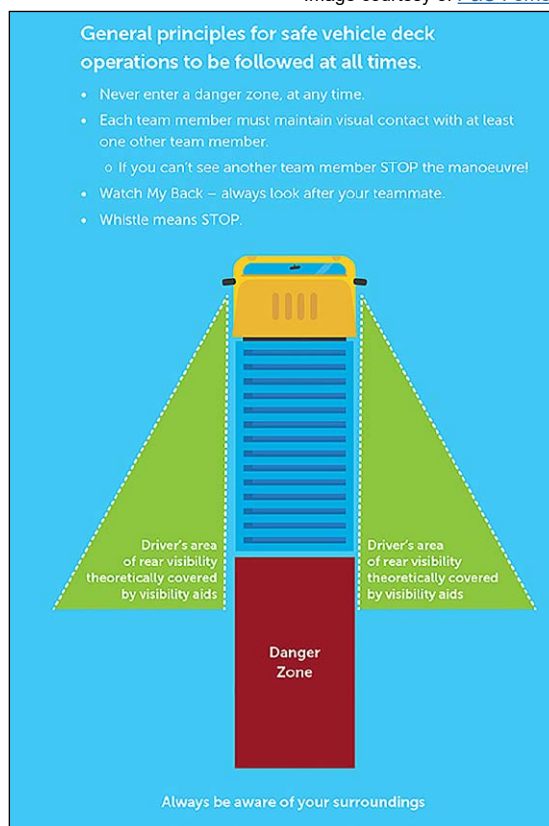
Figure 19: Extract from P&O's *Vehicle Deck Operations*, illustrating the general principles for safe vehicle deck operations

P&O also published *Vehicle Deck Operations*, an additional guide for staff involved in cargo operations to be read in conjunction with SSW V28. This was aimed at anyone who went onto a vehicle deck and focused on the human factors involved in the operation. The guide recommended additional safety enhancements, including dedicated pedestrian walkways to segregate people from vehicles and crash barriers to provide refuge. It also provided further guidance on driver visibility and danger zones (**Figure 19**).

The investigation established that tractor unit drivers were unfamiliar with SSW V28 and could not recall undertaking formal training based on its content.

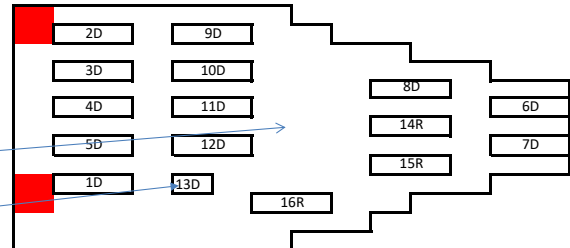
Photographs of the hazardous areas with no escape identified on board *Clipper Pennant*
