Accident

Aircraft Type and Registration:	Rotorsport UK Cavalon, G-CKYT	
No & Type of Engines:	1 Rotax 914-UL piston engine	
Year of Manufacture:	2018 (Serial no: RSUK/CVLN/027)	
Date & Time (UTC):	12 November 2020 at 1250 hrs	
Location:	Farmland between Avoch and Munloch, Black Isle	
Type of Flight:	Solo training flight	
Persons on Board:	Crew - 1	Passengers - None
Injuries:	Crew - 1 (Fatal)	Passengers - N/A
Nature of Damage:	Aircraft destroyed	
Commander's Licence:	Student private pilot	
Commander's Age:	67 years	
Commander's Flying Experience:	117 hours (of which 46 were on type) Last 90 days - 20 hours Last 28 days - 6 hours	
Information Source:	AAIB Field investigation

Synopsis

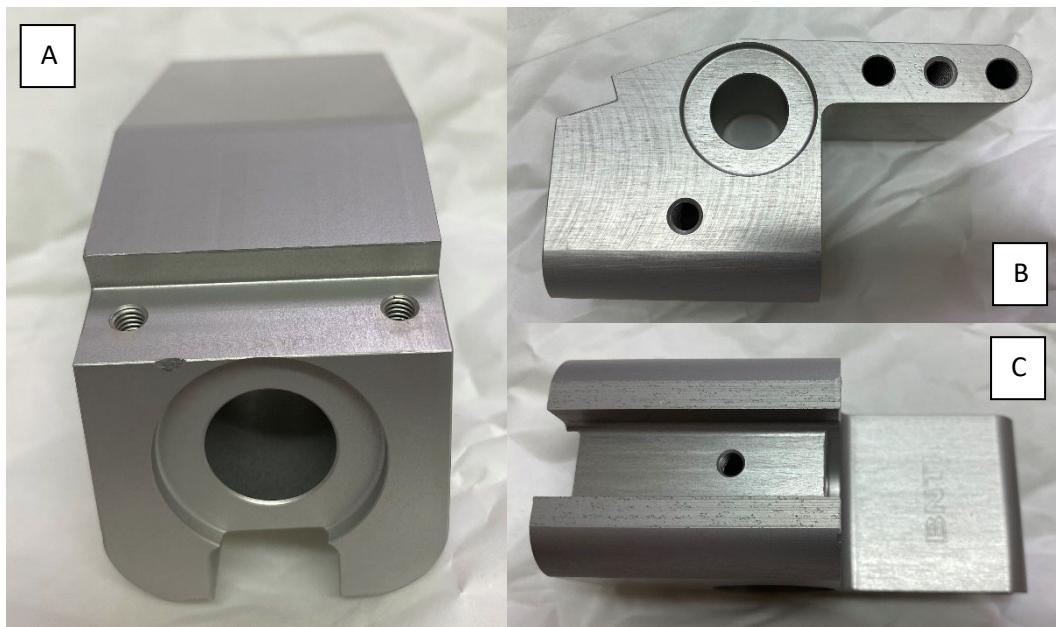
Figure 10

Gimbal block: A – rear, showing roll bolt hole and roll stop channel. B – right side, showing pitch bolt hole. C – bottom, showing roll stop channel and grub screw hole

The gimbal block had failed where two cracks joined. One ran vertically through the roll bolt hole and down the length of the block. The other fracture surface ran horizontally through the centre of the pitch bolt hole for half the width of the gimbal block until it met the vertical fracture surface. The pitch bolt was retained in place and secured the largest section of the gimbal block to the rotor head (Figure 13). The other smaller section of gimbal block was missing and despite an extensive search, could not be located on the accident site or the surrounding fields.

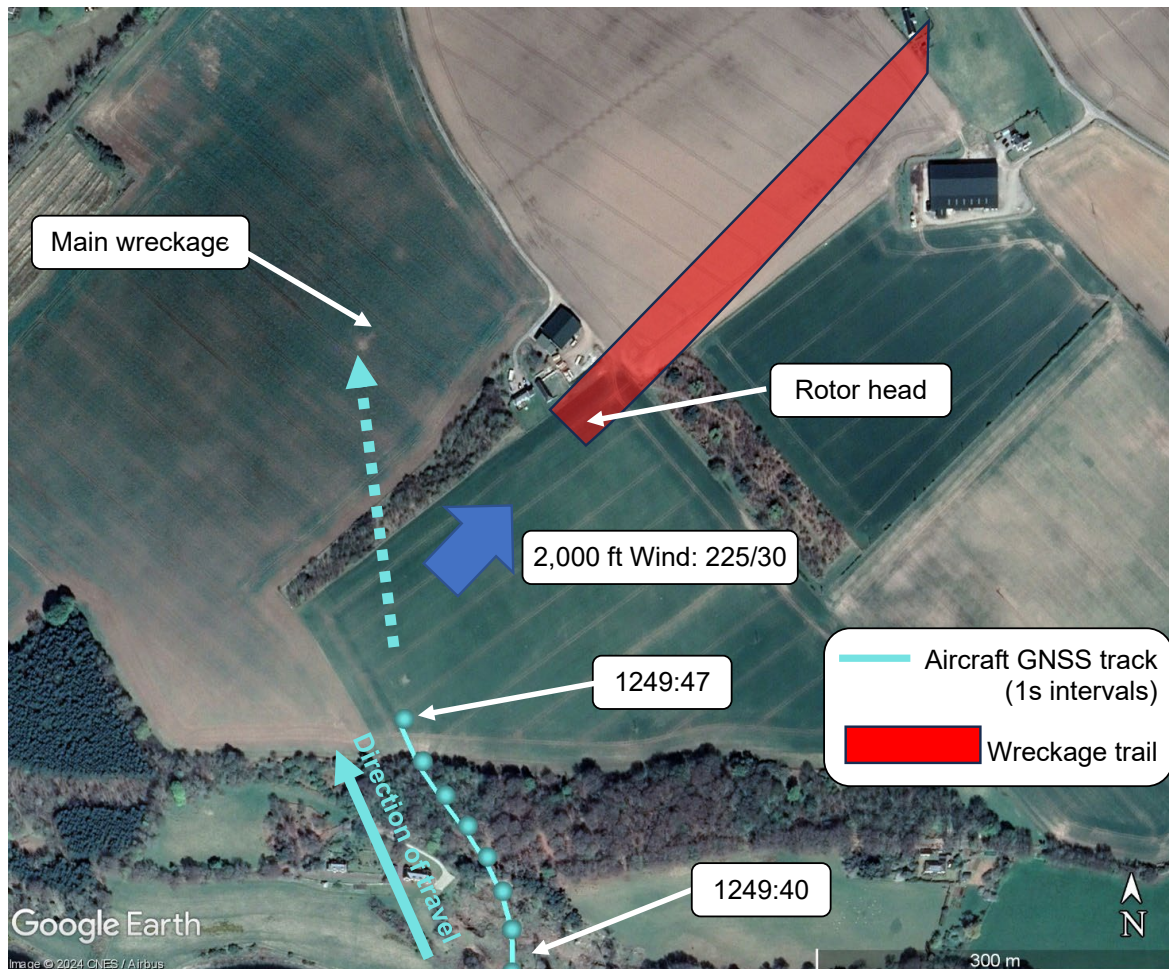
Figure 23

The recorded GNSS path up to 1249:47 hrs, wreckage location and estimated wind conditions were used to help estimate the approximate point of the rotor head failure (Figure 23). The gyroplane had sufficient height that the lightweight, low inertia debris released during the failure sequence was blown downwind to form a long wreckage trail roughly half a kilometre long. The wind direction at 2,000 ft was estimated by the Met Office but corresponds well to the direction of the wreckage trail. The gyroplane had a groundspeed of at least 70 mph during this period, so the debris would have travelled diagonally forward¹⁸ from the point of release. This gives some indication of when the failure must have occurred and is consistent with the period immediately before the data became unreliable.

Image showing wreckage trail and prevailing wind direction relative to the GNSS flightpath

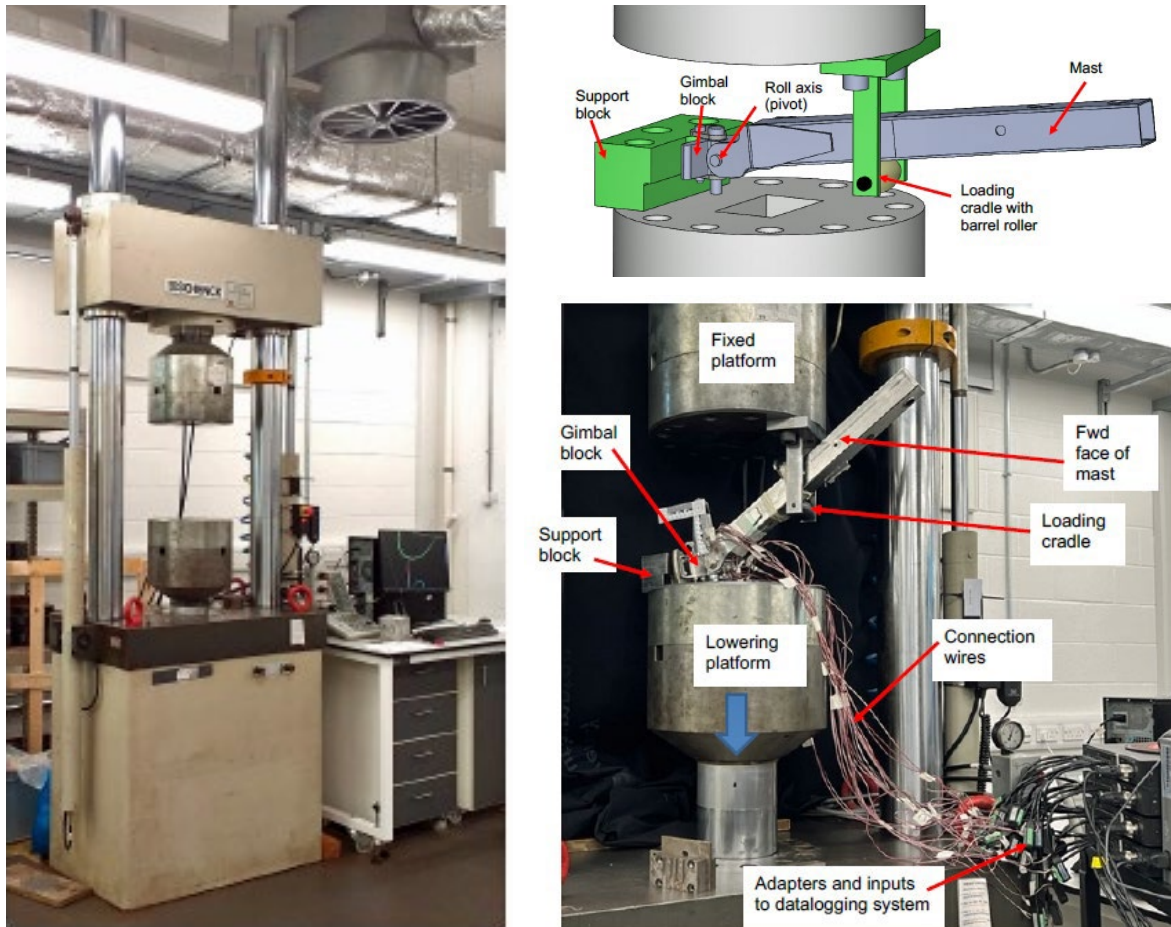
Figure 29

A rig test of an assembled mast and gimbal block was commissioned using nC² engineering consultants at the University of Southampton. The test was designed to apply a load to the side of the gimbal block roll channel, by rotating the mast until the roll stop bar on the mast made contact with the block, then continuing to move the mast to increase the load until the gimbal block failed.

Images of the test machine, test configuration and installed test piece with instrumentation

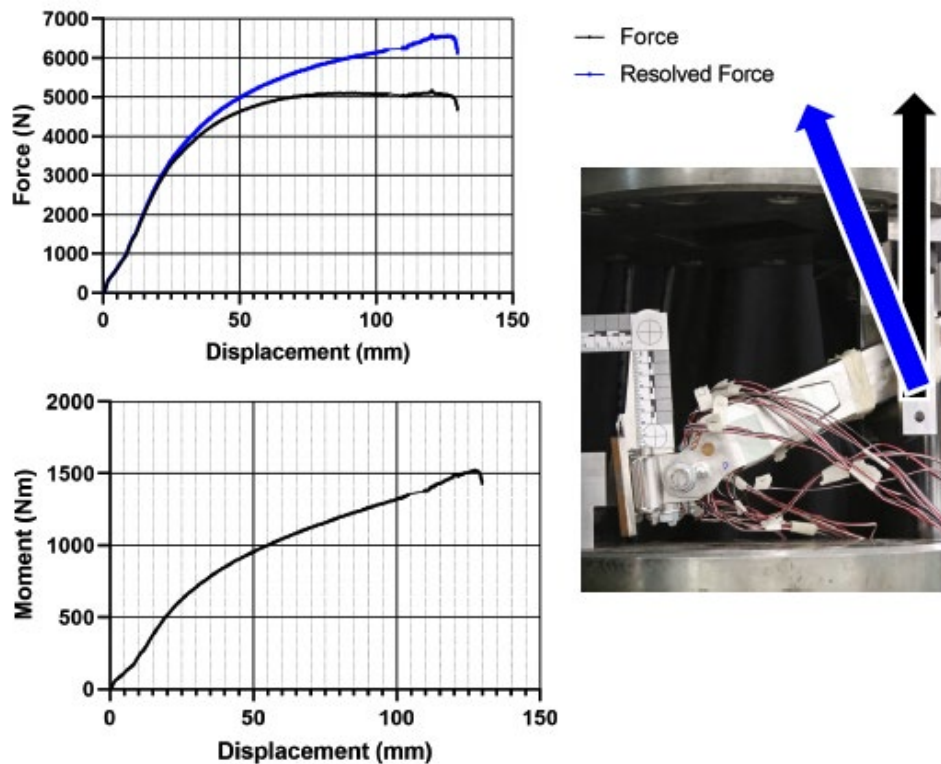
Figure 30

As the mast rotated around the roll bolt pivot continuously through the test, the vertical force readings from the test machine were resolved into a load and moment applied at the point of contact between the roll stop bar and the gimbal block. This raw data is shown in Figure 30.

Raw data test results showing the resolved force (blue) and moment acting on the gimbal block (black)

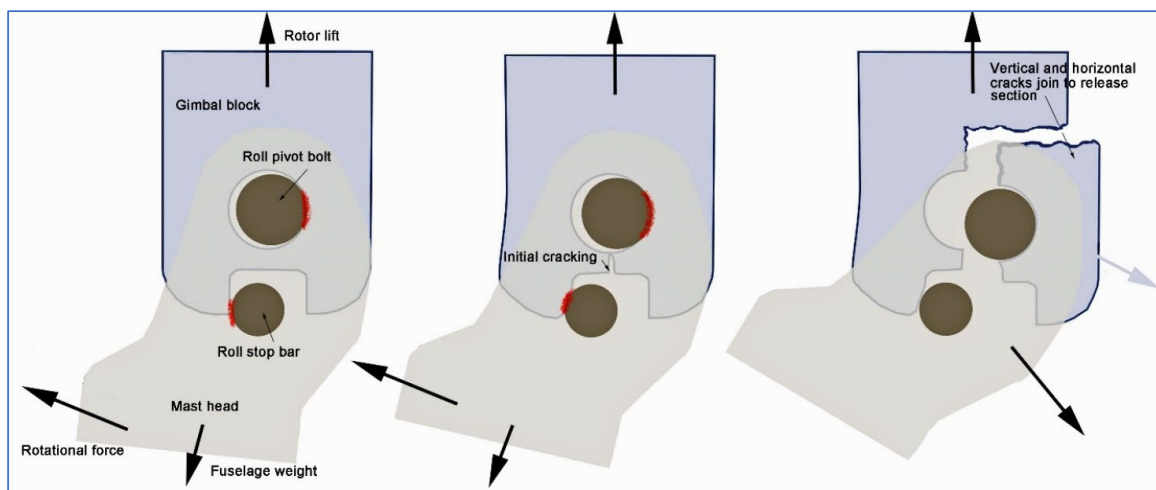
Figure 33

In flight, the gyroplane fuselage hangs from the roll pivot bolt fitted to the gimbal block. This also applies a vertical component to the force on the gimbal block equal to the weight of the fuselage (Figure 33). The damage to the accident gimbal block showed both vertical and horizontal fracture surfaces, with the vertical cracks occurring first, as seen in the rig test. Analysis of the fracture surfaces confirmed the overload had occurred during a single continuous event. As the cross-sectional area of the block carrying the weight of the fuselage was reduced by the vertical cracks during the accident flight, the horizontal cracks also formed due to overload. These cracks joined together resulting in a section of the gimbal block breaking off (Figure 33), allowing the rotor to detach from the fuselage. The separation of the rotor head was therefore caused by a structural failure of the gimbal block from exposure to dynamic flight loads during a single event.

Simple illustration of the final failure sequence of the gimbal block

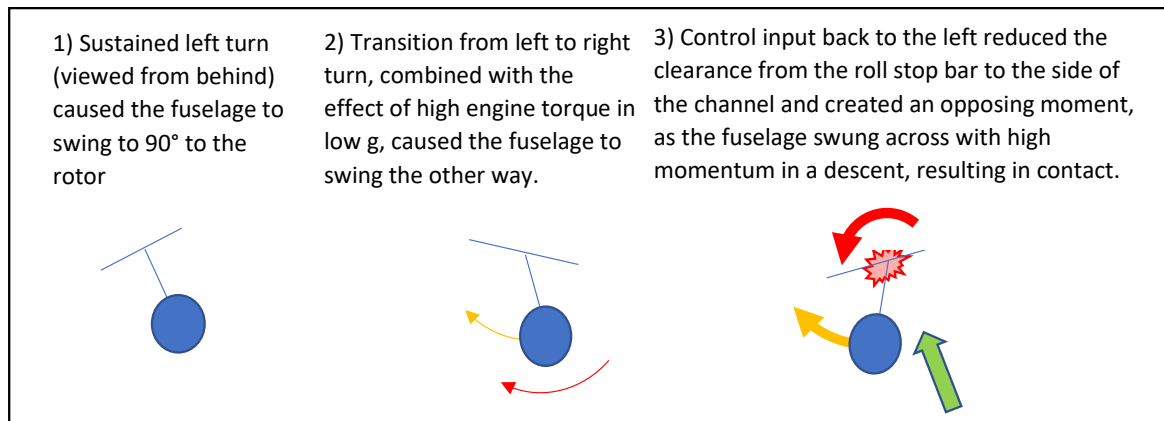
Figure 34

When the gyroplane transitioned between the left and right roll, the fuselage would have swung across with significant momentum. The torque induced rotation of the fuselage would probably have felt to the pilot like an uncommanded roll to the right, likely triggering an instinctive left roll input to counter it. This input would have changed the angle of the rotor relative to the horizontal. The lift and gyroscopic force and the weight of the rotor assembly opposing it effectively acts at the rotor pivot bolt which is a fixed distance away from the roll pivot bolt. The gyroscopic forces, the horizontal component of the lift and the weight vector would therefore create a moment around the roll pivot bolt and thus the contact point between the gimbal block and the roll stop bar. This would act to oppose the moment created by the fuselage rotating in the opposite direction, driven by the engine torque and inertia. This would likely have resulted in an impact between the bar and the gimbal block channel sufficient to generate the force required to cause the block to fracture, as confirmed during testing (Figure 34).

Response of the fuselage to the roll reversal inputs
