Contact between a moving train and an occupied pram at Banbury station, 8 June 2024

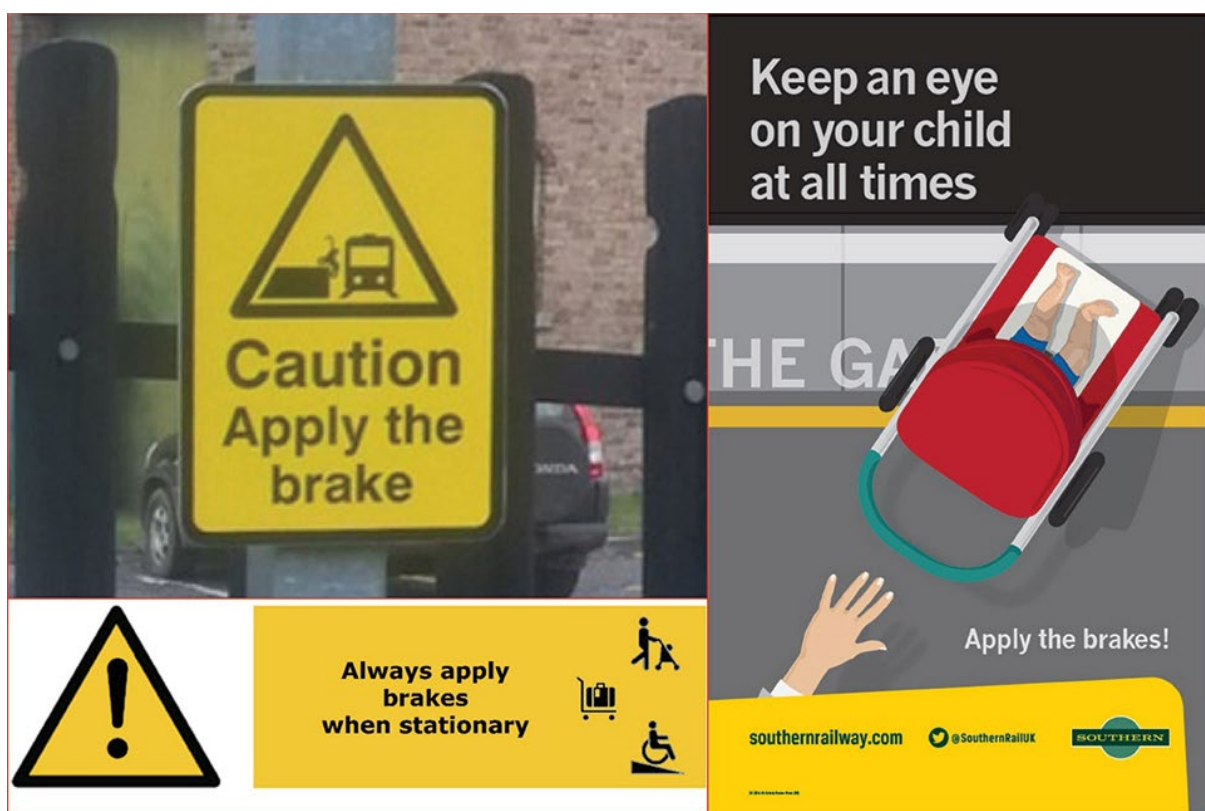
The location where the accident occurred had warning signage on the platform surface, in dark blue and white colour, stating 'Sloping Platform Apply Brakes'. However, the design of the signage was less likely to alert pram users to the hazard, as it did not comply with the general design language (and associated regulations) that are used to convey safety related information. The Health and Safety Executive document '*The Health and Safety (Safety Signs and Signals) Regulations 1996: Guidance on Regulations*', edition 3 dated 2015, outlines that red and yellow colours are used to convey a meaning of warning or danger. The colours that were used would have reduced the conspicuity of the signage against the dark grey colour of the platform surface. It is also possible that the pram or the presence of other passengers on the platform partially or wholly obscured this less conspicuous signage before the accident.

Examples of signage outlined in Rail Delivery Group published Guidance Note RDG-OPS-GN-022 'Safe Management of Pushchairs and Wheelchairs on Station Platforms' (issue 2, dated October 2019).
