Grounding and subsequent loss of the fishing vessel *Ocean Maid* (BA 55) on Cairnbulg Point, Aberdeenshire, Scotland on 24 October 2022

SUMMARY

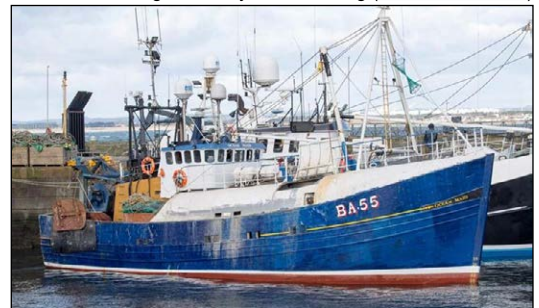
Ocean Maid

At 0549¹ on the 24 October 2022, the UK registered fishing vessel *Ocean Maid* grounded on Cairnbulg Point to the east of Fraserburgh, Scotland. The four crew evacuated to a liferaft and were subsequently rescued by the Royal National Lifeboat Institution. Two of the crew sustained minor injuries and the vessel later broke up and sank. There was no significant pollution.
