Report on the investigation of
a fall from height on the bulk carrier

Equinox Seas

resulting in one fatality

at ONEX Syros Shipyard, Ermoupoli, Syros, Greece

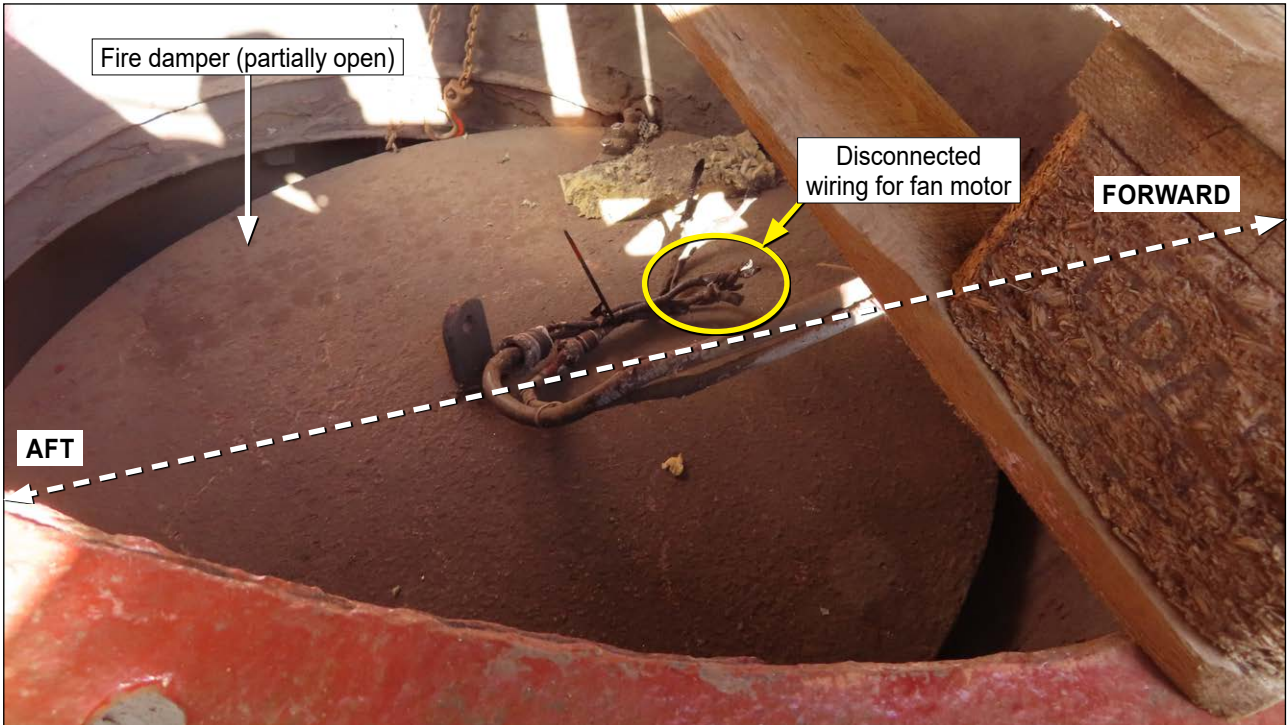
Figure 4: Starboard engine room fan pedestal fire damper

The starboard ventilation trunk fire damper comprised a steel disk pivoted along its central axis, offset by 45° to the centreline of the ship. The damper was designed to rotate by 90° between the open and closed positions. In the closed position, across the airflow, the damper rested against seats set into the pedestal. The aft inboard half of the flap rotated downwards to open the damper (**Figure 4**). An actuator was installed to allow the damper to be operated remotely.

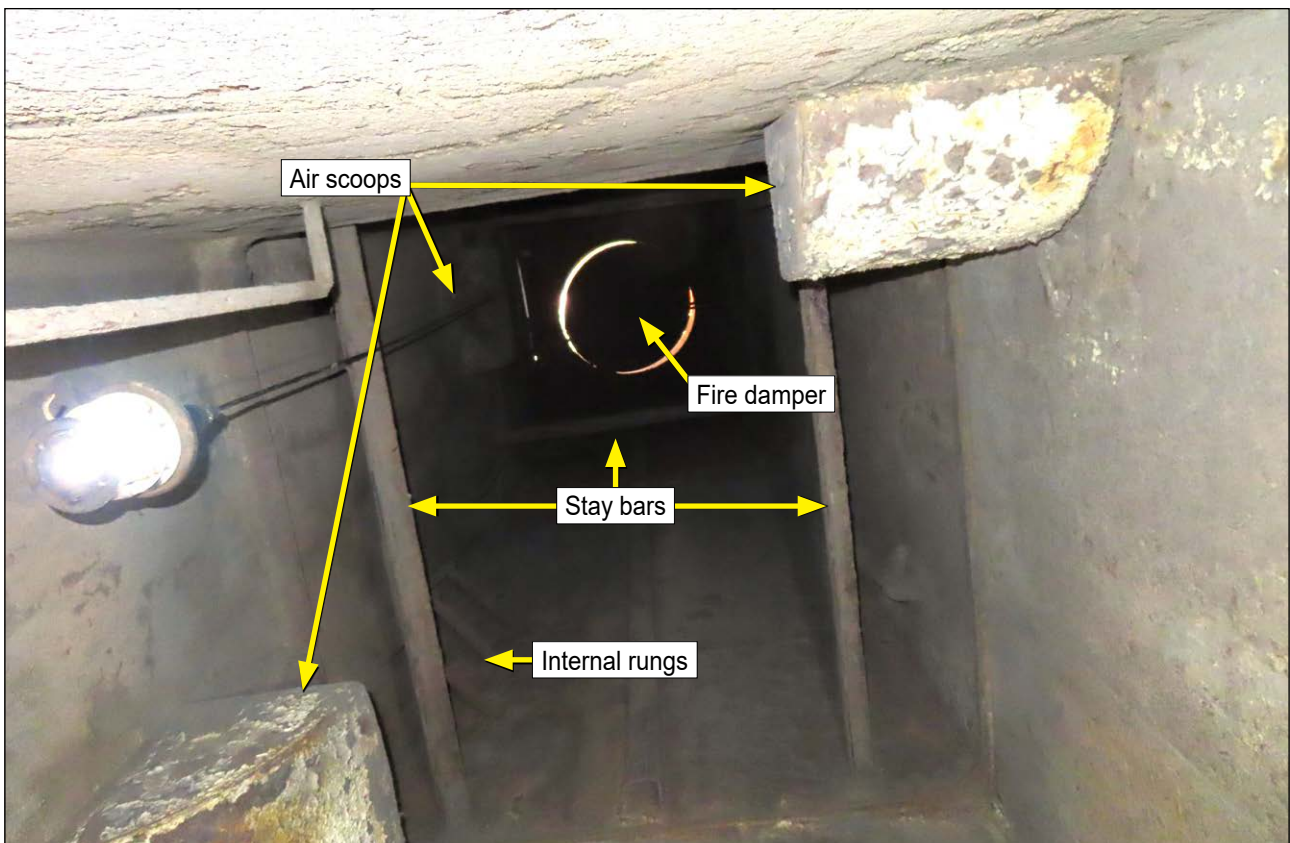
Figure 5: Starboard ventilation trunk internal structure, looking up from the access cover

At the base of the ventilation trunk at deckhead level on the second platform deck, a plenum chamber contained three distribution duct outlets that supplied ventilation to the engine room. Ventilation to the engine casing at main deck level and the first platform deck was provided by a series of scoops set into the vertical trunk leading to distribution ducts on those levels. The trunk was fitted with four stay bars of 50mm angle profile, two each at deck one and main deck levels. Internal rungs providing means to ascend the trunk for maintenance were installed up the forward outboard corner (Figure 5).

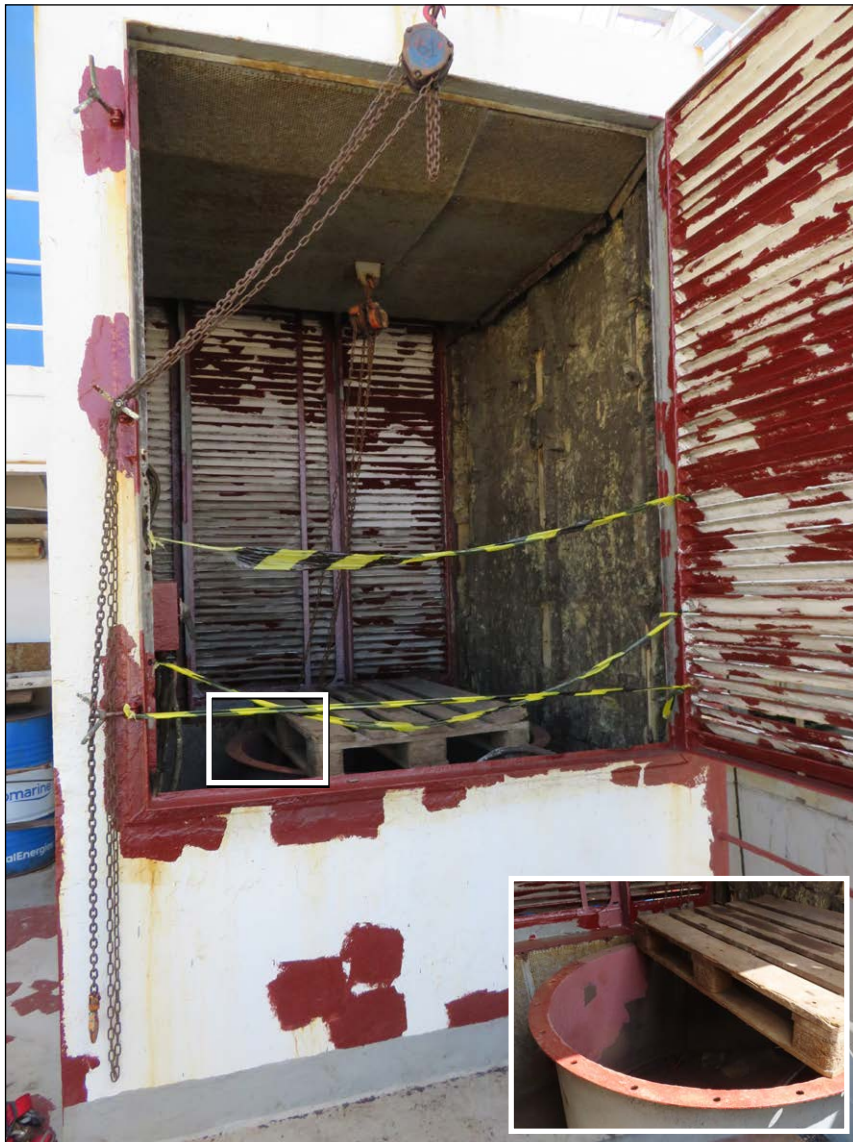
Figure 7: Painting work on the starboard fan room, showing the areas of red and pink primer paint applied by the deck crew

The removal of the fans enabled access to the rear of the fan room and the ship's deck crew were instructed by the C/O, under the direction of the outgoing master, to scale and paint the fan rooms. In the starboard fan room, the louvres of the fan room air inlets and the fan pedestal were scaled back to a good surface where corroded, and primer paint was applied (**Figure 7**). It was intended that the paintwork would be completed after the installation of the fan.
