Fatal man overboard from the sail training vessel *Pelican of London* at Sharpness, England on 2 October 2023

SUMMARY

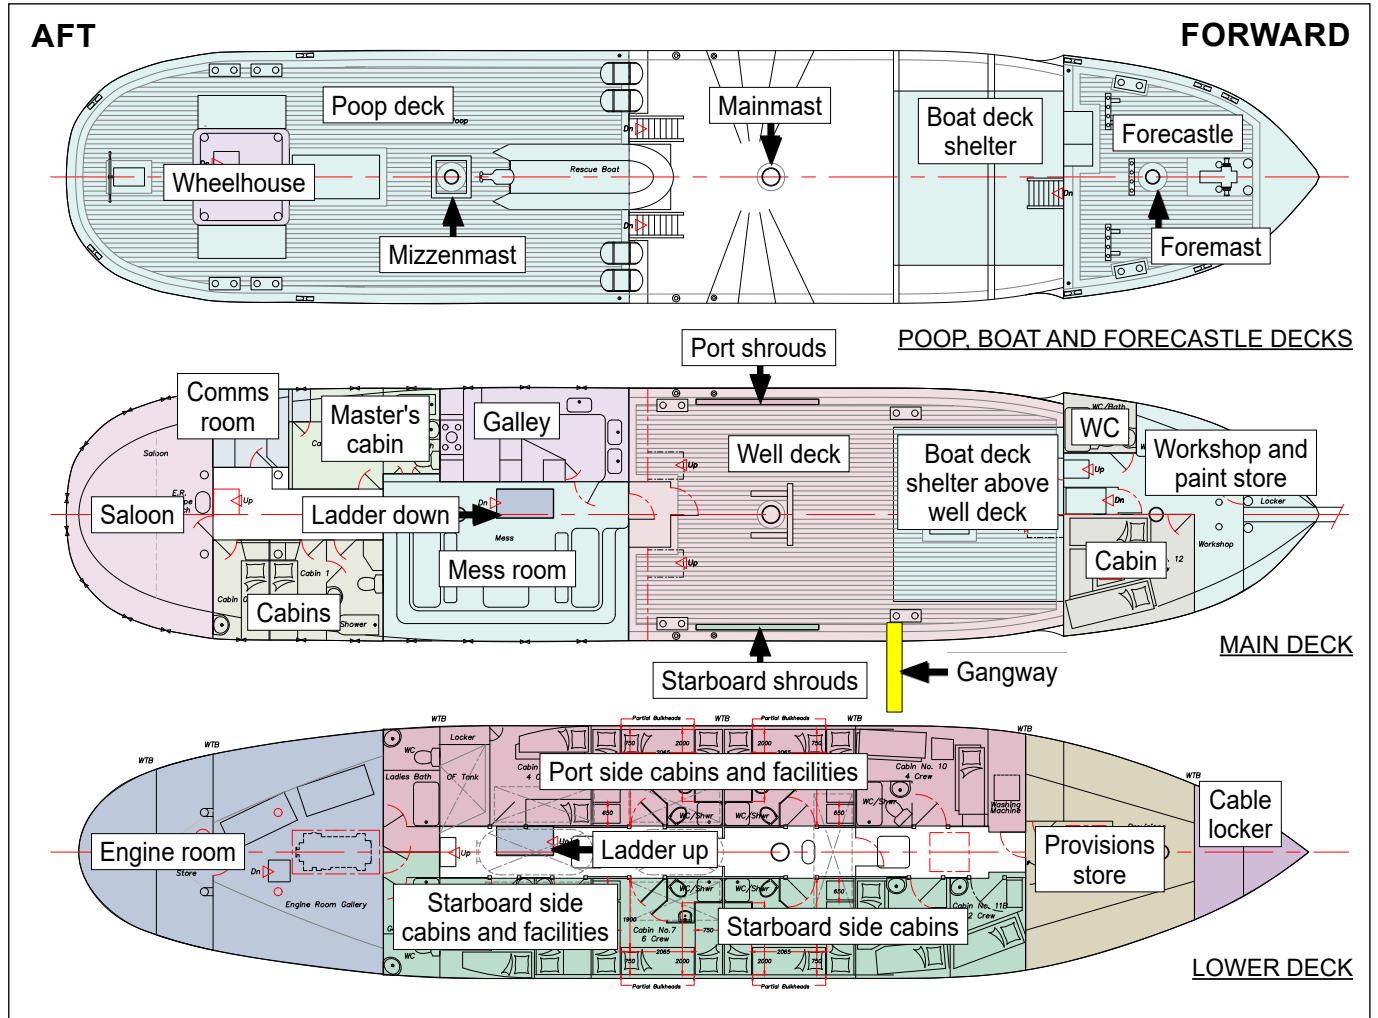
Figure 3: Pelican of London general arrangement

The three decks on *Pelican of London* comprised a lower deck, a main working deck and an upper deck, which was split into forecabin, well deck and poop deck areas (**Figure 3**).
