Report on the investigation of
the capsizing and sinking of the tug

Biter

with the loss of two lives,
while assisting the passenger vessel

off Greenock, Scotland
on 24 February 2023

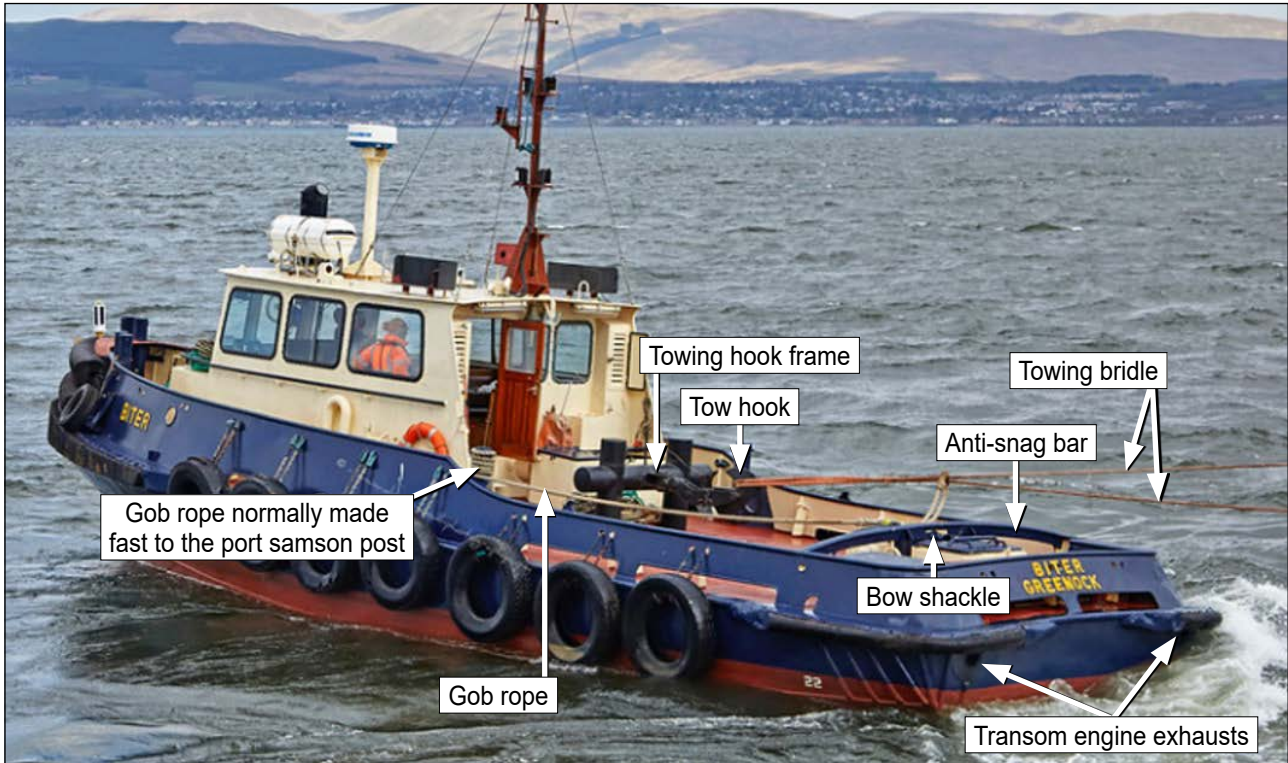
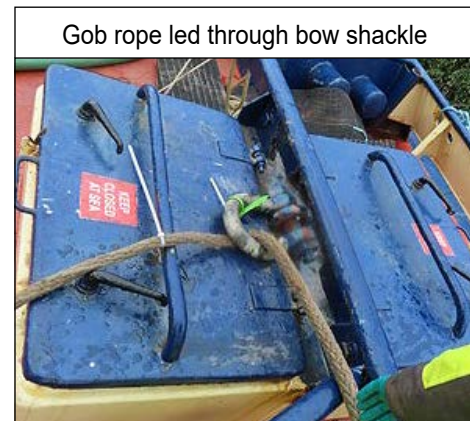
Figure 9: *Biter's* towing arrangements

For ship assist towage, where the vessel being assisted was not fitted with centreline fairleads, *Biter* used two 26m double-eyed tow ropes⁸ known locally as a bridle. When made fast, one eye from each rope would be placed on the tug's tow hook, with the other eyes secured via fairleads to the assisted vessel's bollards on either side of its bow or stern. To ensure that the towing point remained at the aft end of the tug, these tow ropes were always led through the eye of the tug's gob rope (Figure 9).

Biter's gob rope was a 25m long, 22mm diameter, high modulus polyethylene (HMPE) fibre rope with a spliced eye at each end¹¹. Compared to other types of rope, HMPE ropes had a relatively low coefficient of friction¹² and were therefore more prone to slippage. The gob rope was led through a bow shackle before being taken forward and secured to either the port side samson post or towing hook frame (see **Figure 9**).

Photographs of *Biter* in operation indicate that the preferred option for securing the gob rope was for it to be turned up four or five times around the port side samson post before locking turns were placed on the post's two stag horns. The gob rope could be manually loosened or tightened when secured around the samson post; when secured using figure of eights around the towing hook frame the increased friction made the arrangement more secure and harder to adjust. There had been no reported issues with the securing arrangements for the gob rope in CMS's conventional tugs and these methods of securing the gob rope had been in use for many years and were decided on by the tug master. In common with other tug operators, neither method of securing the gob rope had been formally tested or evaluated. Further, neither method allowed the gob rope to be adjusted when the towline or bridle was under tension.

The reason that the gob rope's securing arrangements were unable to withstand the load has not been identified. Potential causes include: the samson post securing arrangement, where the gob rope was wrapped 4 to 5 times around the post before locking turns were applied, was inadequate; or that the locking turns were inadvertently dislodged or lost during the manoeuvre. However, without guidance in the CMS SMS on gob rope securing arrangements the decision of how to secure the gob rope was left to the tug master. As a result, while most masters used the samson post, others placed figure of eights around the tug's towing hook frame (see **Figure 9**).

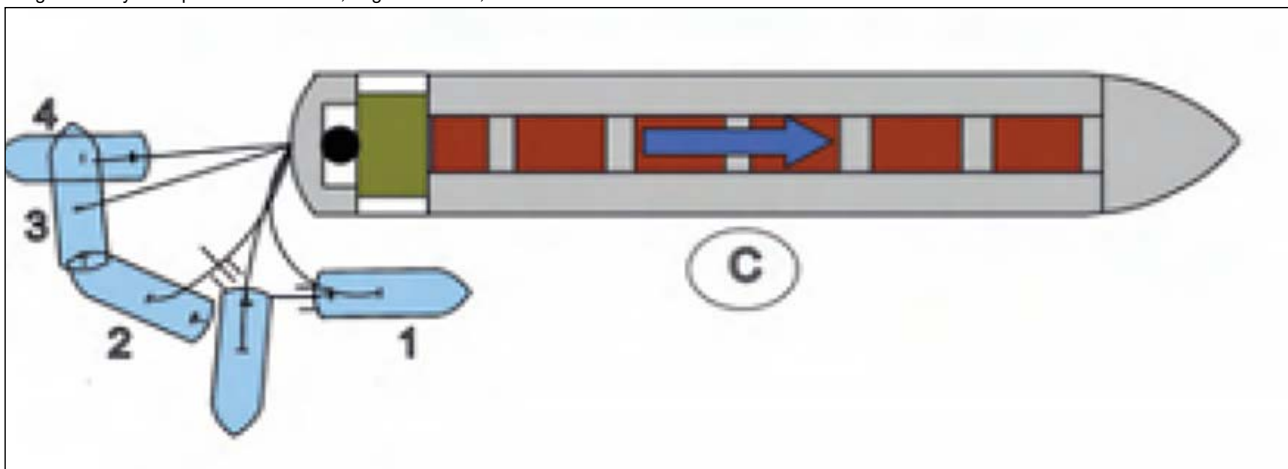
Figure 14: Stern tug manoeuvring from a standby position on starboard or port quarter towards a position astern of the ship

During a certain phase of manoeuvring it may be necessary for a ship with headway to have the port or starboard position tug (Figure 14, position 1) move astern of the ship (Figure 14, positions 3 or 4) to assist in steering or speed control...This manoeuvre is dangerous to conventional tugs when carried out at too high a ship's speed. This is at speeds of more than about three knots, and depends on tug manoeuvrability, stability and freeboard...

The manoeuvre just described is no problem for a tractor or reverse tractor tugs, even with a fairly high ship's speed. Conventional tugs with a gob rope system, whereby the towing point can be transferred towards a far aft position, can also swing around at a higher speed. The gob rope system should be strong enough and fully reliable otherwise such a manoeuvre becomes really dangerous for the tug.¹⁵ [sic]

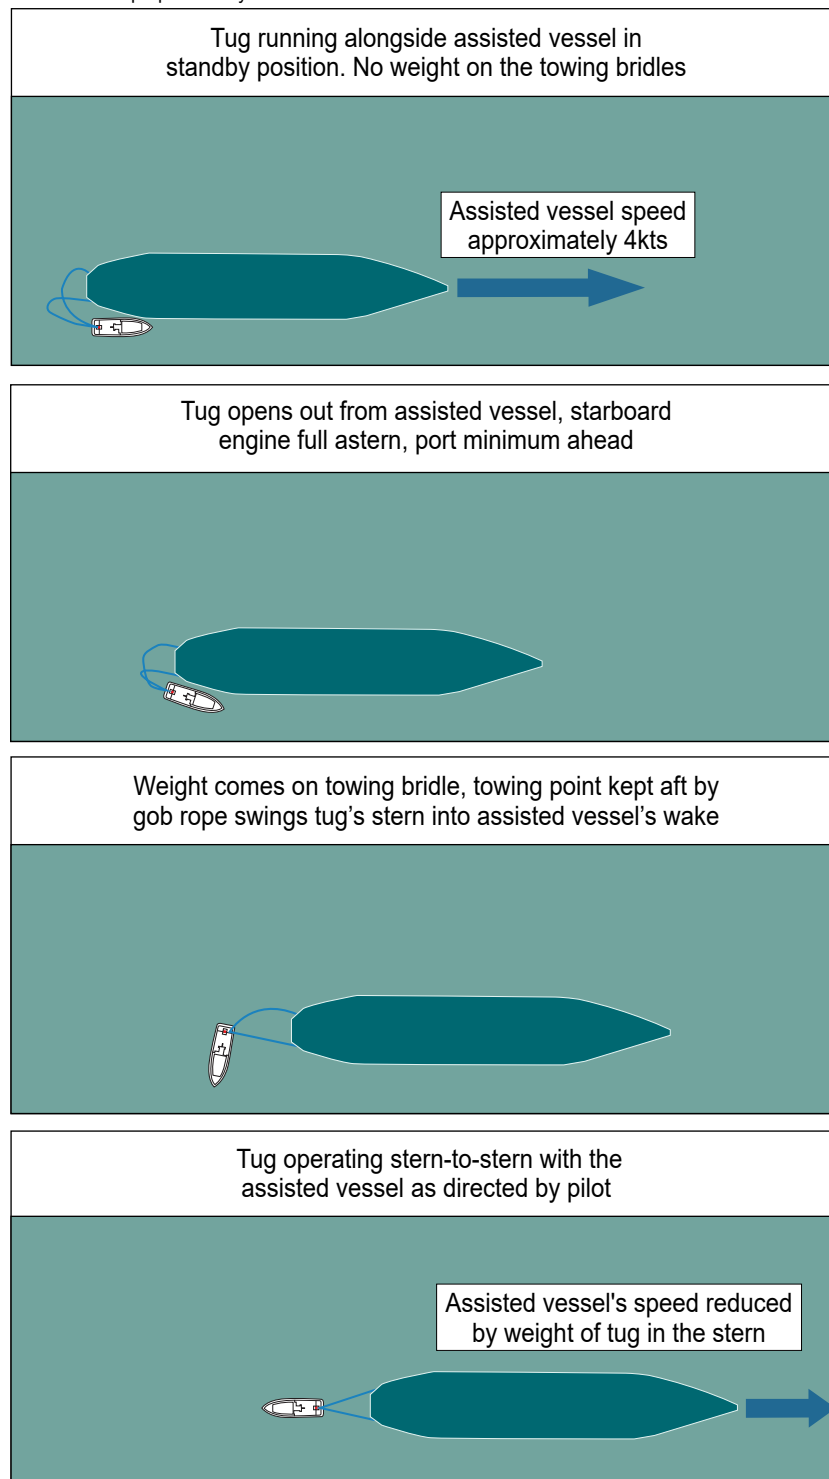
Figure 15: Tug master's planned manoeuvre

There was no guidance in the CMS SMS on how tug masters should conduct this manoeuvre. Some CMS tug masters required the assisted vessel's speed to be less than 2kts, others were content to conduct the manoeuvre at speeds of up to 4kts. The tug masters who required the assisted vessel's speed to be 2kts or less, aimed to complete the manoeuvre while putting minimal weight on the towlines. Those who conducted the manoeuvre when the assisted vessel's speed was at about 4kts relied on the tug's gob rope to complete the turn (Figures 11 and 15). In both cases, once the tug was operating stern to stern with the assisted vessel the tug master would use the tug's engines to orientate their vessel as required by the pilot. When in position the weight of the tug astern acted to reduce the assisted vessel's speed.
