Investigation into Seven Sisters PTI Incident

Presented by Ryan Dearlove - Operations Development Manager

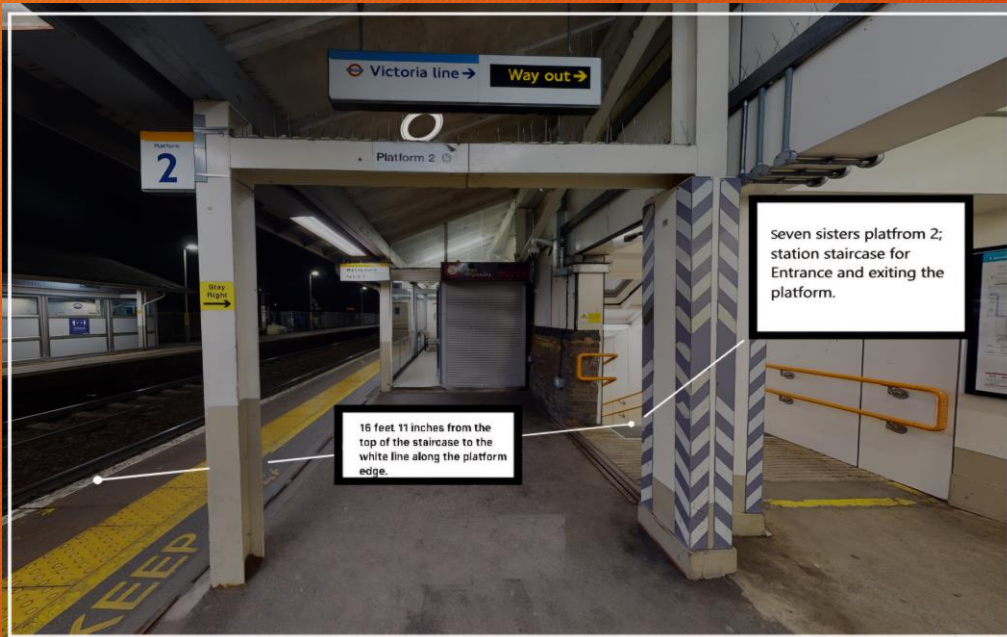
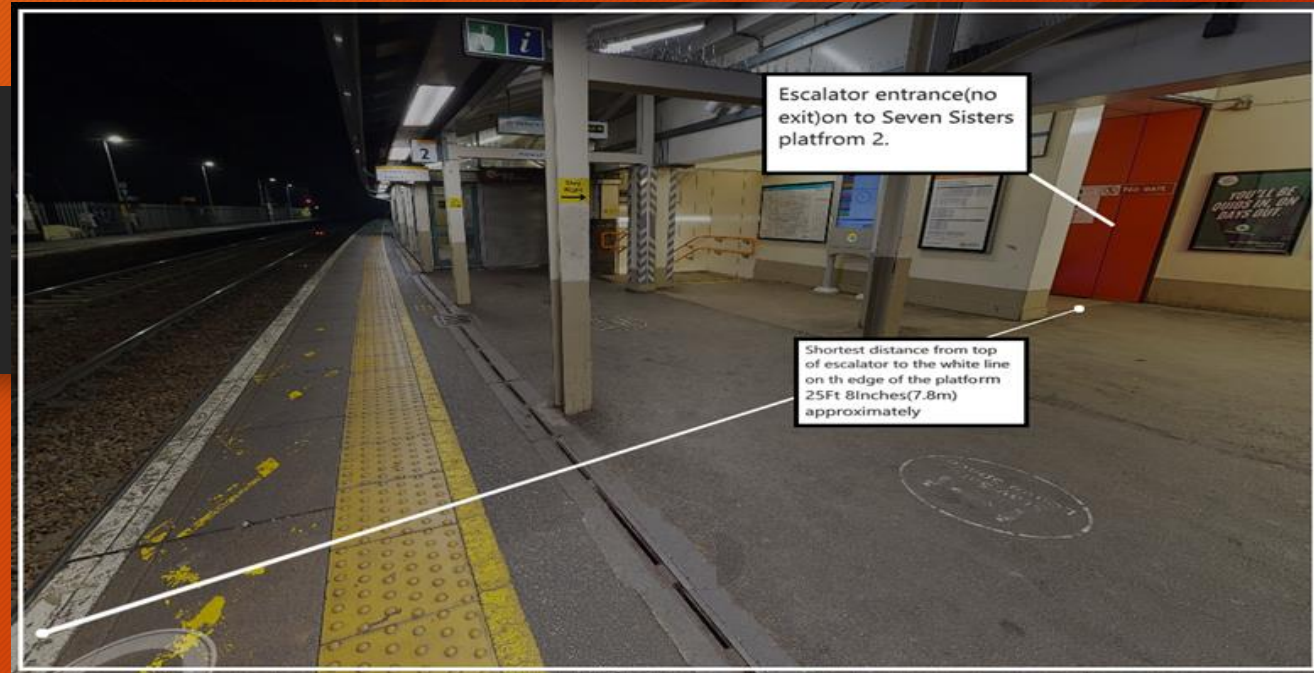
Seven Sisters Platform Layout 2 entrances & 1 exit

- Distance from top of stairs (entry and exit) to the platform edge 4.9m
- Distance from top of escalator (enter only) to platform edge Approximately 7.8m
