Serious Incident

Aircraft Type and Registration:	Boeing 737-8200, EI-HET	
No & Type of Engines:	2 CFM LEAP-1B27 turbofan engines	
Year of Manufacture:	2019 (Serial no: 62310)	
Date & Time (UTC):	4 December 2023 at 1103 hrs	
Location:	London Stansted Airport	
Type of Flight:	Commercial Air Transport (Passenger)	
Persons on Board:	Crew - 4	Passengers - 122
Injuries:	Crew - None	Passengers - None
Nature of Damage:	None	
Commander's Licence:	Airline Transport Pilot's Licence	
Commander's Age:	46 years	
Commander's Flying Experience:	5,300 hours (of which 2,800 were on type) Last 90 days - 235 hours Last 28 days - 29 hours	
Information Source:	AAIB Field Investigation

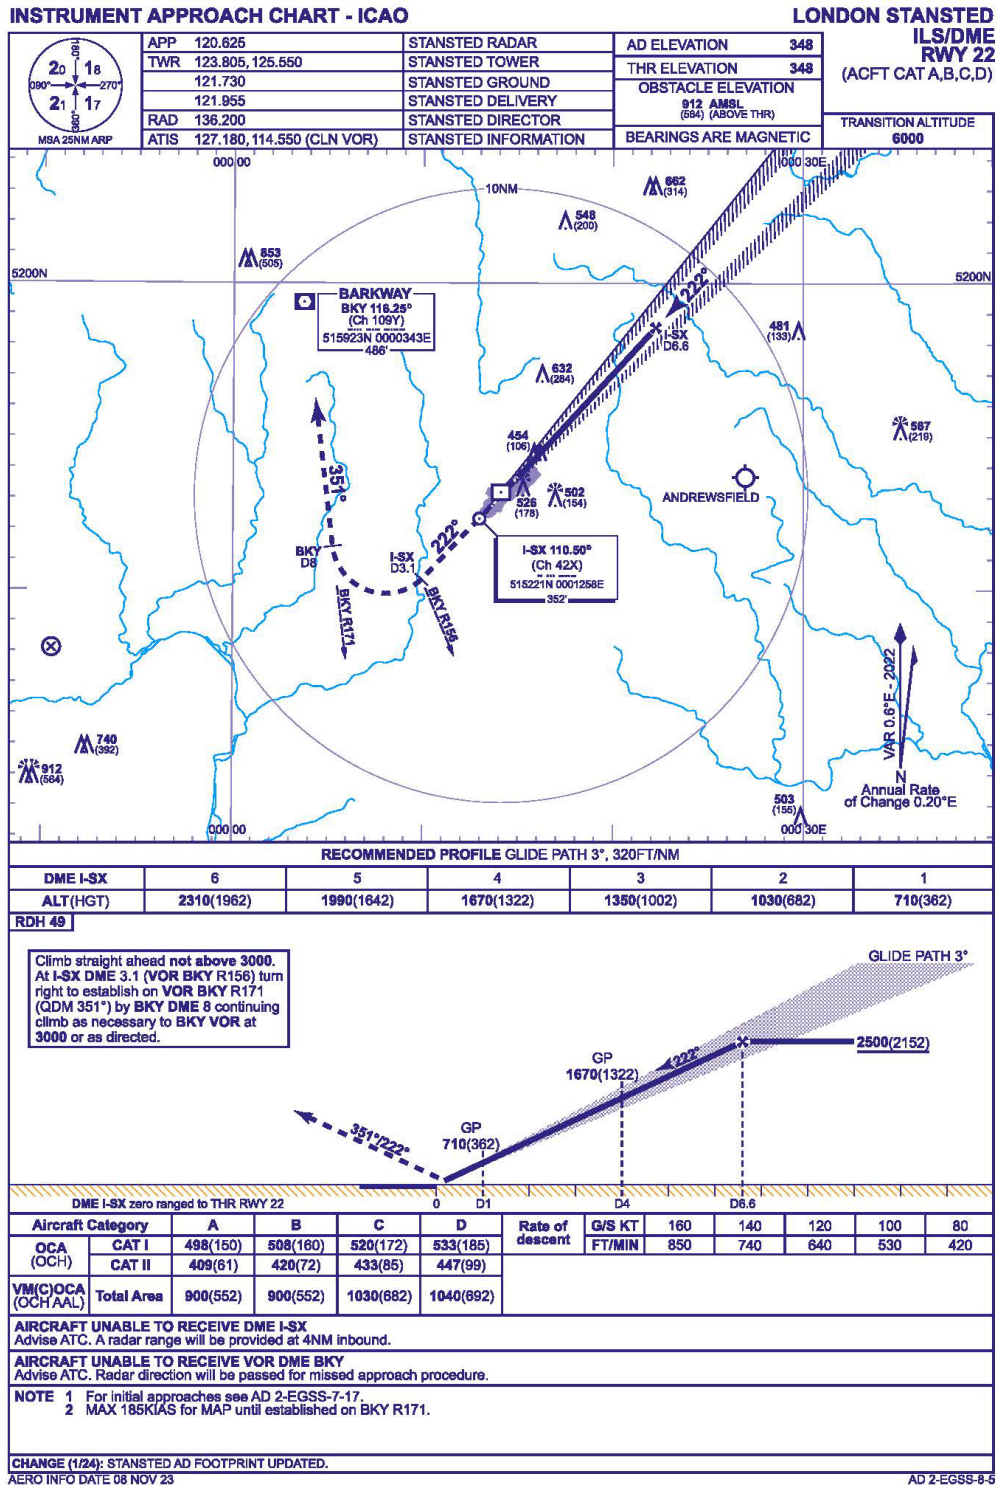
Figure 3

London Stansted Airport is 348 ft amsl and has two runways orientated 04/22. The ILS approach chart for Runway 22 is at Figure 3. It stated that when an aircraft was on the 3° G/S it will descend at 320 ft/nm.

Approach chart for ILS to Runway 22 at London Stansted Airport (UK AIP)
