Report on the investigation of the
fatal man overboard from the potting vessel

***Pioneer* (NN200)**

south of Hastings, England

on 29 July 2021

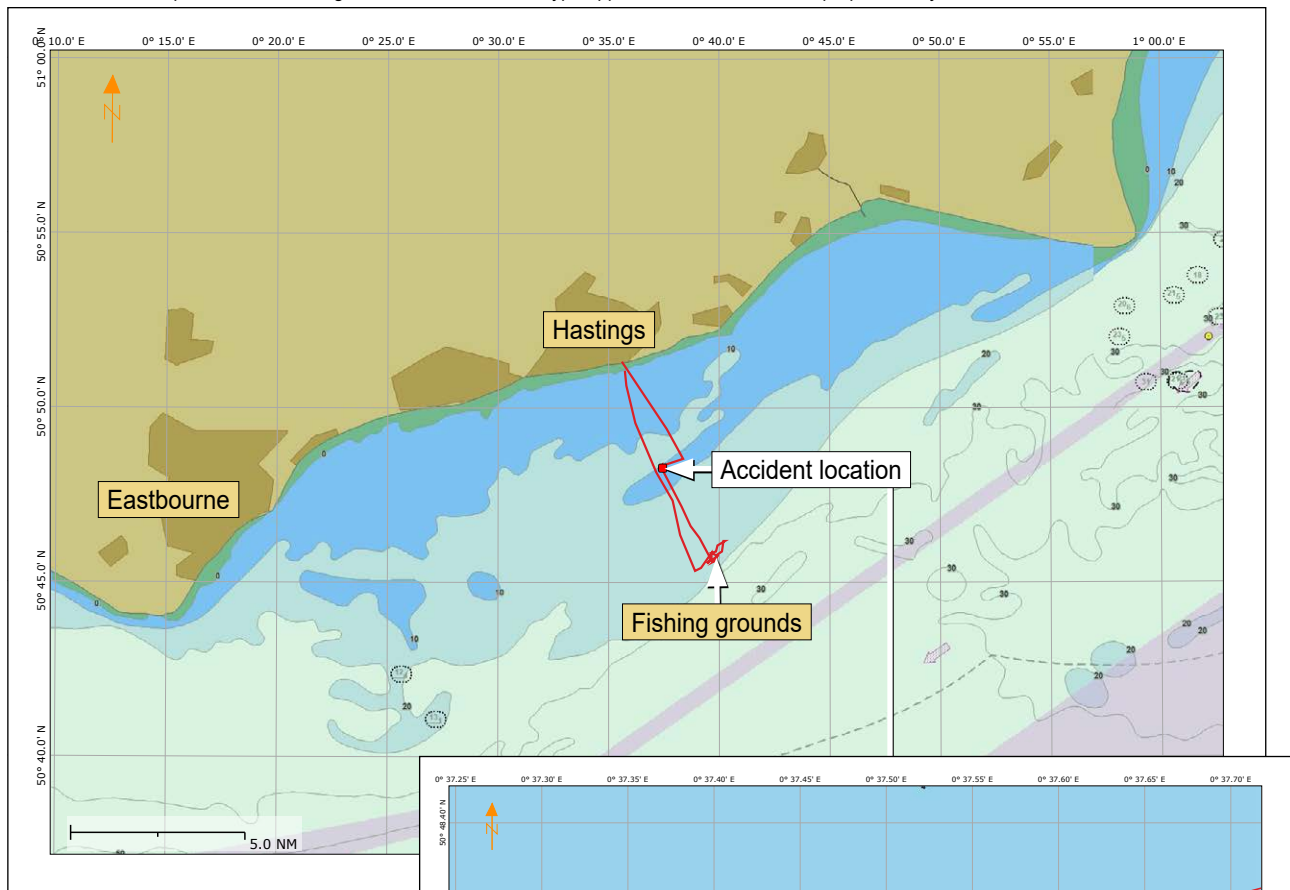
Figure 1: Location of accident and track of *Pioneer*

At 0520 on 29 July 2021, the UK registered potter/gill netter *Pioneer* (NN200) set off from its beach standing at Hastings, England with the vessel's owner/skipper (the skipper) and a deckhand on board. The skipper was at the helm, and it took less than an hour for the vessel to reach its fishing grounds on Shingle Bank, about 6.3 nautical miles to the south of Hastings (**Figure 1**).

At about 0853, the deckhand had just released the helm lashing when they heard the skipper cry out. The open door of the wheelhouse blocked the deckhand's view of the starboard side of the aft deck and, when they stepped out of the wheelhouse, they saw that the skipper was in the water some distance aft of the vessel. The skipper was struggling to stay afloat and was calling for help (**Figure 1**).

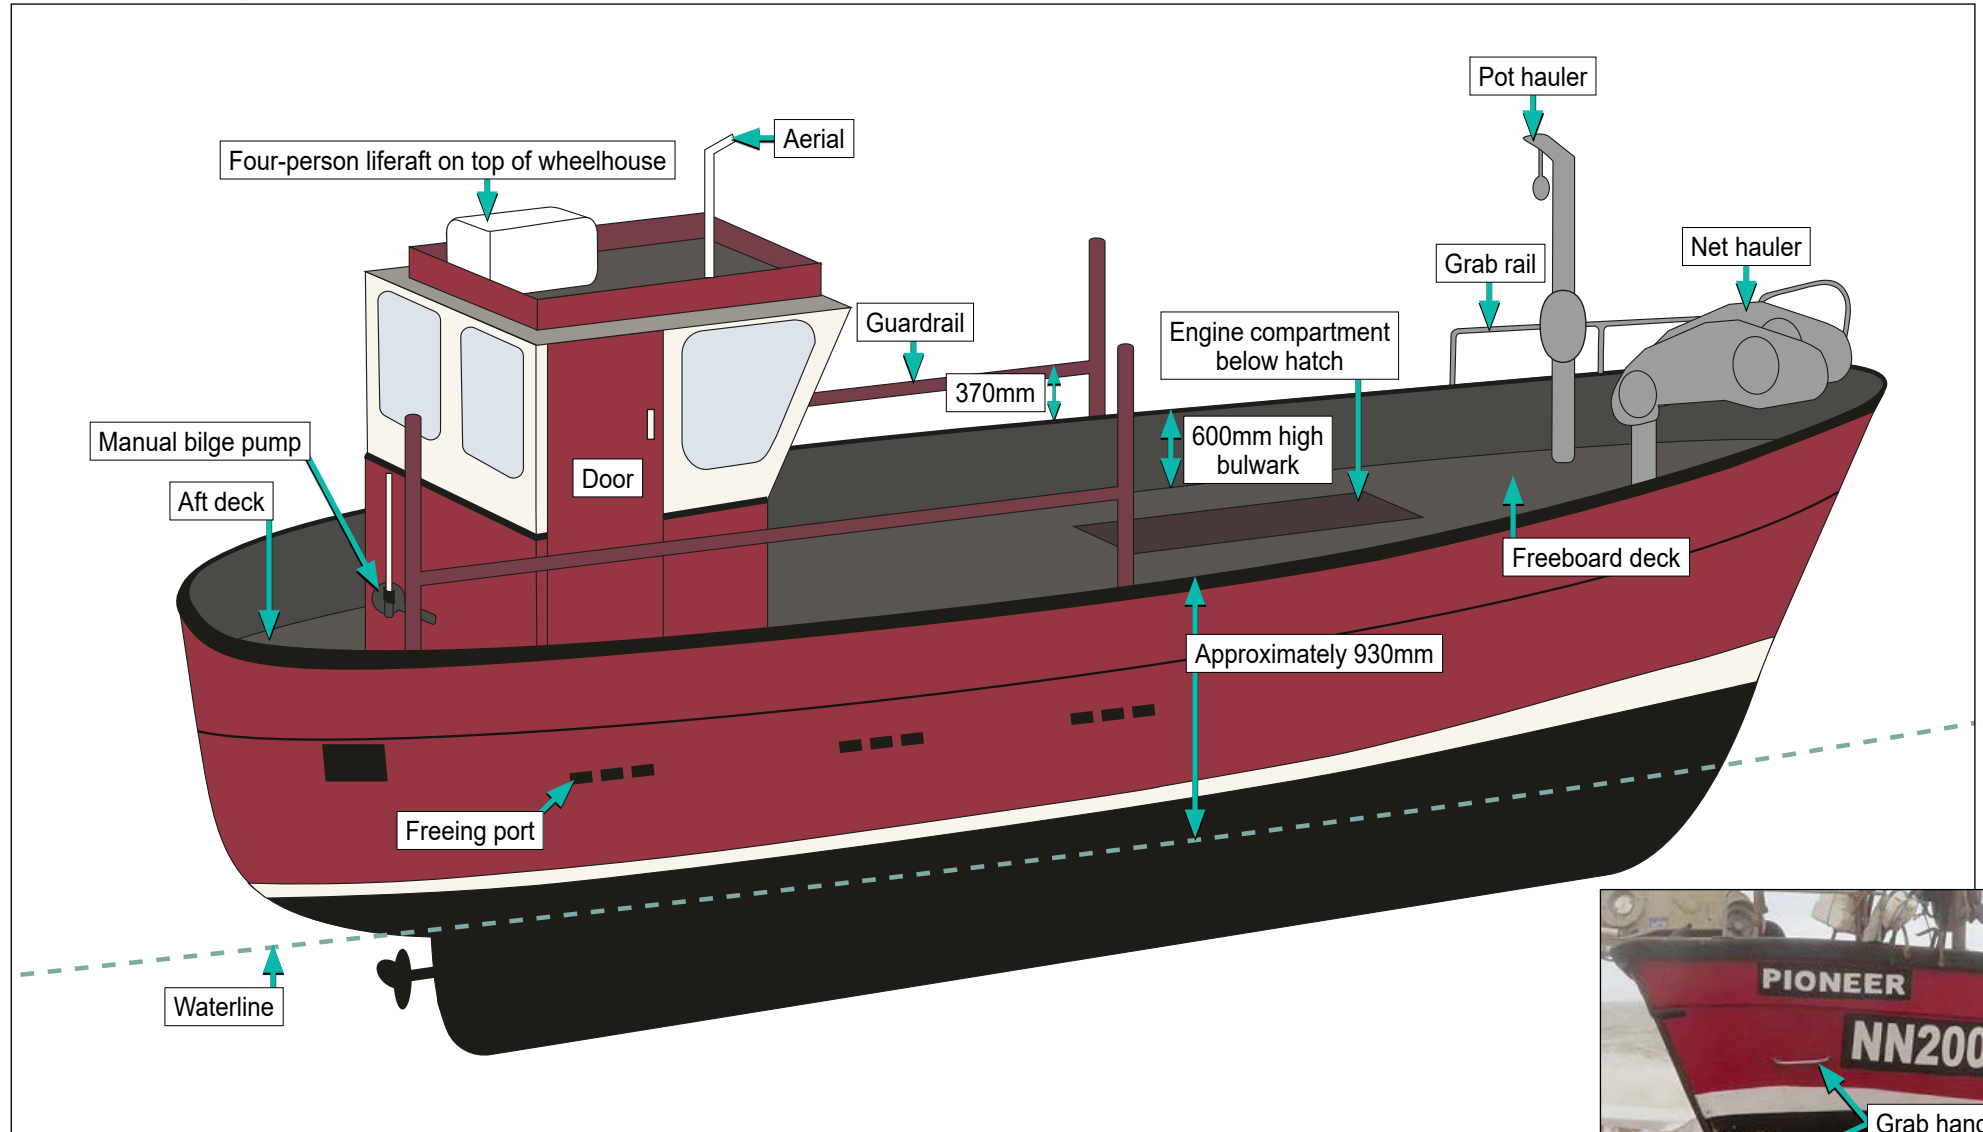
Figure 2: Pioneer's deck arrangement

Pioneer (**Figure 2**) was a 7.94m glass reinforced plastic vessel built in 1988 in Dover, England. The vessel was powered by a 63 kilowatt engine, which was housed in a compartment below a hatch forward of the wheelhouse on the freeboard deck.

A pot hauler was mounted on the vessel's port bow and a net hauler was mounted opposite this on the starboard bow. The gill nets were stowed in plastic bins on the freeboard deck when not in use. Two rectangular metal grab handles were mounted externally, one above the other, on the port bow (see **Figure 2** inset).
