## Serious Incident

<b>Aircraft Type and Registration:</b>	Boeing 737-8K5, G-FDZS	
<b>No &amp; Type of Engines:</b>	2 CFM56-7B27/3 turbofan engines	
<b>Year of Manufacture:</b>	2009 (Serial no: 35147)	
<b>Date &amp; Time (UTC):</b>	4 March 2024 at 1104 hrs	
<b>Location:</b>	On take off from Bristol Airport	
<b>Type of Flight:</b>	Commercial Air Transport (Passenger)	
<b>Persons on Board:</b>	Crew - 6	Passengers - 163
<b>Injuries:</b>	Crew - None	Passengers - None
<b>Nature of Damage:</b>	None reported	
<b>Commander's Licence:</b>	Airline Transport Pilot's Licence	
<b>Commander's Age:</b>	47 years	
<b>Commander's Flying Experience:</b>	14,500 hours (of which 4,500 were on type) Last 90 days - 220 hours Last 28 days - 81 hours	
<b>Information Source:</b>	AAIB Field Investigation

## Synopsis

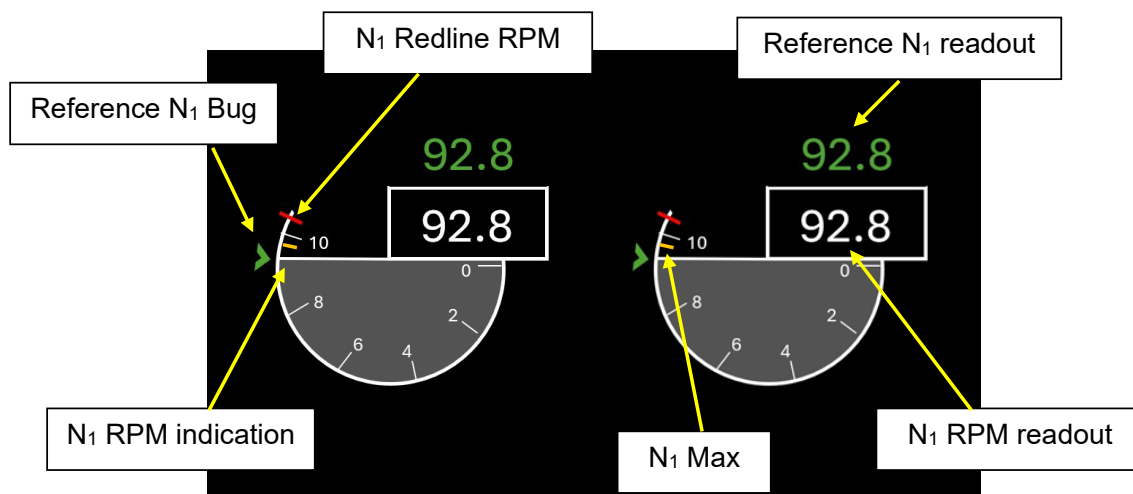
**Figure 6**  
N<sub>1</sub> gauges G-FDZS

The  $N_1$  gauges at the top of the Upper DU display a large amount of information to the pilots in both pictorial and digital formats (Figure 6). The actual  $N_1$  is indicated on the gauge by the white needle with a grey shaded area behind it. The difference between the actual  $N_1$  and that commanded by the thrust lever position is shown with a white arc (not shown on the diagram). The reference  $N_1$  is shown as a green bug. Both the actual  $N_1$  and reference  $N_1$  are also shown in digital figures. The maximum  $N_1$  is indicated by an orange line and is the  $N_1$  for full rated thrust, whilst the  $N_1$  operating limit is indicated by a red line.

During takeoff the green bug and green reference digital reading should match the calculated  $N_1$  to be used for takeoff. With the AT engaged and TOGA switch pressed, thrust levers should move toward the bug and the white needle and white digital readout of actual  $N_1$  should then match the green bug and green digital figure.
