Report on the investigation of an engine room fire
on board the roll-on/roll-off passenger ferry

Stena Europe

while approaching Fishguard, Wales

on 11 February 2023

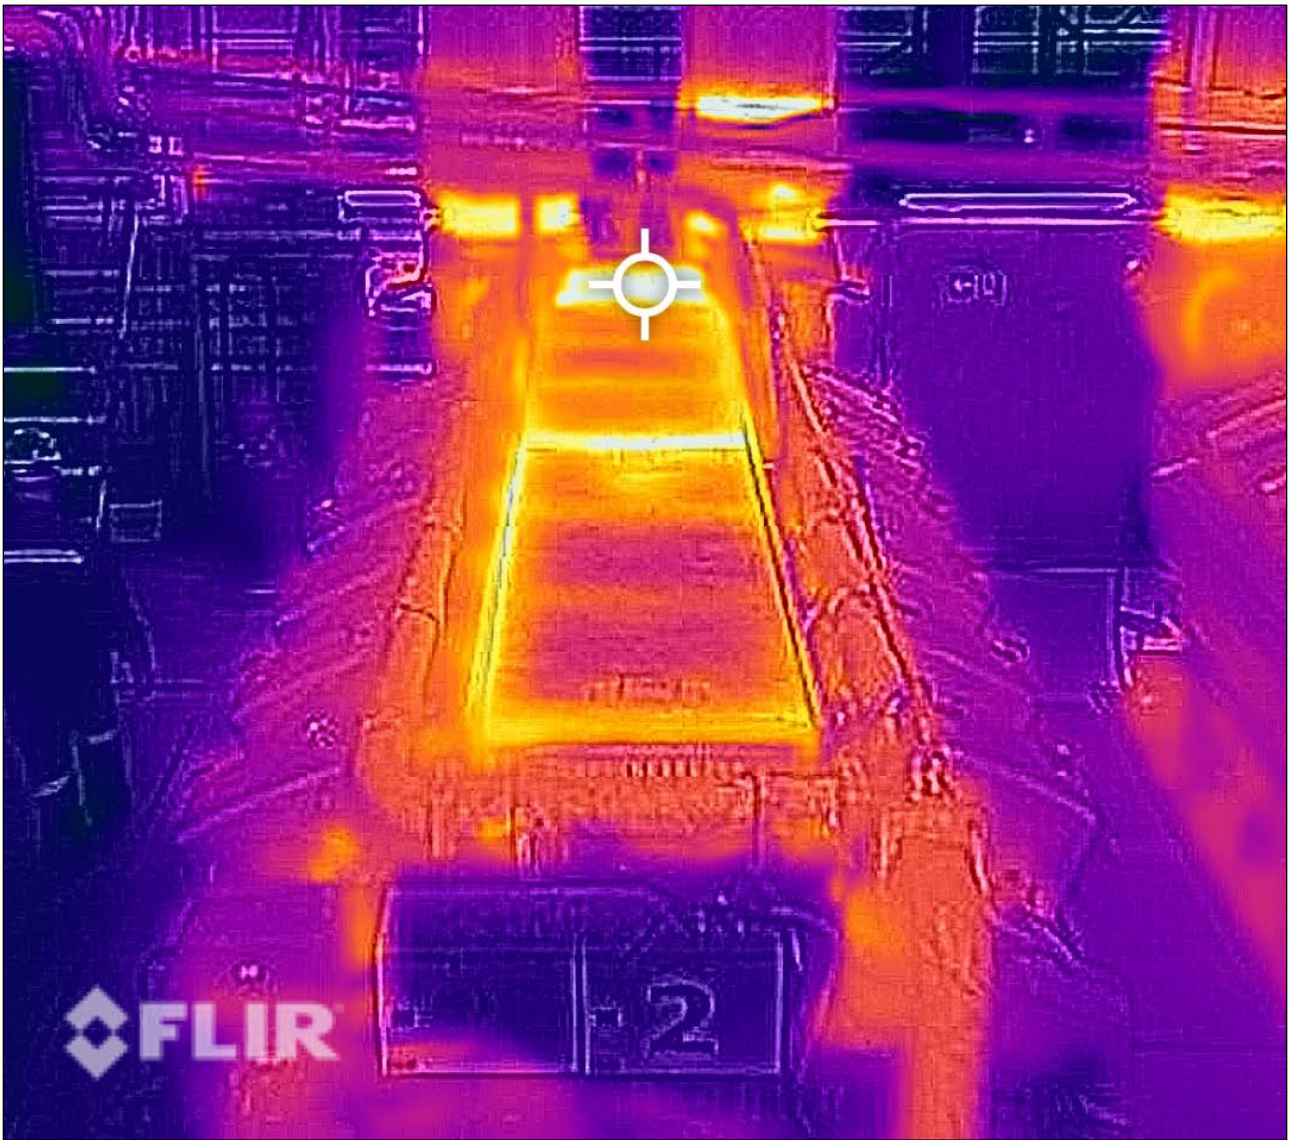
Thermographic image of a main engine on *Stena Europe*

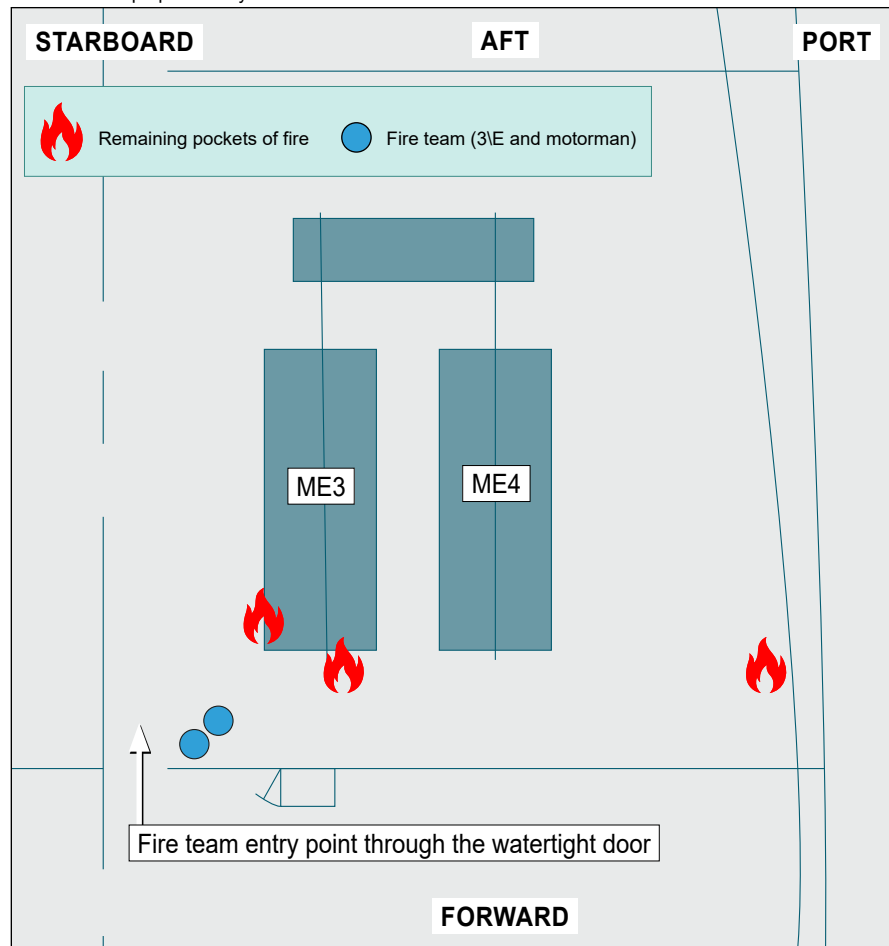
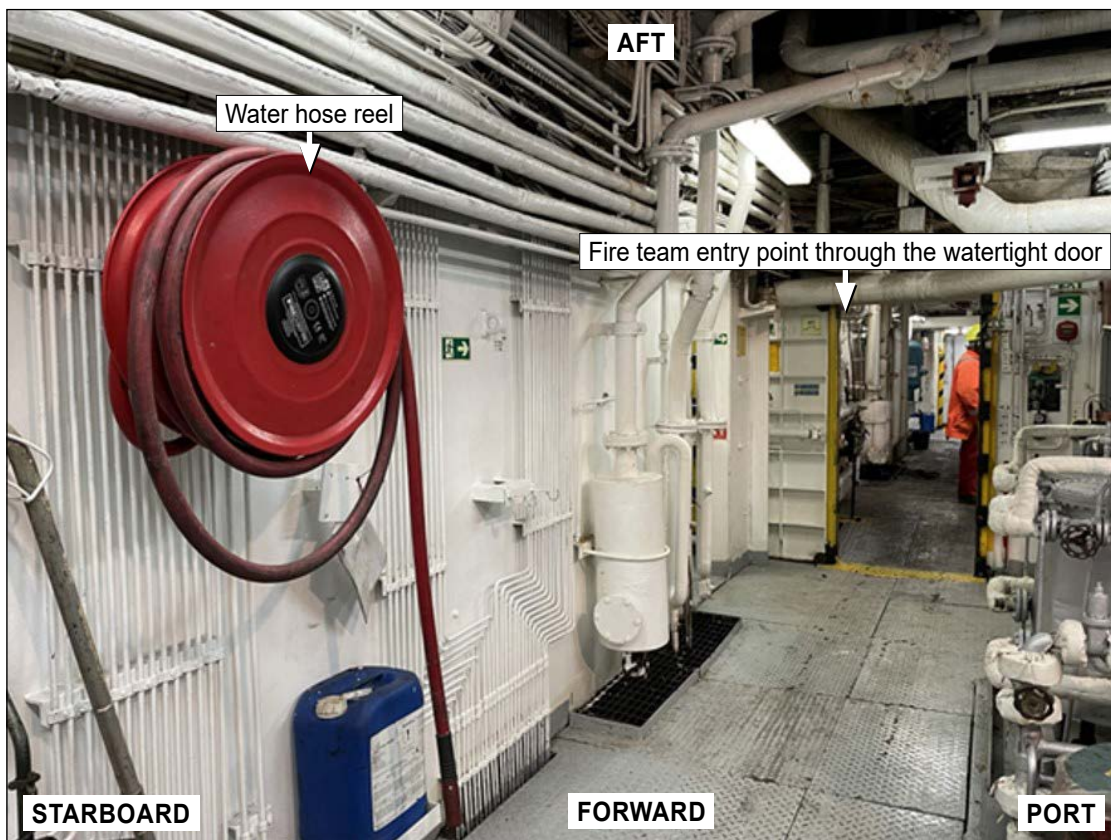
Figure 4: Water hose reel and (inset) the port main engine room

Both chief engineers went to the auxiliary engine room and prepared a nearby water hose reel in readiness for use (**Figure 4**). Once they were in position at the forward watertight door to the engine room the door was opened; it was immediately apparent that the water mist system had extinguished most of the fire and only small, isolated pockets of flames remained. The C/E(d) then stepped into the space through the watertight door close to the forward end of ME3.

The fire had damaged cabling in the port engine room and rendered the telephone systems inoperative. The C/E(n) used their ultrahigh frequency radio to contact the bridge team and requested the operation of the remote QCVs by the control located at the aft end of the bridge. A member of the bridge team activated the closing mechanism for the fuel valves of all four main engines.
