Rail Accident Investigation Branch

# Rail Accident Report

## **Collision between on-track machines near to Strood, Kent 16 November 2023**

Report 11/2024  
October 2024

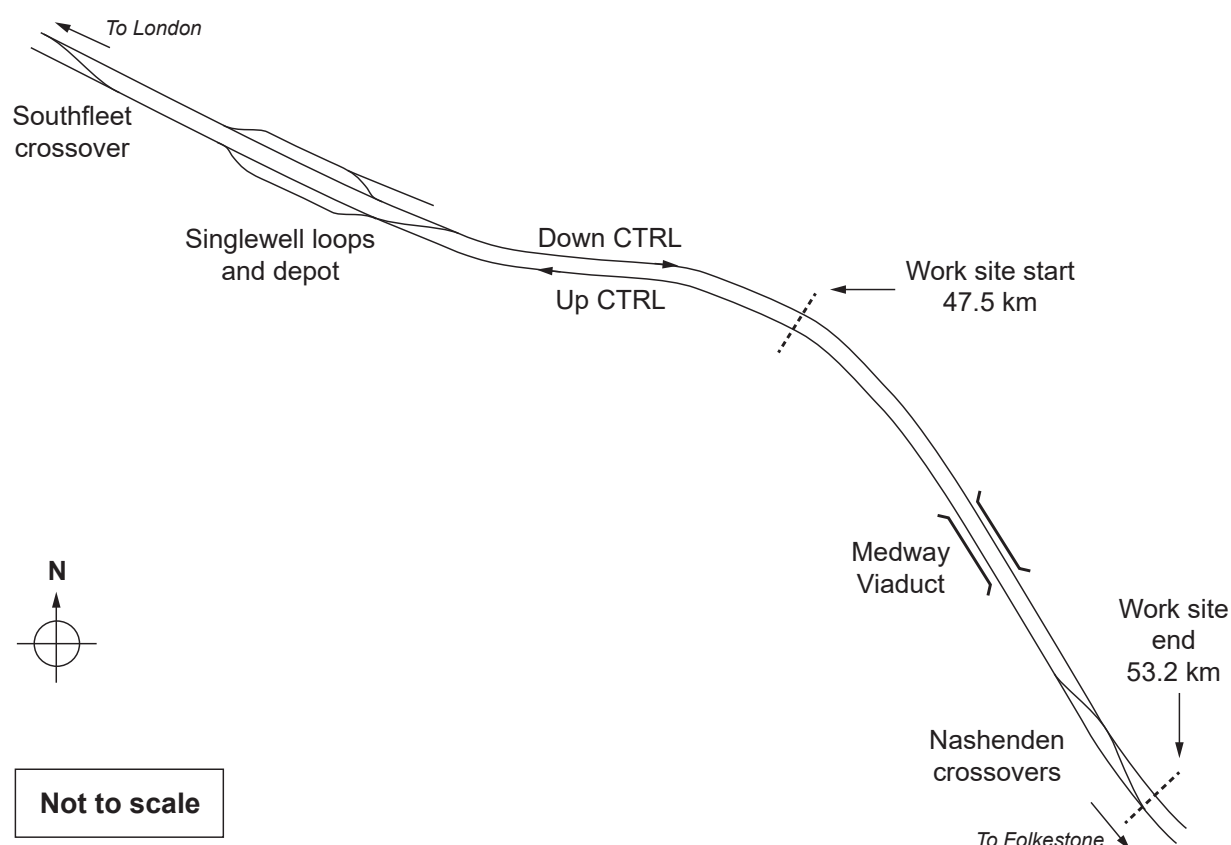
Figure 2: Track layout showing Singlewell depot, the work site limits and the Medway Viaduct.

- 7 HS1 is the high-speed rail line which runs between St Pancras International station in London and the Channel Tunnel at Folkestone. It is 109 km long, composed mainly of twin track railway and has maximum permissible speeds of up to 300 km/h (186 mph). Distances on HS1 are measured in kilometres and metres from a datum point located at St. Pancras International station.
- 8 The accident occurred at 47.67 km, just north of the River Medway, and near to the town of Strood in Kent. Maintenance of HS1 is conducted from Singlewell depot, situated around 43 km from St Pancras (figure 2).
