Rail Accident Investigation Branch

Rail Accident Report

Collision between a road-rail vehicle and a trolley near Brading, Isle of Wight 22 November 2023

Report 12/2024
October 2024

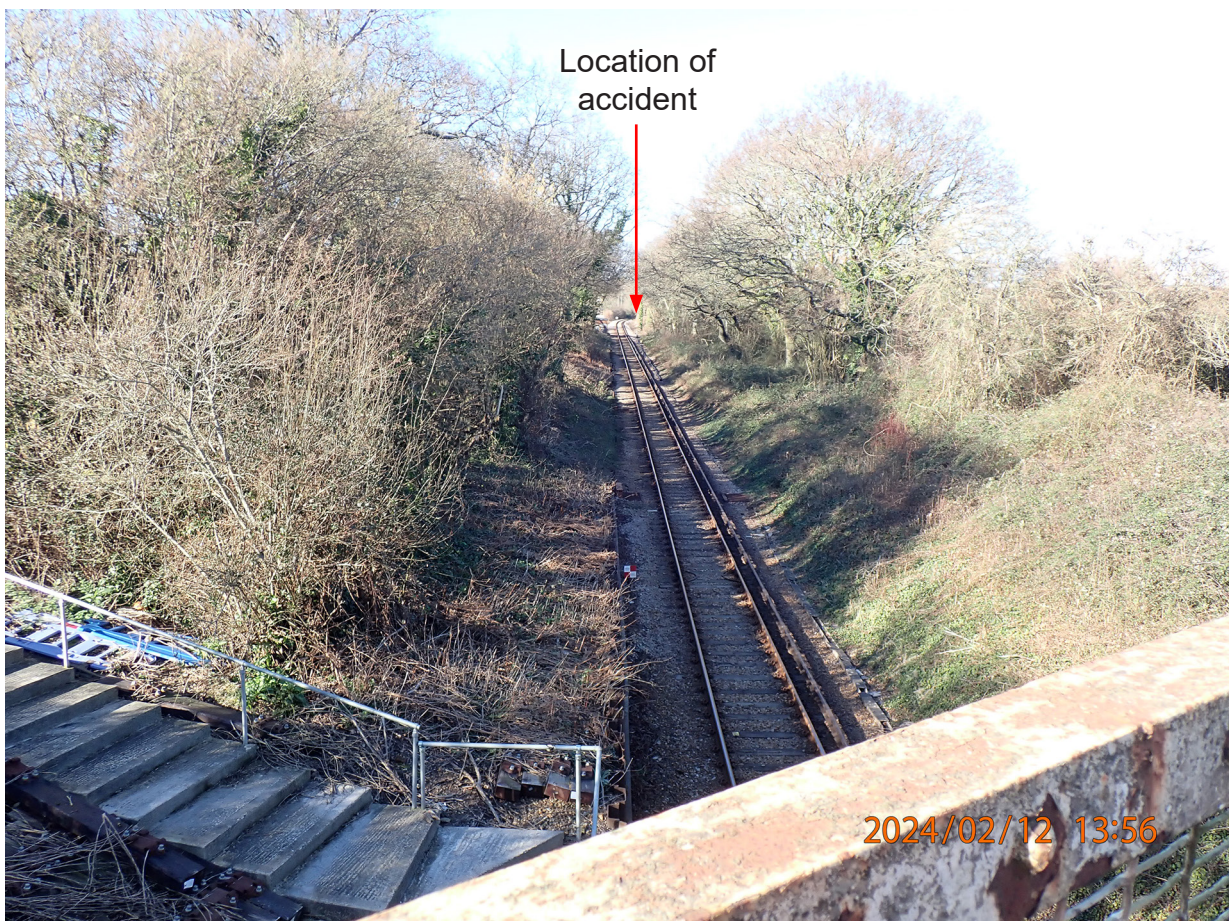
Figure 7: View from Rowborough Lane bridge looking north up the gradient towards location of accident.

- 43 The COSS and the track repair work group then travelled by road to a track access gate at Rowborough Lane bridge (3 miles 60 chains) near the middle of their planned site of work (figure 7). The COSS phoned the ES at 00:25 to confirm they had arrived at the access gate, then briefed the work group that there would be an RRV in the area.
