AAIB Bulletin

12/2024

Aircraft Type and Registration:	Boeing 737-8K5, G-TAWD	
No & Type of Engines:	2 CFM56-7B27E turbofan engines	
Year of Manufacture:	2011 (Serial no: 37265)	
Date & Time (UTC):	20 October 2023 at 1153 hrs	
Location:	Leeds Bradford Airport	
Type of Flight:	Commercial Air Transport (Passenger)	
Persons on Board:	Crew - 6	Passengers - 195
Injuries:	Crew - None	Passengers - None
Nature of Damage:	Main landing gear tyres and nosewheel tyres damaged. Left nosewheel inner axle bearing destroyed	
Commander's Licence:	Airline Transport Pilot's Licence	
Commander's Age:	41 years	
Commander's Flying Experience:	14,250 hours (2,800 hours on type) Last 90 days - not known Last 28 days - 88 hours	
Information Source:	AAIB Field Investigation

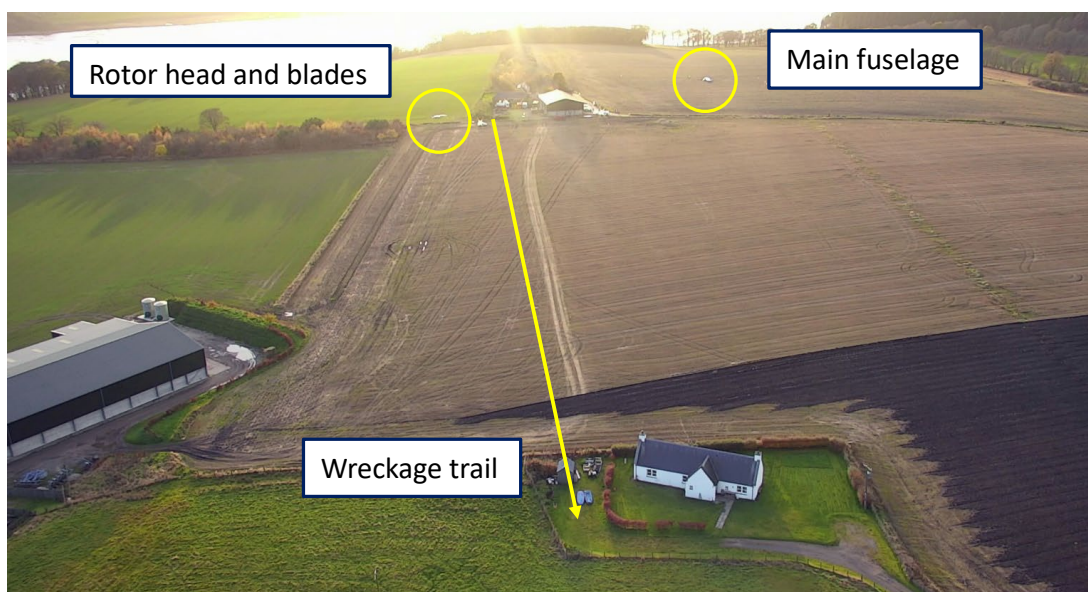
Figure 3

The fuselage was located in a field approximately 150 m west of farm buildings and was surrounded by smaller items, which had been released when the fuselage initially struck the ground. The rotor head and blades had detached from the fuselage together and were located in an adjacent field to the fuselage, some 65 m south-south-east of the same farm buildings. Two ground marks from the leading edge of each blade striking the ground were positioned at an obtuse angle to each other. A trail of small items of wreckage stretched from the location of the detached rotor head east-north-east for approximately 500 m across farmland and into the garden of a private residence (Figure 3). These items of wreckage consisted of sections of the right door of the aircraft, along with the tip of one of the propeller blades.

Wreckage location

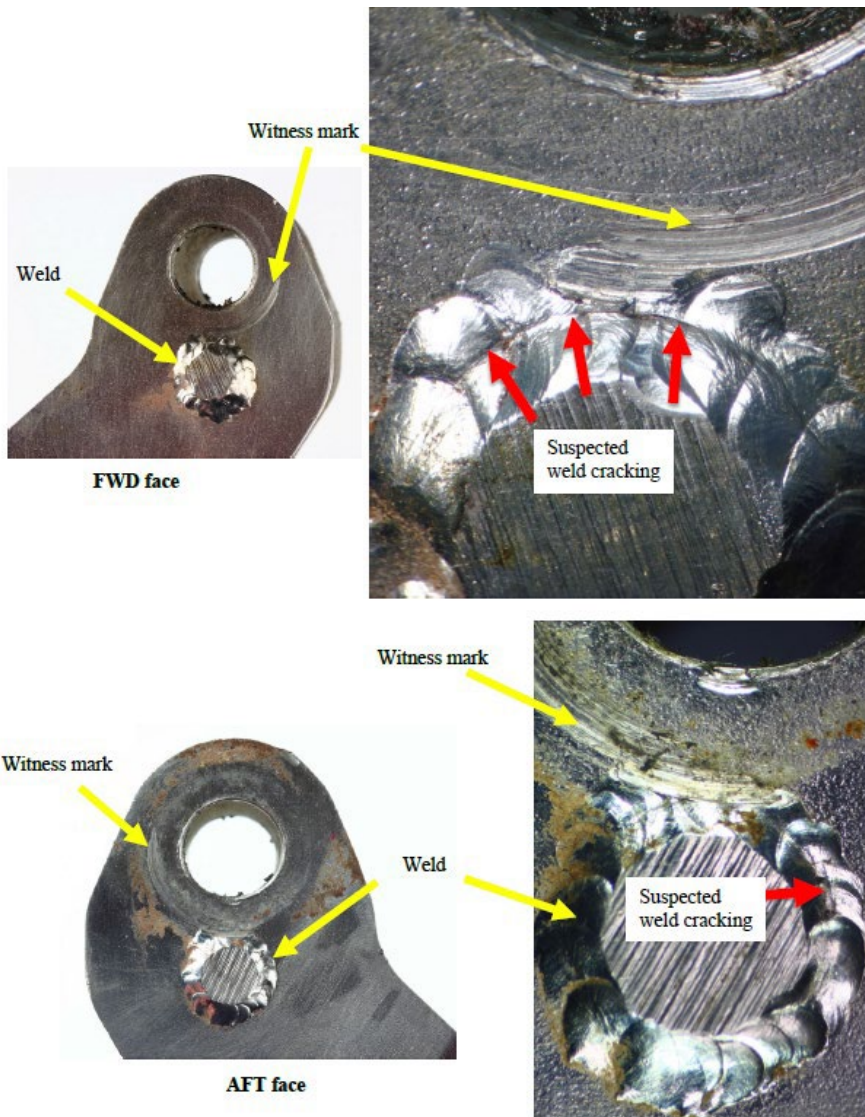
Figure 15

Detailed inspection of the roll stop bar end welds

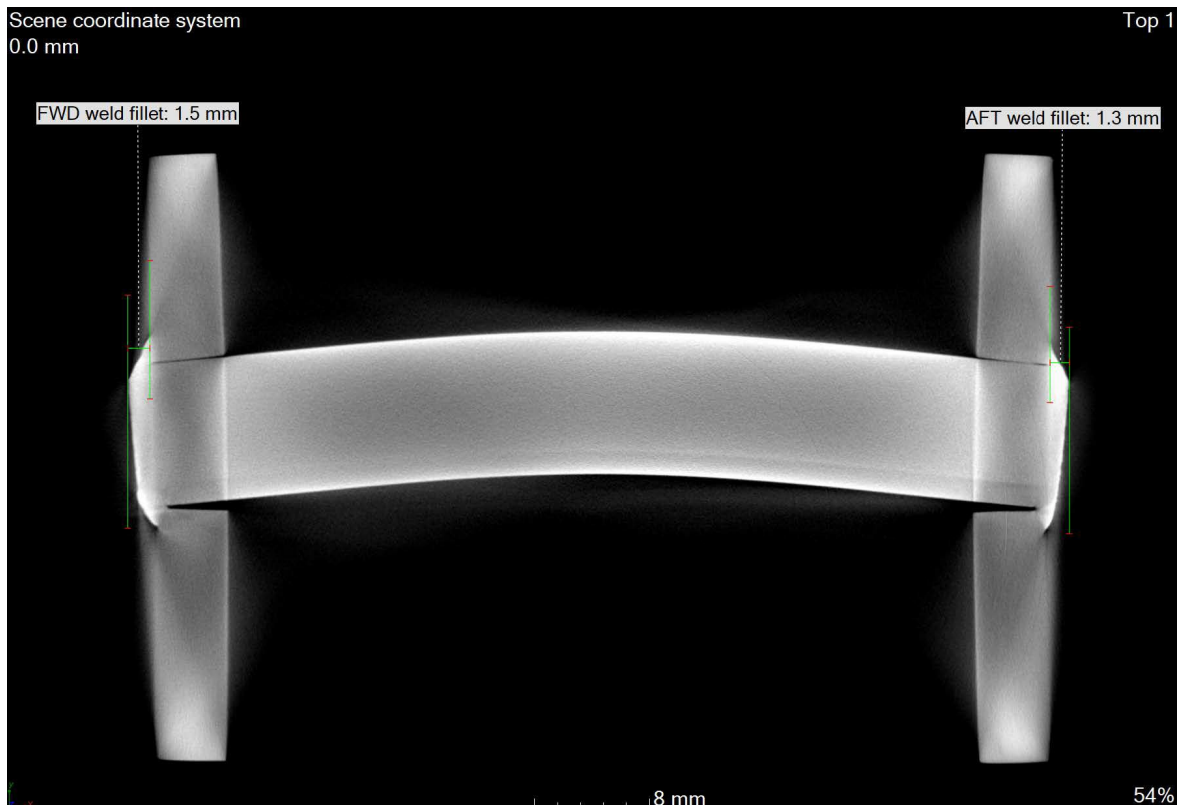
Figure 21

CT scan measurement of roll stop bar extension beyond the mast side plates

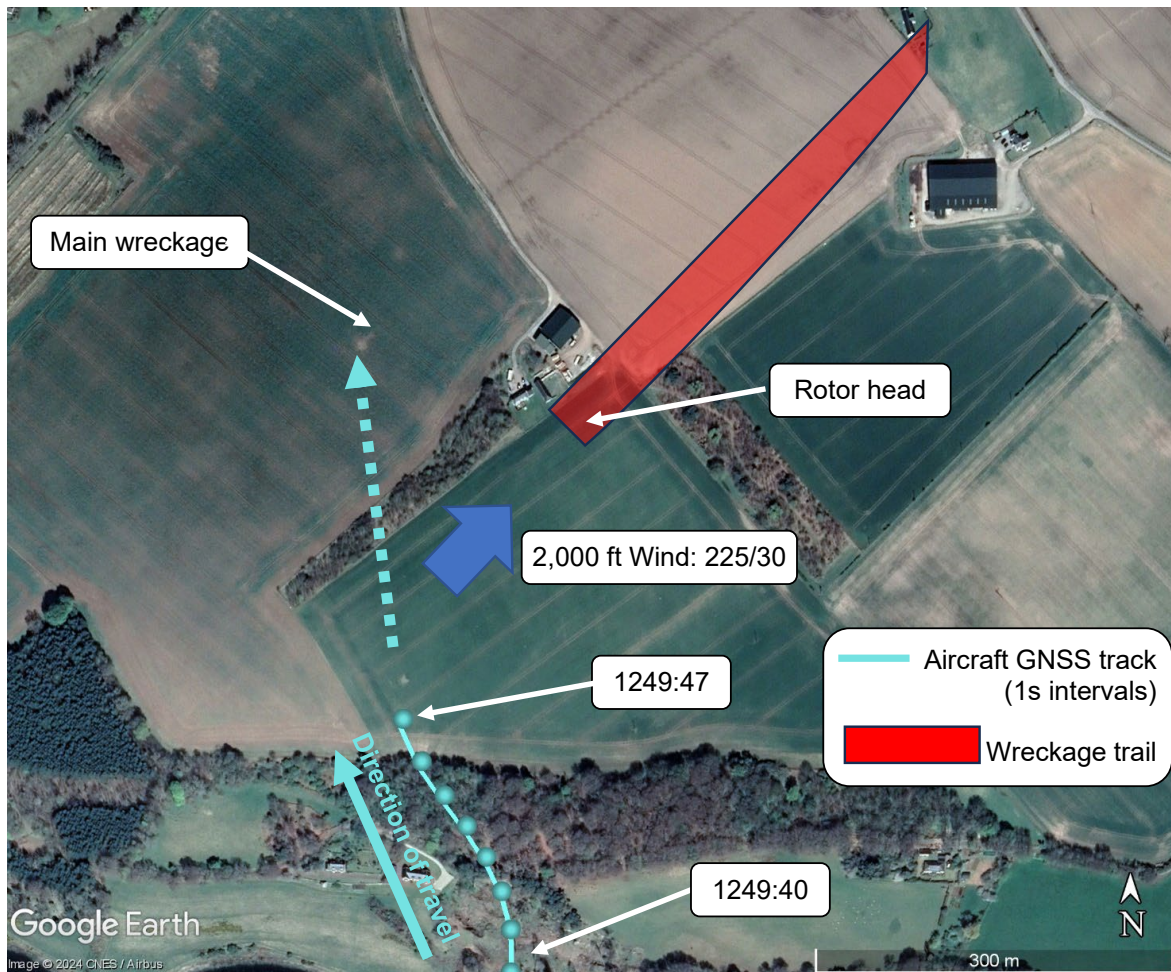
Figure 23

The recorded GNSS path up to 1249:47 hrs, wreckage location and estimated wind conditions were used to help estimate the approximate point of the rotor head failure (Figure 23). The gyroplane had sufficient height that the lightweight, low inertia debris released during the failure sequence was blown downwind to form a long wreckage trail roughly half a kilometre long. The wind direction at 2,000 ft was estimated by the Met Office but corresponds well to the direction of the wreckage trail. The gyroplane had a groundspeed of at least 70 mph during this period, so the debris would have travelled diagonally forward¹⁸ from the point of release. This gives some indication of when the failure must have occurred and is consistent with the period immediately before the data became unreliable.

Image showing wreckage trail and prevailing wind direction relative to the GNSS flightpath

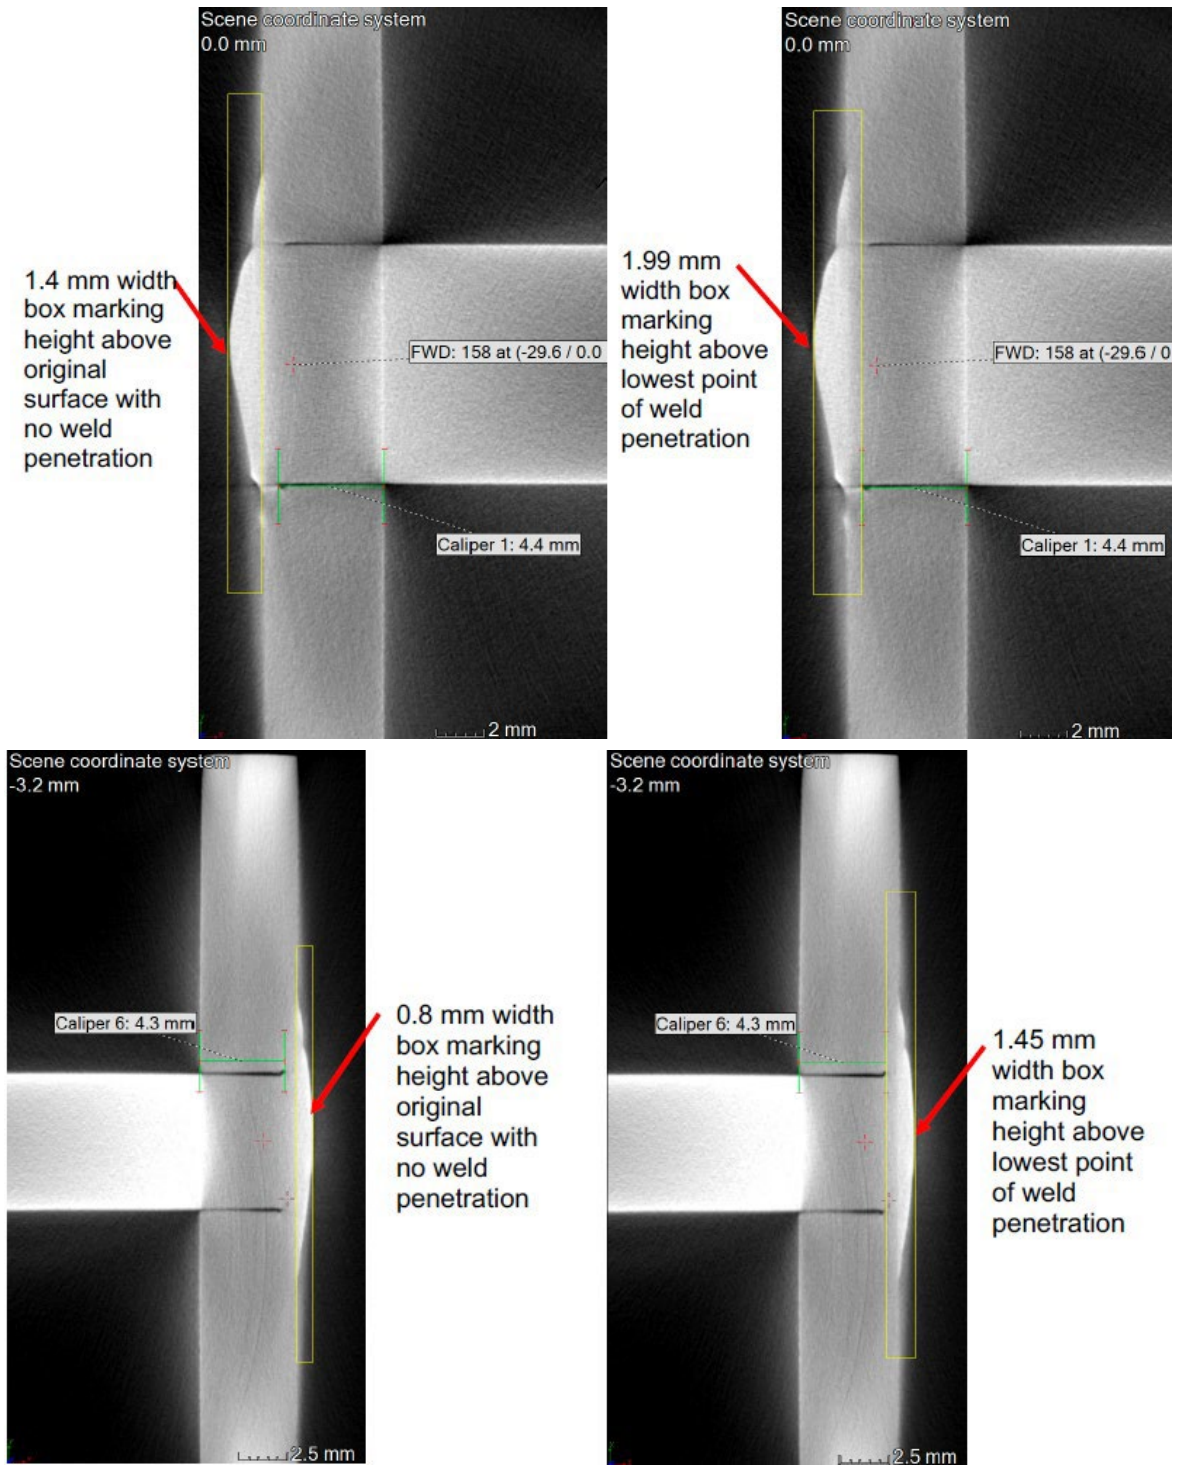
Figure 26

Measurements taken from the scan showed that the roll stop bar at its highest points extended beyond the external face of the side plates by 1.4 mm on the aft side and 0.8 mm on the forward side, although the measurement dropped significantly away from the peak. The weld depth at its deepest penetration was 1.99 mm and 1.45 mm respectively on each side, but this also varied significantly across its diameter (Figure 26).

CT scan of new production mast top showing the roll stop bar weld (aft side - top images, forward side - bottom images)

According to the design drawing dimensions, for a nominal plate width of 5 mm, the roll stop bar should extend between 1.5 mm and 1.25 mm, depending on manufacturing tolerances.

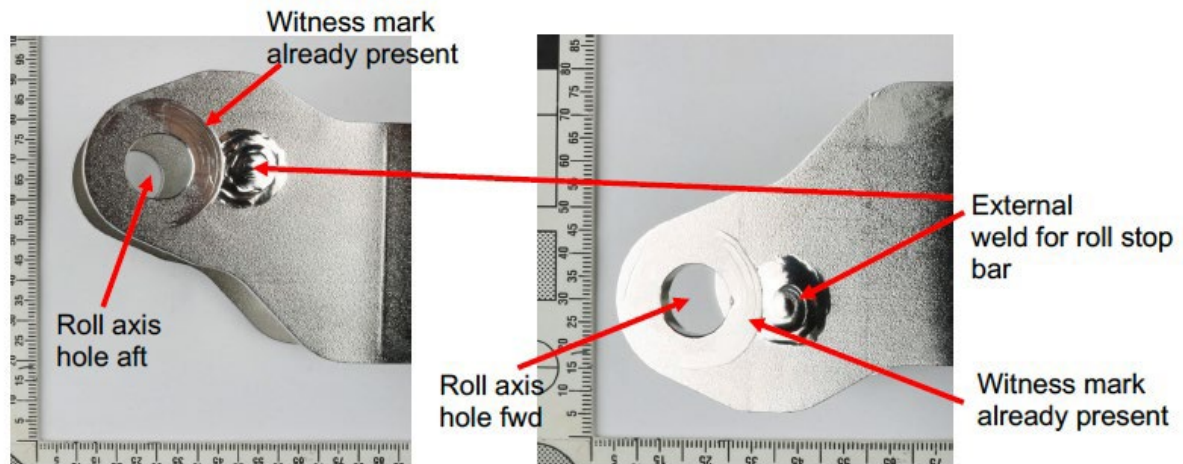
Figure 27

The mast arrived with an existing witness mark on the side plates. The manufacturer confirmed that these were machine marks, where the faces and weld had been machined flat during manufacture to accommodate the washers fitted during assembly of the roll pivot bolt. (Figure 27).

As received part showing damage to weld

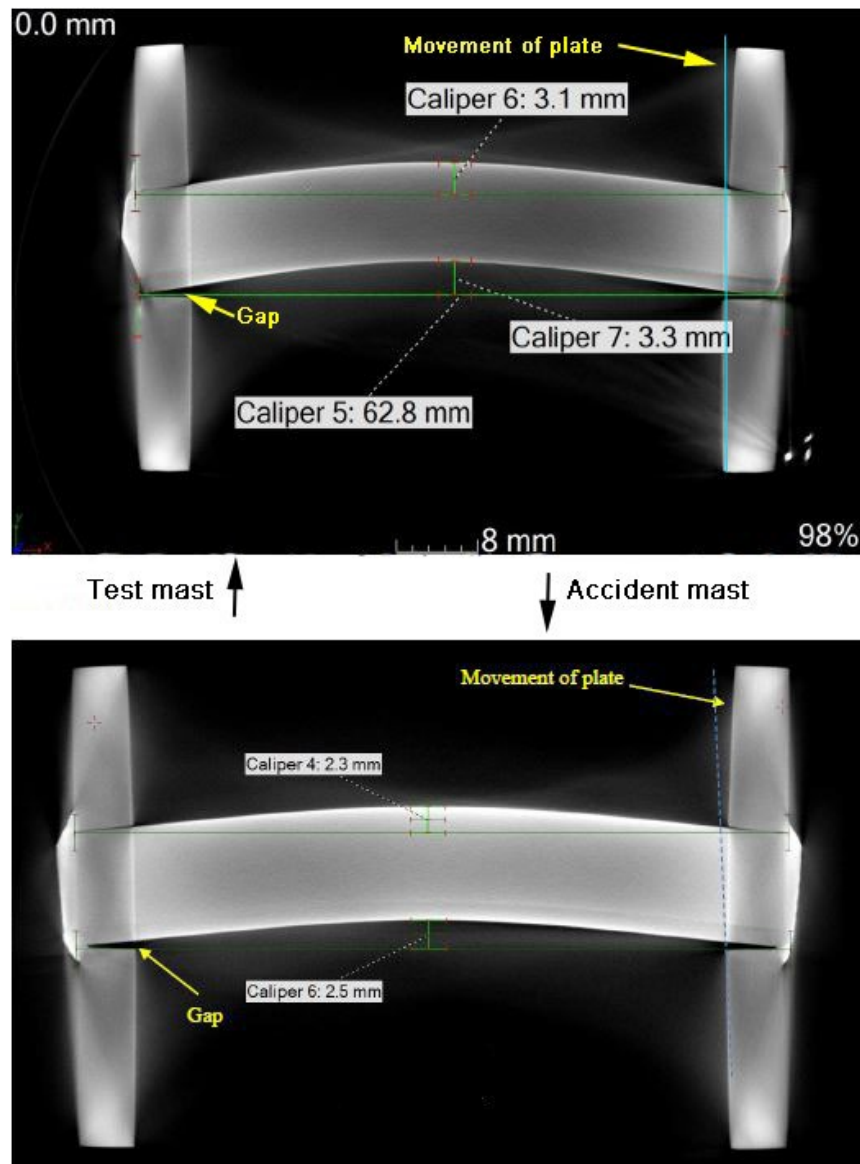
Figure 31

Inspection of the components following the test showed that the roll stop bar had plastically deformed, matching the profile seen on the accident mast.

CT scans of the mast following the test confirmed that the bar had deformed slightly more than the accident mast, with the displacement from straight at the centre measuring 3.3 mm compared to 2.5 mm on the accident mast. The side plates were deformed outwards similar to the accident mast and the roll stop bar welds had failed on both sides, producing the same large gaps between the bar and the plate locating hole on the concave side of the bar (Figure 31).

Plastic deformation of the roll stop bar post-test (top)
compared with the accident mast (bottom)

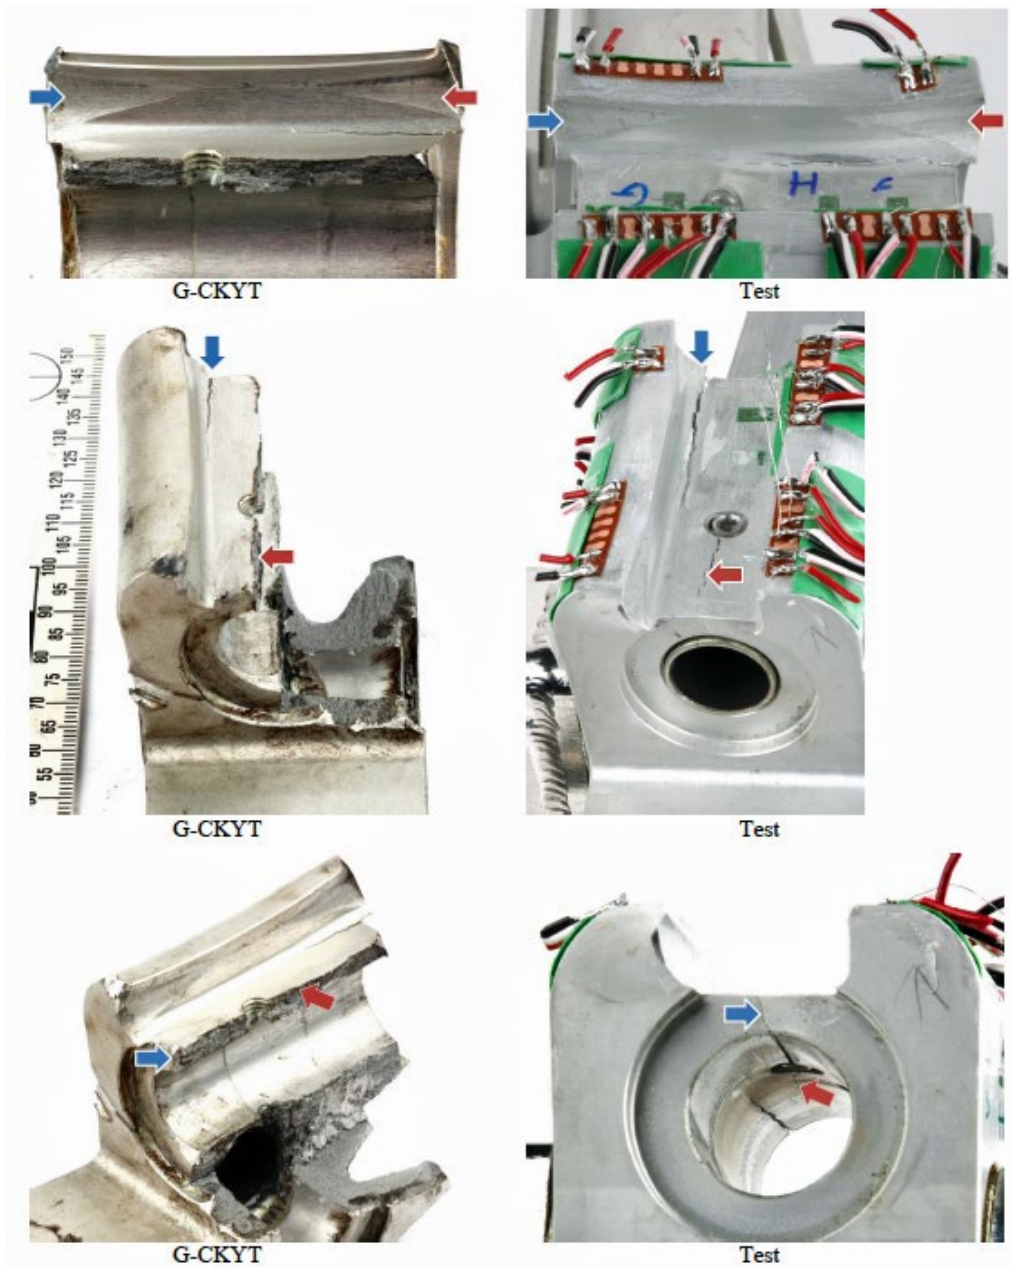
The gimbal block had also failed in a similar manner to the accident block, though as the force applied was only in the horizontal plane, only the vertical cracks were present. However, they were located in the same positions and had progressed to similar extents. Figure 32 shows this by highlighting the same cracks with the same-coloured arrows. It also shows the identical indentation marks and distortion left on the side of the channel by the roll stop bar.

Cracks in the gimbal block post-test compared to the same cracks seen on the accident gimbal block

The damage to the gimbal block and mast from the test closely matched that seen on the accident gimbal block and mast. The differences were considered to be due to the fact that the test was stopped before complete fracture of the block (for safety reasons) and that only the torque (or rotational) load component from contact between the mast roll stop bar and the gimbal block was applied during the test.

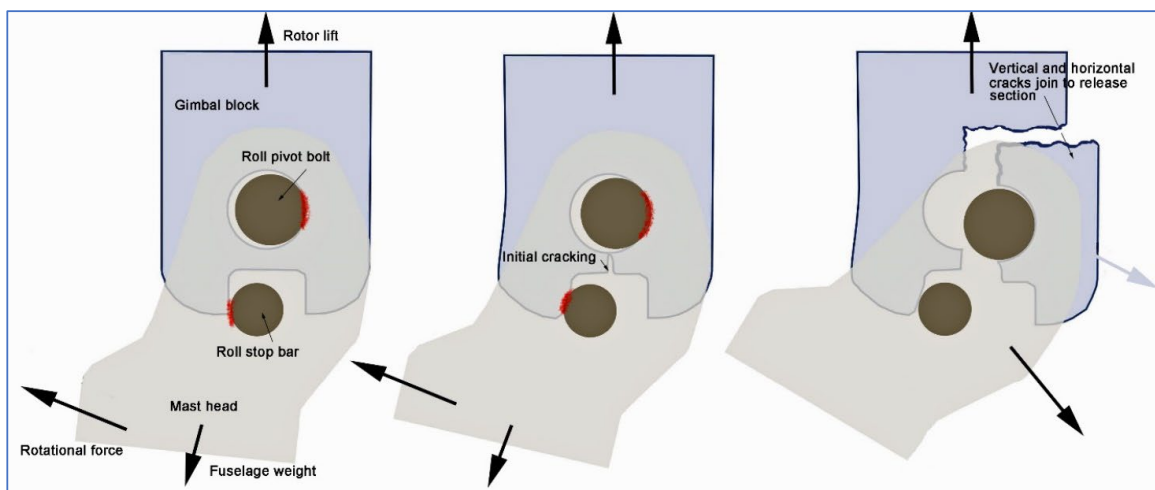
Figure 33

In flight, the gyroplane fuselage hangs from the roll pivot bolt fitted to the gimbal block. This also applies a vertical component to the force on the gimbal block equal to the weight of the fuselage (Figure 33). The damage to the accident gimbal block showed both vertical and horizontal fracture surfaces, with the vertical cracks occurring first, as seen in the rig test. Analysis of the fracture surfaces confirmed the overload had occurred during a single continuous event. As the cross-sectional area of the block carrying the weight of the fuselage was reduced by the vertical cracks during the accident flight, the horizontal cracks also formed due to overload. These cracks joined together resulting in a section of the gimbal block breaking off (Figure 33), allowing the rotor to detach from the fuselage. The separation of the rotor head was therefore caused by a structural failure of the gimbal block from exposure to dynamic flight loads during a single event.

Simple illustration of the final failure sequence of the gimbal block

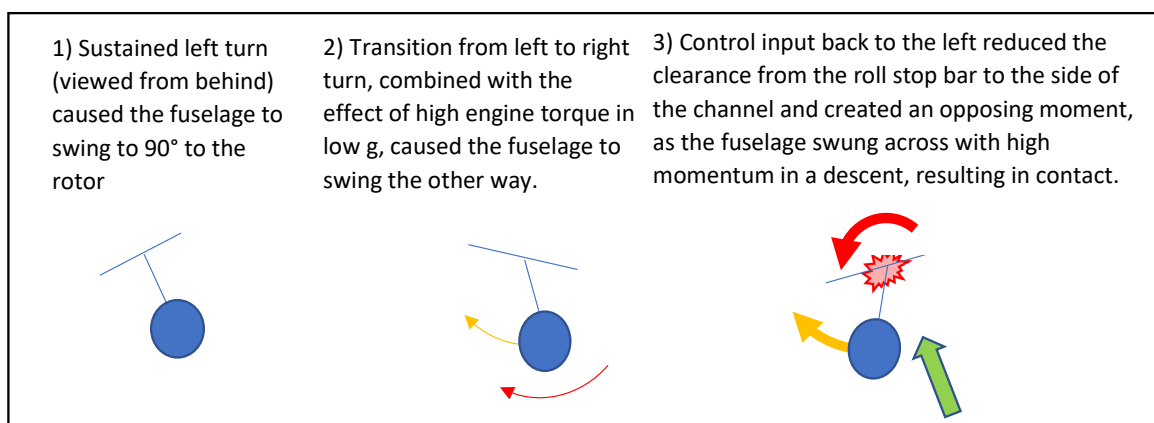
Figure 34

When the gyroplane transitioned between the left and right roll, the fuselage would have swung across with significant momentum. The torque induced rotation of the fuselage would probably have felt to the pilot like an uncommanded roll to the right, likely triggering an instinctive left roll input to counter it. This input would have changed the angle of the rotor relative to the horizontal. The lift and gyroscopic force and the weight of the rotor assembly opposing it effectively acts at the rotor pivot bolt which is a fixed distance away from the roll pivot bolt. The gyroscopic forces, the horizontal component of the lift and the weight vector would therefore create a moment around the roll pivot bolt and thus the contact point between the gimbal block and the roll stop bar. This would act to oppose the moment created by the fuselage rotating in the opposite direction, driven by the engine torque and inertia. This would likely have resulted in an impact between the bar and the gimbal block channel sufficient to generate the force required to cause the block to fracture, as confirmed during testing (Figure 34).

Response of the fuselage to the roll reversal inputs

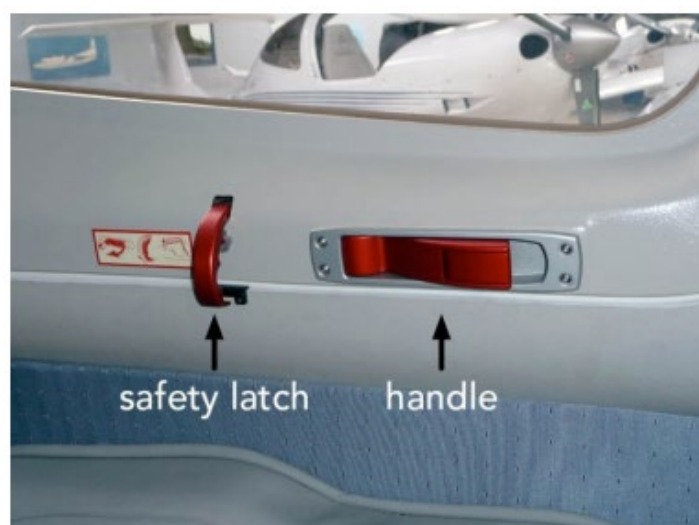
Figure 2

An additional safety latch is fitted (Figure 2). The function of this red safety latch is to hold the unlocked passenger door in a near closed position, whilst the aircraft is parked on the ground, protecting the passenger door from wind gusts. It also helps reduce the risk of a passenger door separation in case of an inadvertent opening of the door locking mechanism by a passenger during flight. Although it should be noted that the original design intent of the red safety latch was not to prevent a passenger door from separating from the aircraft because of a failure to lock the passenger door before flight.

Rear passenger door handle configuration (image used with permission)
