Air Accidents Investigation Branch  
Farnborough House  
Berkshire Copse Road  
Aldershot  
Hants GU11 2HH

Published 13 October 2016

**CONTENTS****SPECIAL BULLETINS / INTERIM REPORTS**

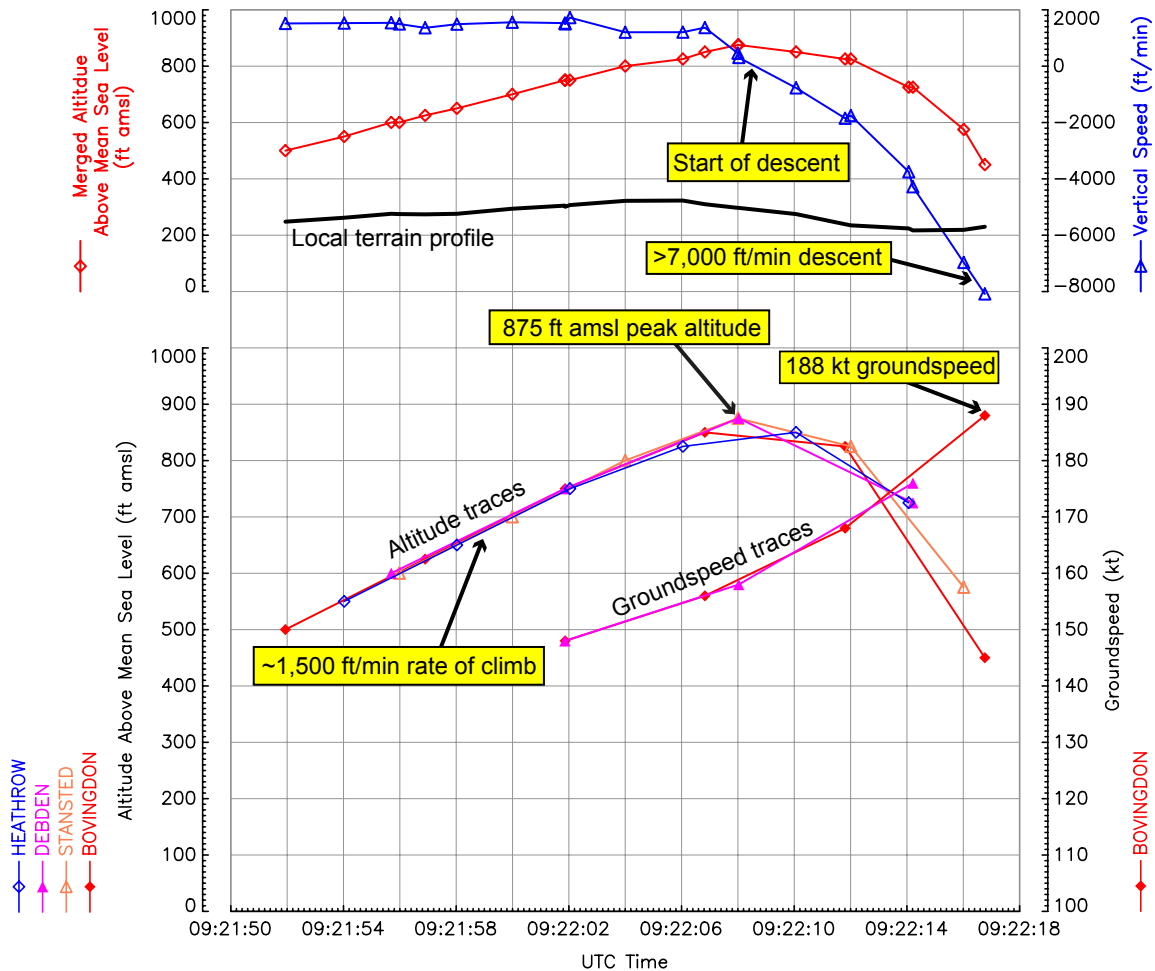
**Figure 5**  
Flight parameters

Ground tracks from the four radar installations are shown in Figure 4. Figure 5 shows the altitude and groundspeed values transmitted by the aircraft plotted against time. In the case of altitude, the values have been corrected for the regional pressure setting. In the upper half of Figure 5, the altitude trace, which shows merged altitude data from each radar installation, was used to derive the vertical speed trace.

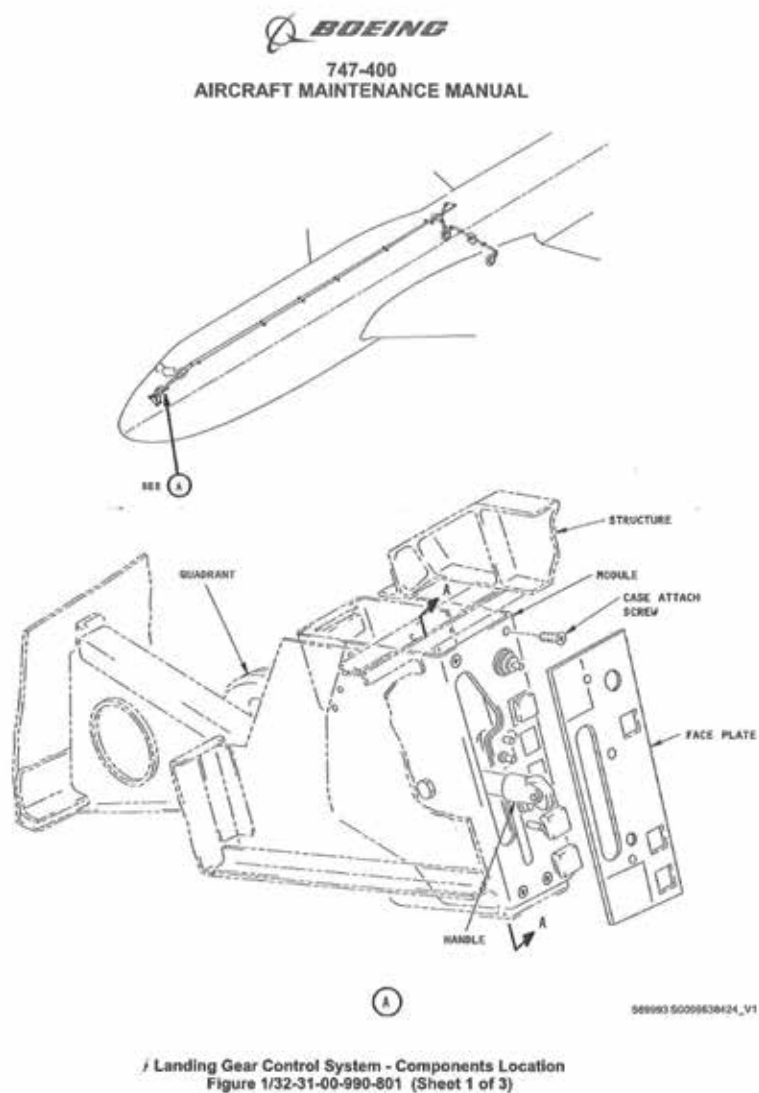
**Figure 2**

The handle is connected to a control rod, which in turn is connected to a quadrant, and attached to the quadrant is a cable that runs to the wing gear selector valve quadrant located in the right hand body gear wheel well. Another cable runs from the wing gear selector valve quadrant to the nose/body gear selector valve quadrant located in the left-hand body gear wheel well (Figures 2 and 3).

Landing Gear Control Module and cable runs
