Rail Accident Investigation Branch

Rail Accident Report

**Collision between a passenger train and a fallen tree at Broughty Ferry, Dundee
27 December 2023**

Report 13/2024
December 2024

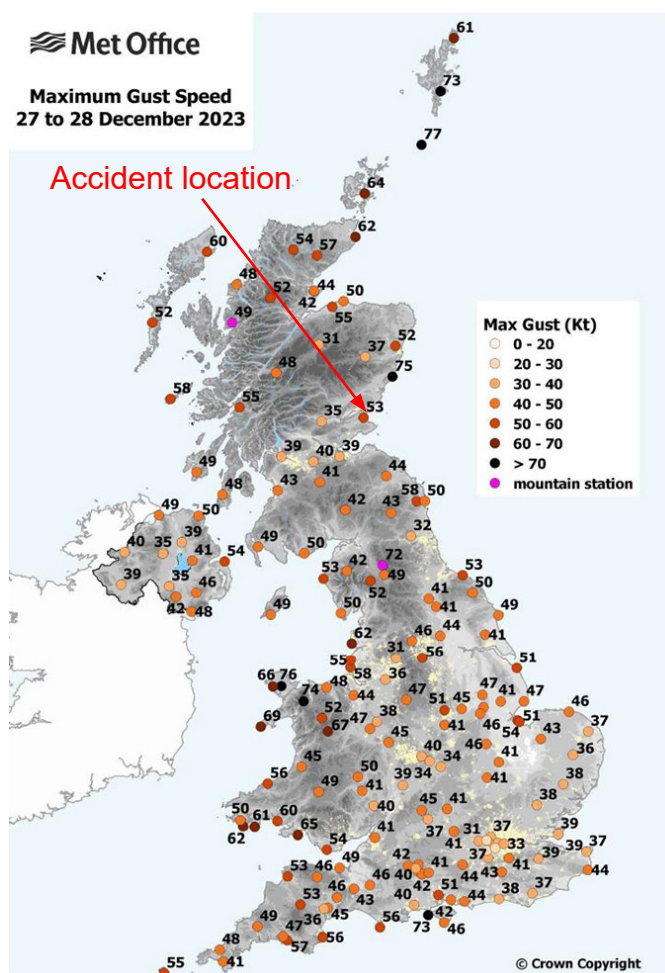
- 24 At the time of the accident, the Met Office had issued a weather warning associated with named Storm Gerrit. This warning was for high winds and heavy rain which extended across the country. The subsequent Met Office report stated that '*Storm Gerrit brought damaging winds and heavy rain to the United Kingdom from 27 to 28 December with Wales, north-west England and Scotland worst affected. In the most exposed locations, winds gusted at over 70 Knots (130 km/h) while heavy rain led to increased flooding concerns.*' The maximum gusts recorded during the storm are shown in figure 5.

Figure 5: Met Office chart indicating 53 Knots (98 km/h) maximum wind gusts associated with Storm Gerrit near accident location (courtesy of the Met Office).

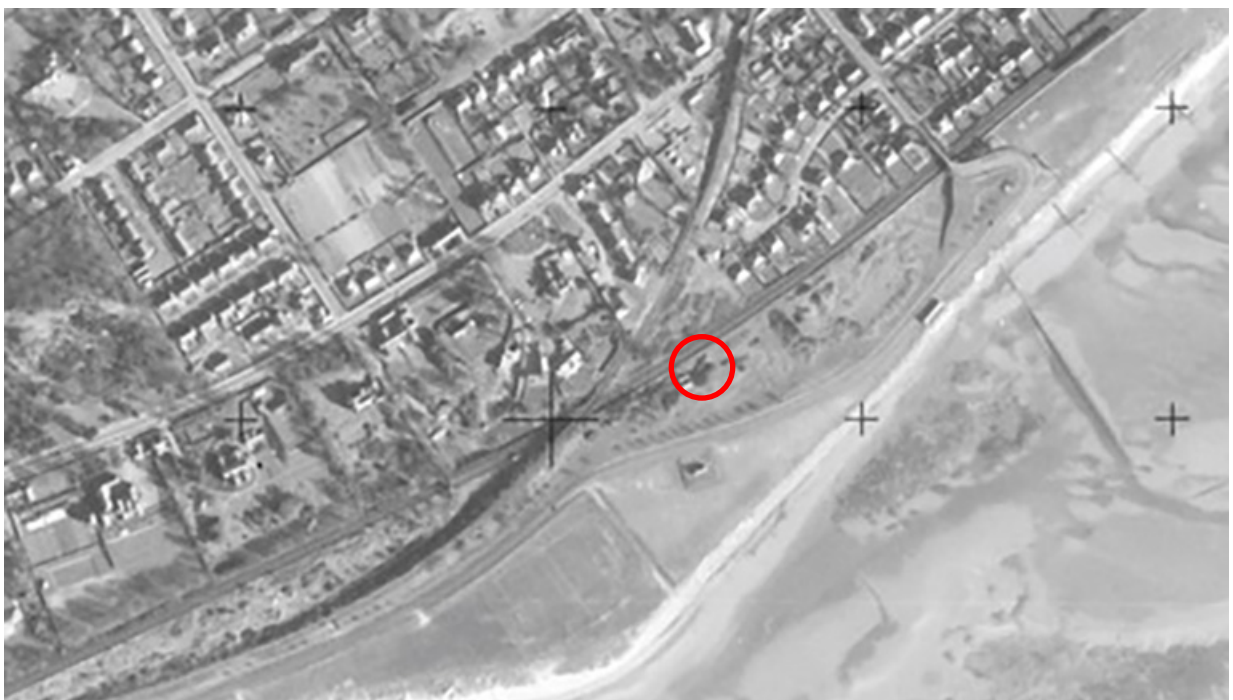
- 46 The tree was a Monterey cypress (*Cupressus macrocarpa*), a species only native to the coastal areas of California, which was growing in a small group of trees of the same species. Historic imagery from the National Collection of Aerial Photography shows no trees in the location of the fallen tree in 1941 and a collection of established trees in 1969. Barnhill Rock Gardens is the responsibility of DCC and its website states that the garden was started in 1955 on the site of a former golf course. Therefore, it is likely the tree was planted in the gardens sometime between 1955 and 1969.

Figure 8: Barnhill Rock Gardens in 1969 with RAIB annotation (courtesy of NCAP/ncap.org.uk).

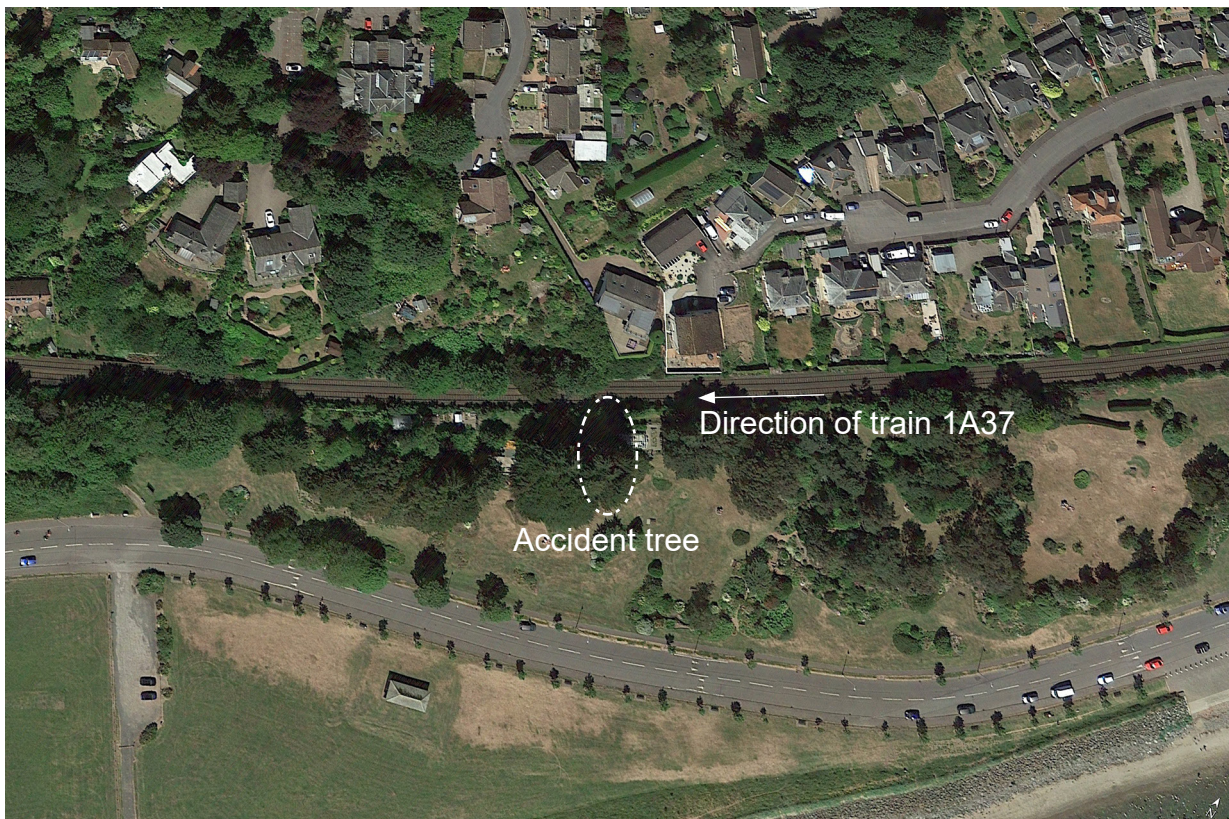
59 The fallen tree was located within a group of trees and for most of its life it had been in a position nearest to the railway and furthest from the Firth of Tay. As the tree developed, three of the four companion trees, which had been recently lost (paragraph 56), would have provided shelter from winds from the Firth of Tay.

60 Google Earth and Street View images show how this group of trees has changed over a 12-year period. It can be seen in the satellite image taken of the group in June 2018 that the group of trees was well established. By May 2023, Google Earth images show that the group had been much reduced (figures 11 and 12). The Street View images capture this change from ground level and show how the trees on the southern side of the group provide shelter from the ground up to those trees behind (figures 13 and 14).

Figure 11: Google Earth image showing the group of trees in June 2018 (courtesy of Google with RAIB annotations).

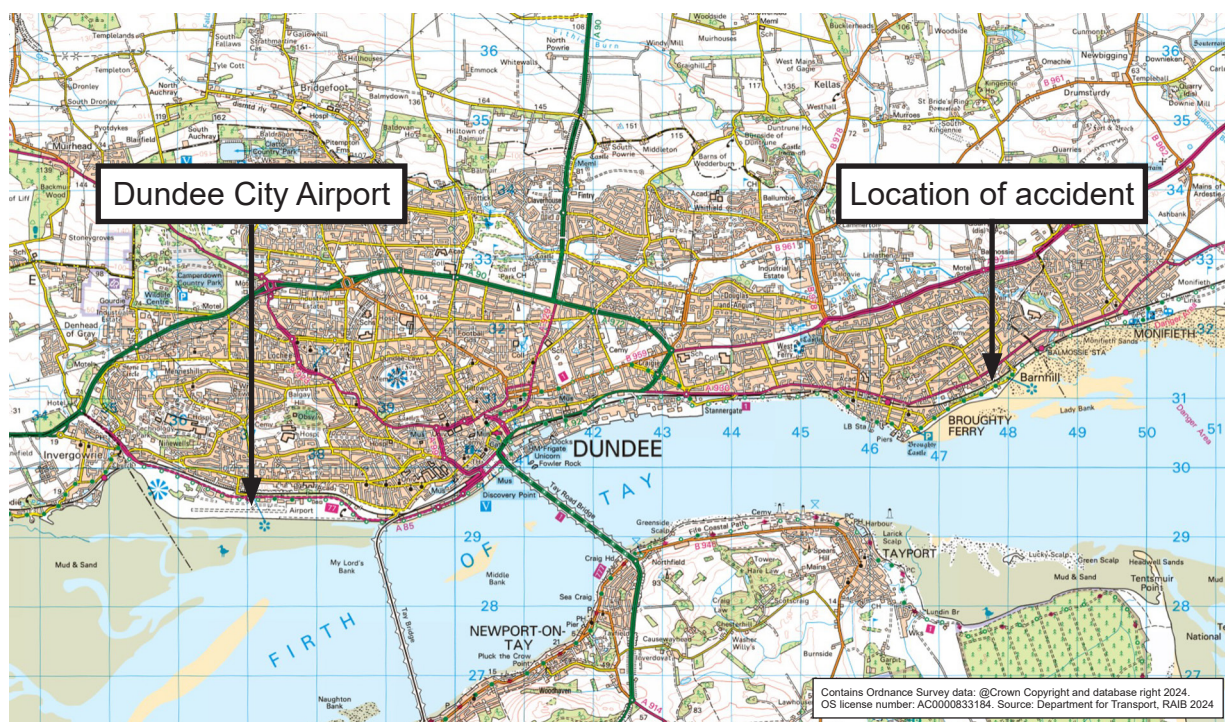
- 70 The precise wind speed which the failed tree was subject to is unknown. Observations taken from Dundee City Airport saw gusts up to 87 km/h for the hour in which the tree failed, which is just below the wind speed range for force 10 of 88 km/h to 101 km/h. Although the weather station is located further along the Firth of Tay shoreline from the tree, RAIB considers that the speeds recorded are likely to be similar to the wind experienced by the failed tree (figure 17).

Figure 17: Map showing Dundee City Airport and accident location relative to Firth of Tay.

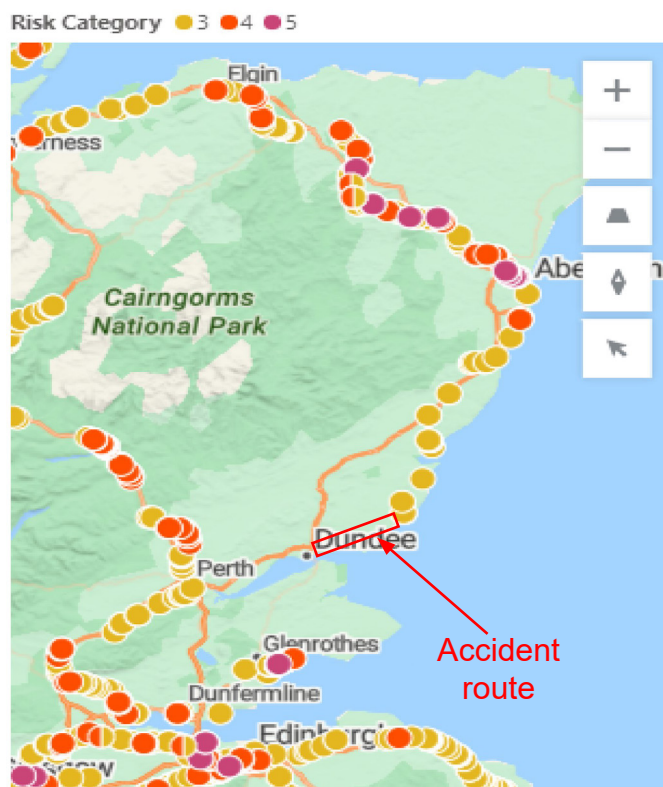
- 90 Network Rail had identified trees at risk of falling along the coastal section north of Arbroath but found that there were no trees of concern to the south (figure 18). With this information, the EWAT conference attendees concluded it was not necessary to recommend a BSR for high winds on the section alongside the Firth of Tay on which the accident occurred.

Figure 18: Network Rail database of hazardous trees north of Dundee.
