AAIB Bulletin

1/2025

Aircraft Type and Registration:	ATR 72-202, G-NPTF	
No & Type of Engines:	2 Pratt & Whitney Canada PW121 turboprop engines	
Year of Manufacture:	1990 (Serial no: 192)	
Date & Time (UTC):	7 March 2023 at 0138 hrs	
Location:	Belfast International Airport	
Type of Flight:	Commercial Air Transport (Cargo)	
Persons on Board:	Crew - 2	Passengers - None
Injuries:	Crew - None	Passengers - N/A
Nature of Damage:	None reported	
Commander's Licence:	Airline Transport Pilot's Licence	
Commander's Age:	45 years	
Commander's Flying Experience:	6,750 hours (of which 92 were on type) Last 90 days - 65 hours Last 28 days - 25 hours	
Information Source:	AAIB Field Investigation

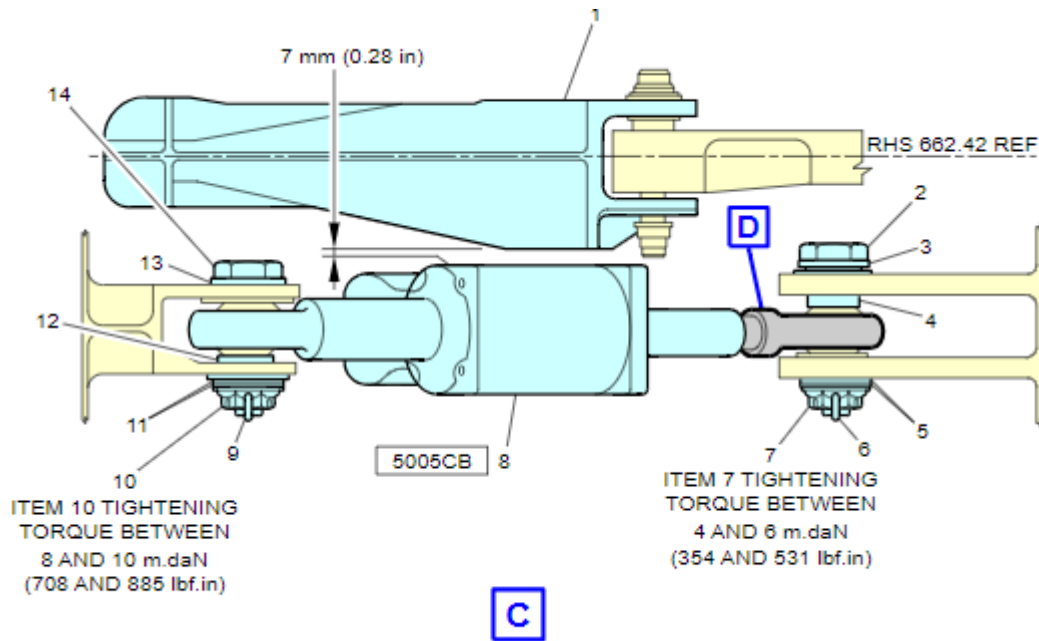
Figure 8

A subsequent torque check of rudder damper attachment bolts revealed that the torque on the forward attachment bolt (vertical stabiliser side) was within limits (allowable 8-10 daNm). However, the aft attachment bolt (rudder side) had been over-torqued and required more than 10 daNm to loosen it (allowable 4 – 6 daNm). When the bolt was removed, moisture was present on the bolt shank and within the attachment lugs and the bushing was seized to the bolt. There was no evidence of grease present at either attachment.

The ATR 72 maintenance manual⁷ tasks for removal and installation of the rudder damper refer to a figure which includes an overview on sheet 1, showing the location of the rudder damper. Sheet 2 (Figure 8) shows a detailed view of the rudder damper and its attachment points, specifying the allowable torque values. While the overview on sheet 1 includes an orientation arrow to show the forward direction, the detailed view on sheet 2 does not include any orientation arrows, to differentiate the forward and rear aft attachment points and the detailed view is shown in the opposite orientation to the overview.

Extract from ATR 72 AMM figure showing rudder damper attachment allowable torque values

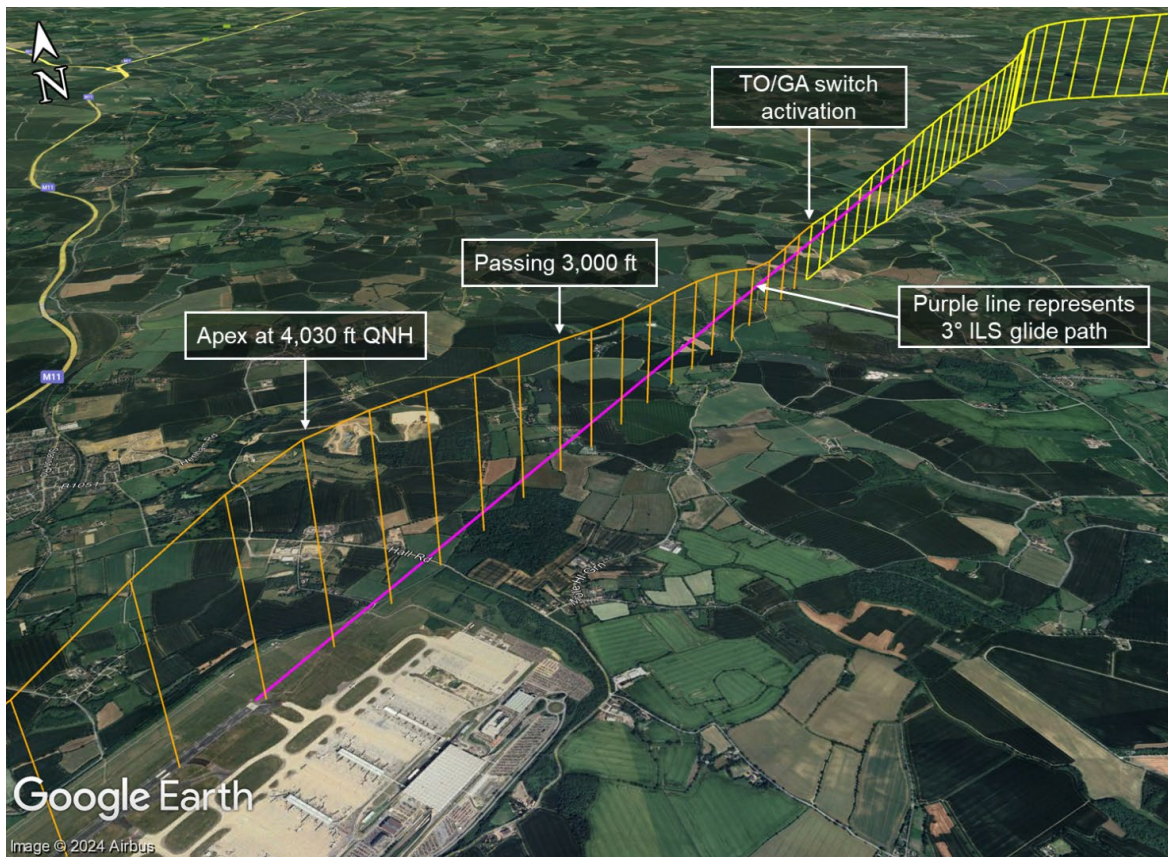
At 1,940 ft amsl (1,579 ft aal) and 3.6 nm from touchdown, the commander initiated a go-around (GA) and the co-pilot advised ATC of this. See Figure 2 for EI-HET's approach from radar data, showing the path before the GA was initiated, and the aircraft's subsequent track.

EI-HETs approach from radar data, showing path before TO/GA switch activation (yellow track), and subsequent track (orange track). 3° ILS G/S illustrated by purple line

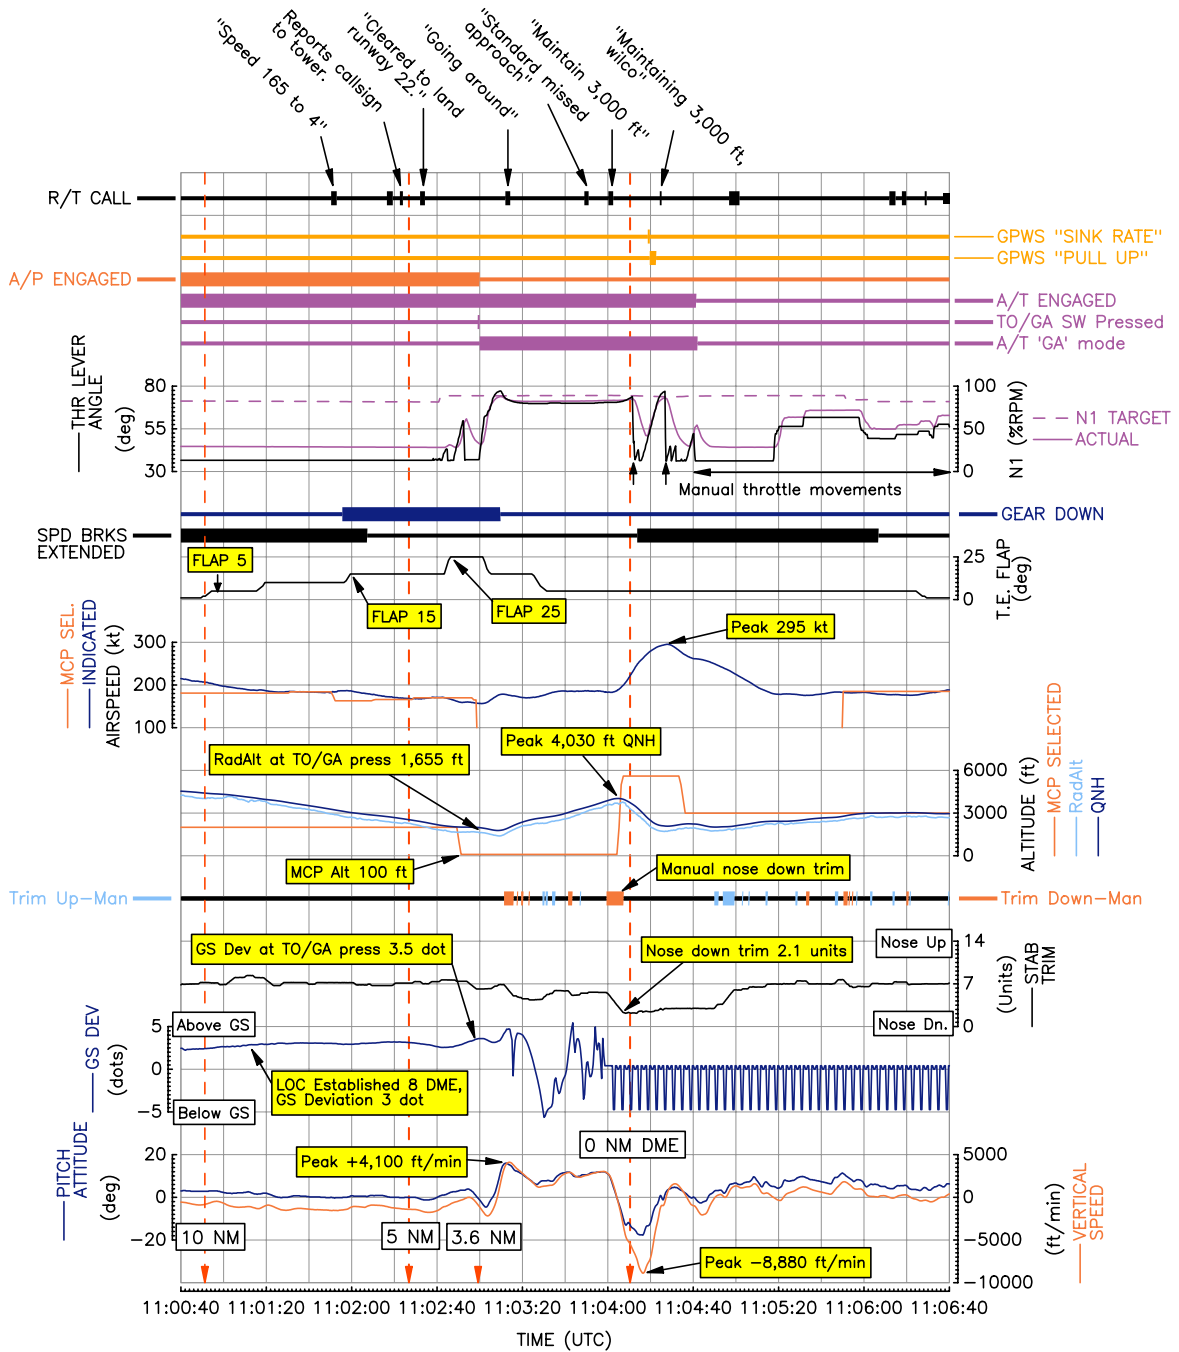
Figure 4 shows the pertinent FDR parameters for the event, with recorded RTF transmissions made by the flight crew to ATC. Activations of the EGPWS and Autopilot and Flight Director System (AFDS) modes are also shown. Each square along the x-axis represents 10 seconds.

Pertinent parameters from the FDR, with R/T transmissions to ATC

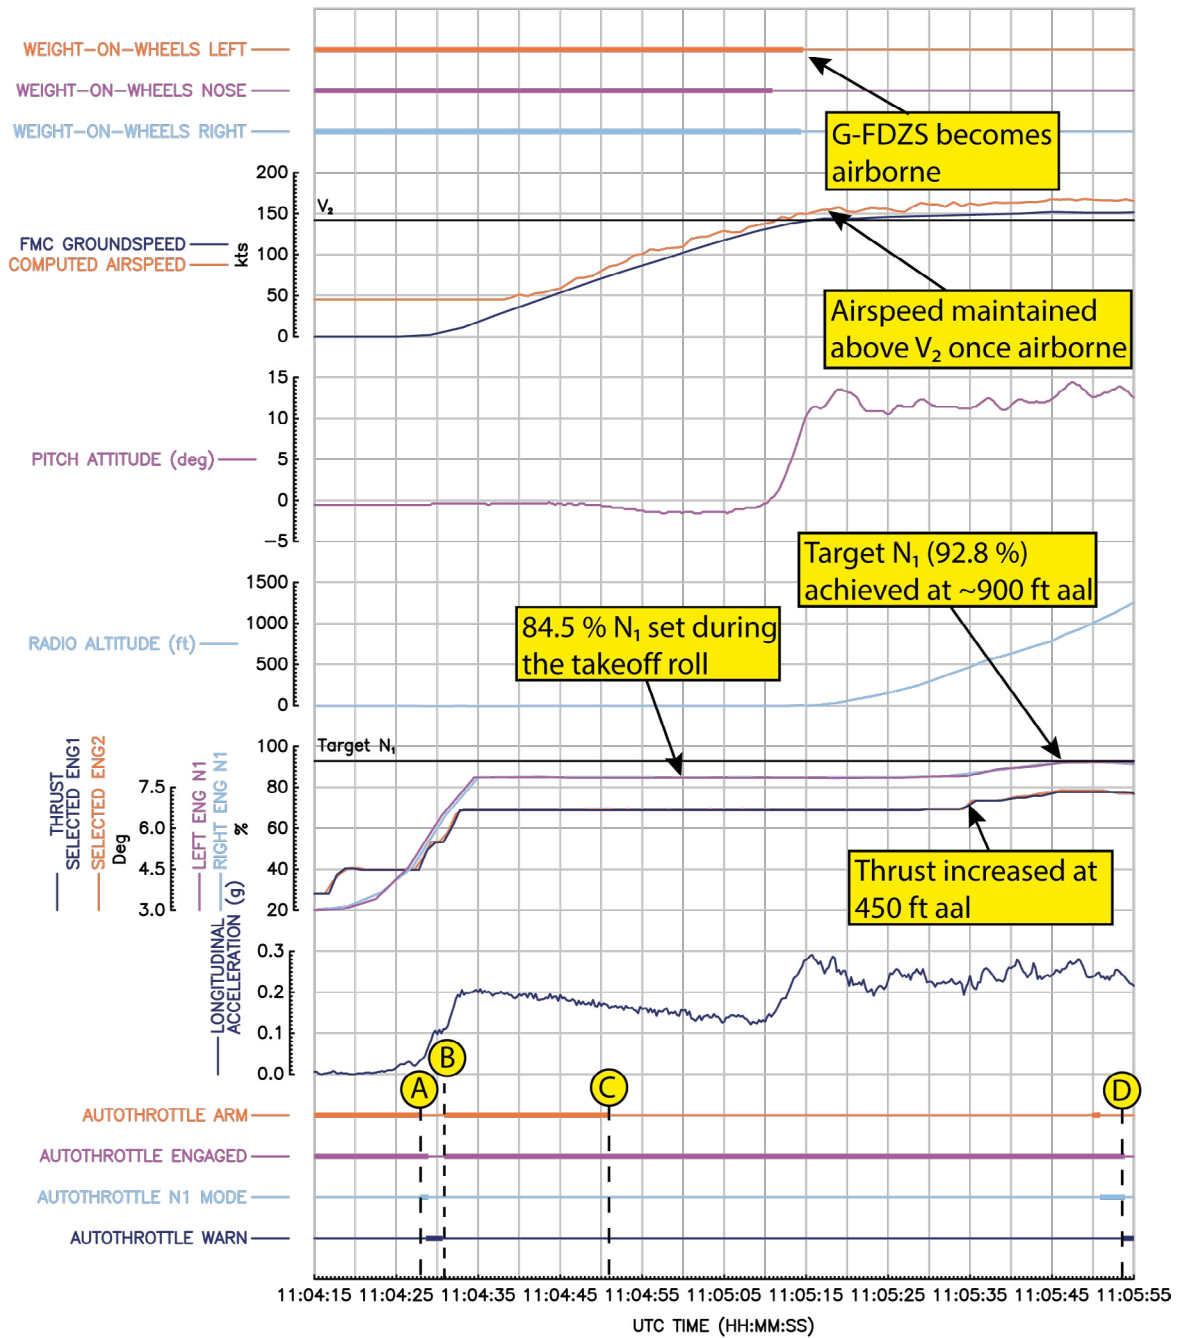
Figure 1

G-FDZS was fitted with both an FDR and a CVR. The CVR fitted to G-FDZS was not removed from the aircraft as it continually overwrites itself, retaining only the last two hours of audio. As such, the recording of the takeoff would have been overwritten during the flight to Las Palmas. However, the FDR was removed and downloaded. Data from the FDR is shown in Figure 1.

- (A) A/T transitions from ARM to N1 mode on TOGA selection, disconnects almost immediately with a warning
- (B) A/T re-armed within five seconds but no active mode selected
- (C) A/T transitions to ARM HOLD mode, as per design, at 84 kt
- (D) A/T transitions from ARM to N1 mode, but disconnects with a warning almost immediately (2nd uncommanded disconnect)

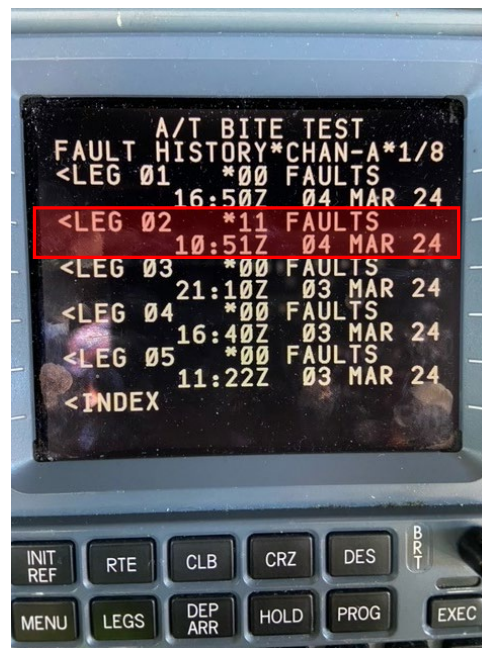
Figure 2

The MCDU allows maintenance personnel to interrogate the health of several aircraft subsystems, including the A/T, and to investigate any logged faults. The fault history for the A/T, (Figure 2), shows that 11 faults were logged for the incident flight to Las Palmas - LEG 02 - but no faults were logged on the return flight to the UK, or on the preceding day.

A/T fault history for the incident flight and the preceding day

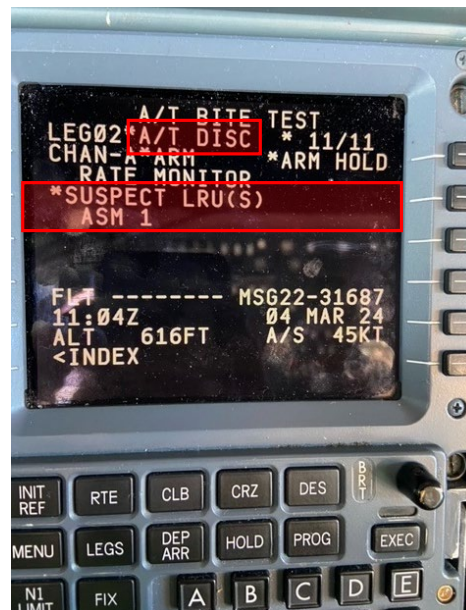
Figure 3

Five of the 11 logged faults related to uncommanded A/T disconnections. The first of these fault records is shown in Figure 3, and occurred at 1104 hrs when, from the FDR data, G-FDZS was on the runway at the beginning of the takeoff roll.

Detailed fault record for the initial uncommanded A/T disconnection, showing the suspected cause as the rate monitor logic within ASM 1

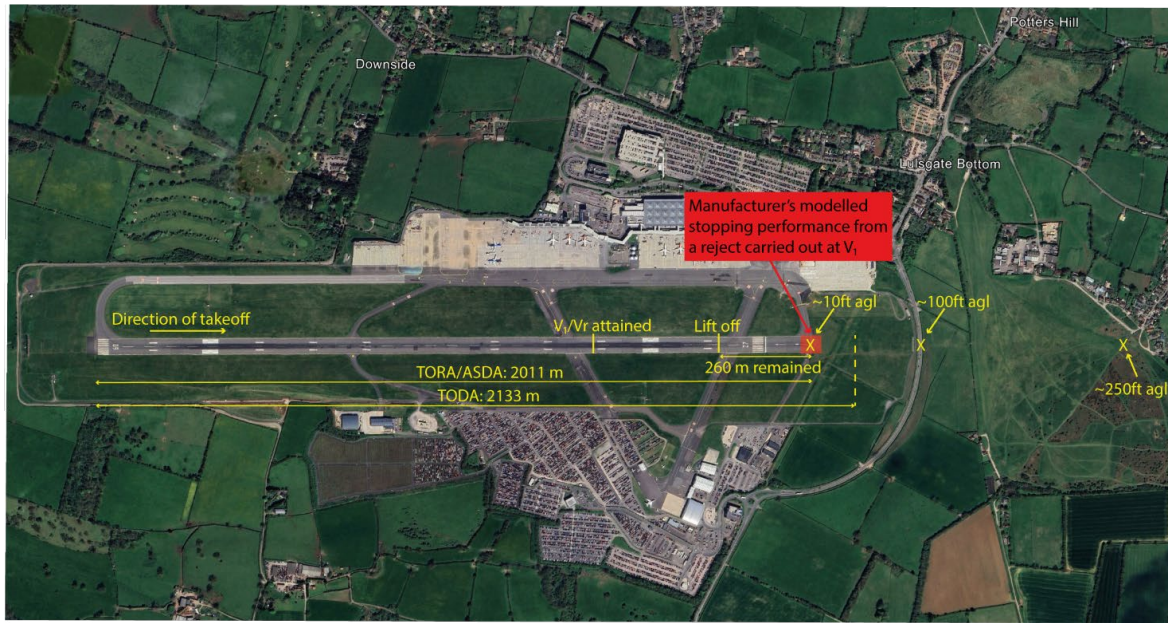
Unfactored calculations by the aircraft manufacturer indicated that with no increase in thrust, had an engine failed at V_1 and the crew decided to stop, the aircraft would probably have stopped on the runway as long as the crew had used maximum reverse thrust. Had the crew elected to continue or if the engine failed above V_1 , calculations indicate that the aircraft would not have been able to climb away without the application of more power. Figure 7 shows some of this data on a graphic of Bristol Airport.

Graphic of G-FDZS's takeoff from Bristol Airport
© 2024 Google, Image © 2024 Airbus

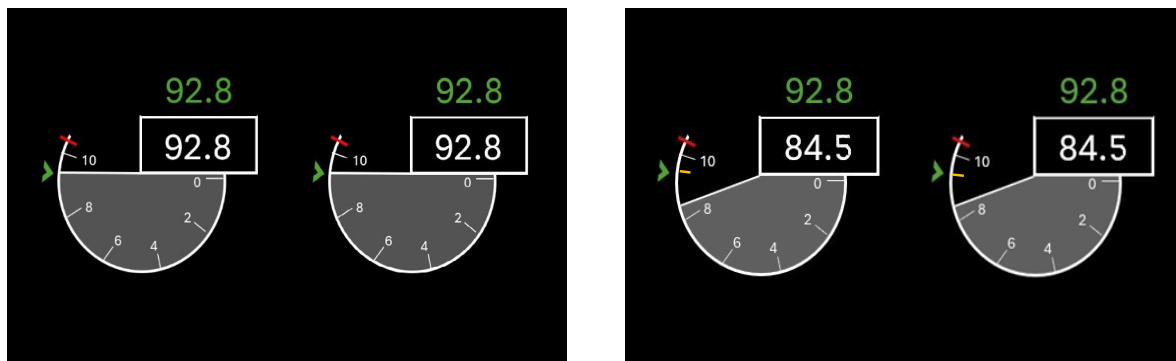
Figure 8

The reference N_1 was set in the FMC at 92.8% as per the performance calculation completed before departure from the stand. This reference N_1 was displayed on the N_1 gauges as previously described. During the takeoff run, after the A/T had disengaged, the selected N_1 was 84.5%. A demonstration of what the N_1 gauges should have looked like compared to the actual N_1 used for takeoff is shown at Figure 8.

N_1 display as should have been (left) and with the N_1 used for takeoff showing (right)

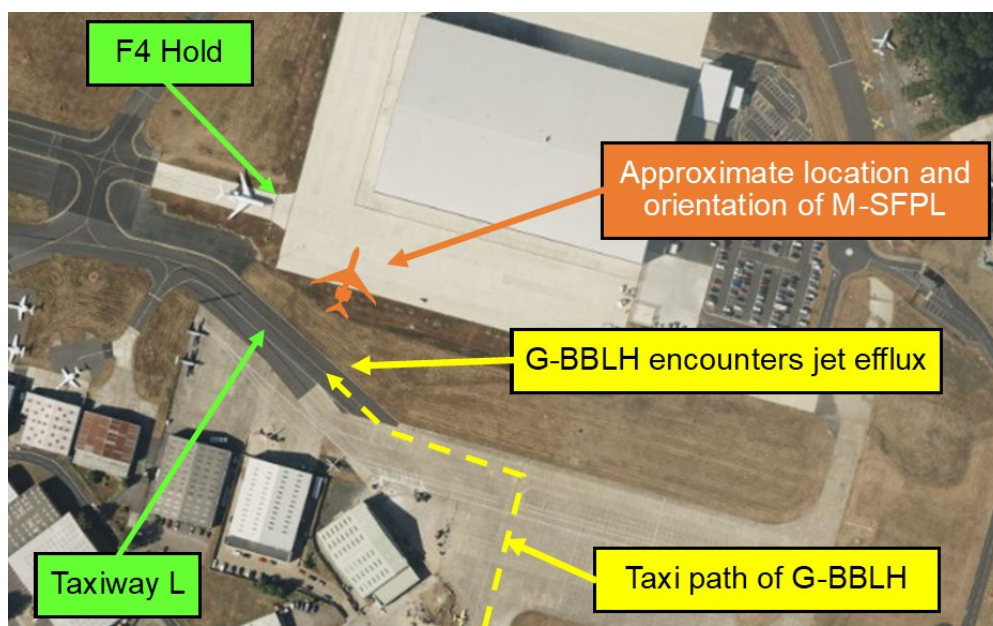
Figure 1

G-BBLH was proceeding along Taxiway L at London Biggin Hill Airport (Biggin Hill) when it got caught in the jet efflux from M-SFPL, a G6000 parked on a northerly heading with its engines running on an adjacent apron (Figure 1). The pilot of G-BBLH was not aware that the G6000 had started its engines before he taxied behind it.

Incident location and respective positions of G-BBLH and M-SFPL
(image ©Vexcel Imaging ©2024 Microsoft)

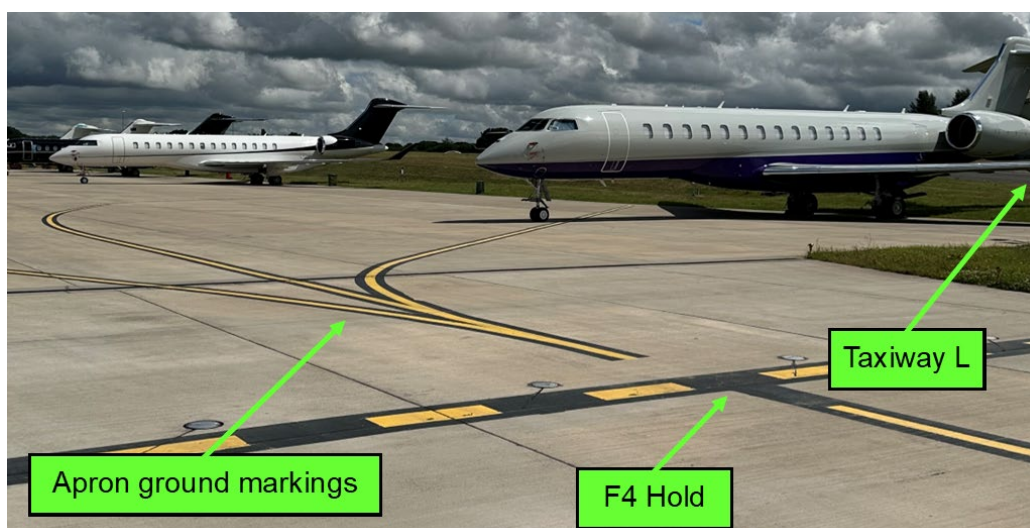
Figure 2

The distance between the newly established apron and Taxiway L was limited so jet efflux attenuation barriers were not installed when it was constructed. Instead, the airport and maintenance organisation came to an agreement that apron line markings would be installed for the movement of aircraft. These lines were designed by the airport and subsequently installed by the maintenance organisation. The ground markings in the area close to Taxiway L are aligned on an approximate north-westerly heading rather than perpendicular to the apron edge (Figure 2). The airport operator explained these ground markings were positioned so efflux from aircraft parked there “would be diagonal to the L taxiway and towards the rising ground (grass) between the [maintenance apron] and the airport’s South-East apron.”

An internal investigation by the maintenance organisation found “a level of normative practise in the positioning of aircraft” where aircraft were parked “along the apron resulting in reduced area to park aircraft in what would be the appropriate positioning in line with the taxi markings” (Figure 2).

F4 Hold and aircraft parked on maintenance organisation’s apron
