Rail Accident Investigation Branch

Rail Accident Report

Trap and drag accidents at Archway and Chalk Farm stations 18 February and 20 April 2023

Report 06/2024
June 2024

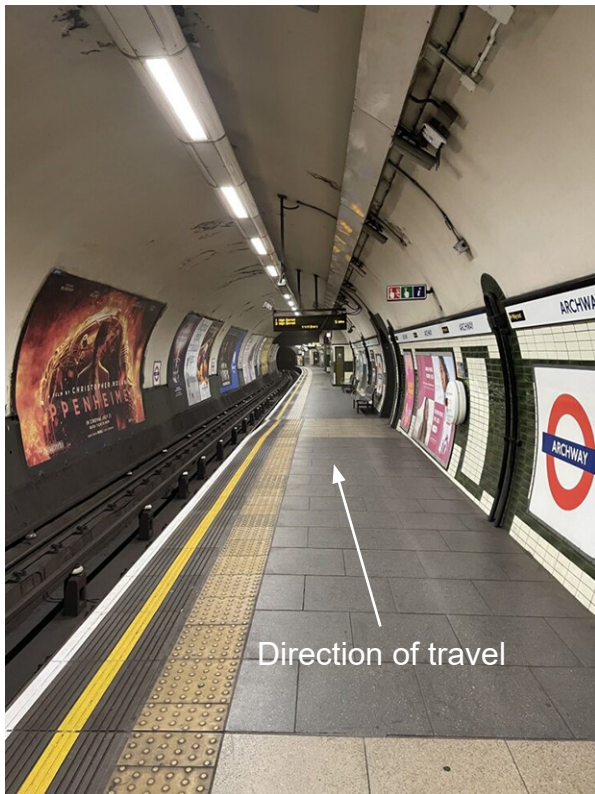
Figure 2: View northbound from the west (tailwall) end of platform 1 at Archway.

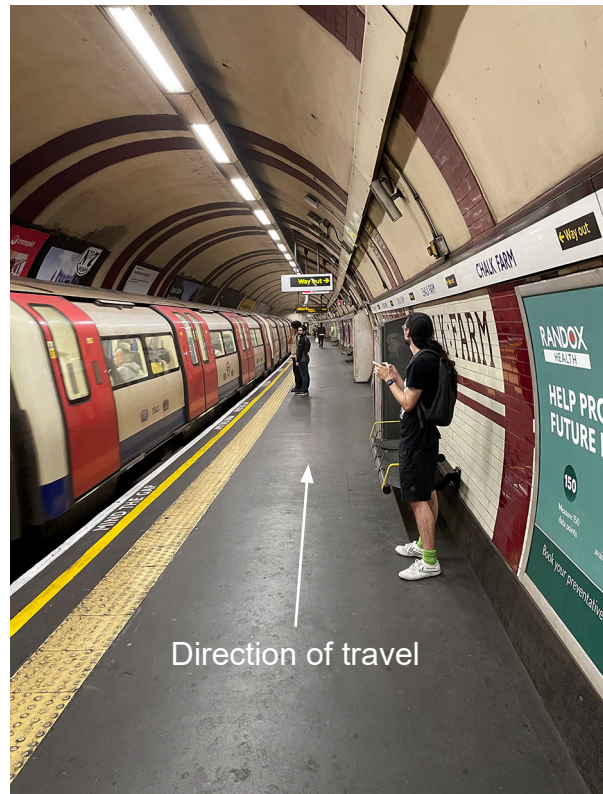
Figure 3: View southbound from the west (tailwall) end of platform 2 at Chalk Farm.

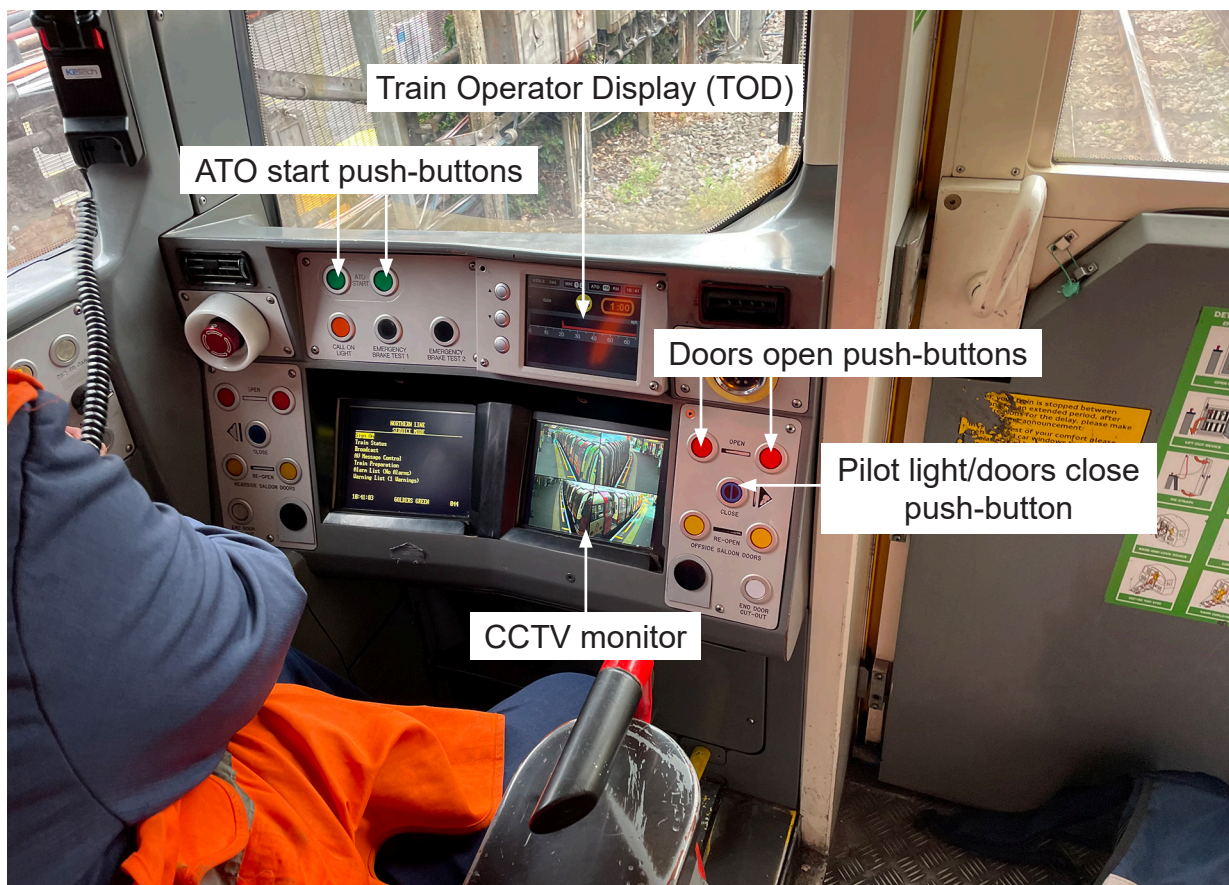
Figure 4: 1995 stock cab display and control panels. The panels to the left and right are for door operation on each side of the train. There is an LCD monitor to display platform CCTV images, and a primary display panel.

- 127 The monitor in the train cab is approximately 100 mm x 150 mm and displays images from cameras located on the platform (figure 4). The image is displayed on the monitor from just before entering a station until the last car has left the station (paragraph 11). OPO CCTV document No: S1150 issue A2 states: '*All presented images shall be either a 2-way full vertical split, 3-way vertical split or 4-way vertical split (no full captured image used).*' The split at Chalk Farm was into two images, rather than four smaller images. Although four smaller images may have given a closer view of the passenger, they might have taken more time to scan than two images.

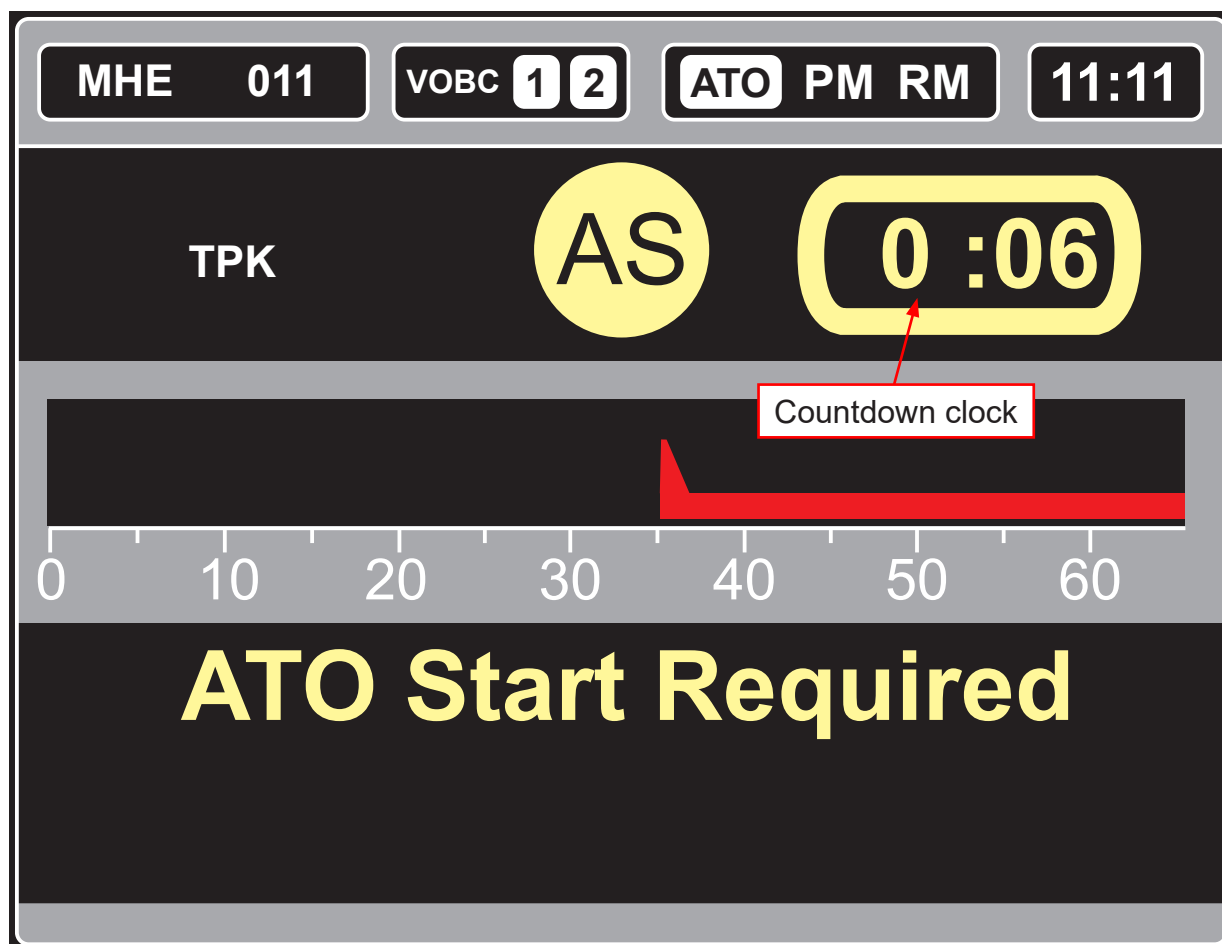
Figure 5: ATO countdown to departure (in seconds) TOD.

- 67 Although train operators are not specifically aware of the platform dwell times calculated by the SMC, they receive target departure time information that is displayed in the driving cab during the station stop (figure 5). As soon as the wheels stop with the train in the platform, the ATO countdown starts. When the timer begins counting down the numbers are displayed in yellow on the TOD. When the countdown reaches 11 seconds, there is an audible tone and 'ATO start required' is displayed. When the countdown reaches zero, the numbers are displayed in orange and then start counting up.
