Rail Accident Investigation Branch

Rail Accident Report

**Collision between a passenger train and a fallen tree at Broughty Ferry, Dundee
27 December 2023**

Report 13/2024
December 2024

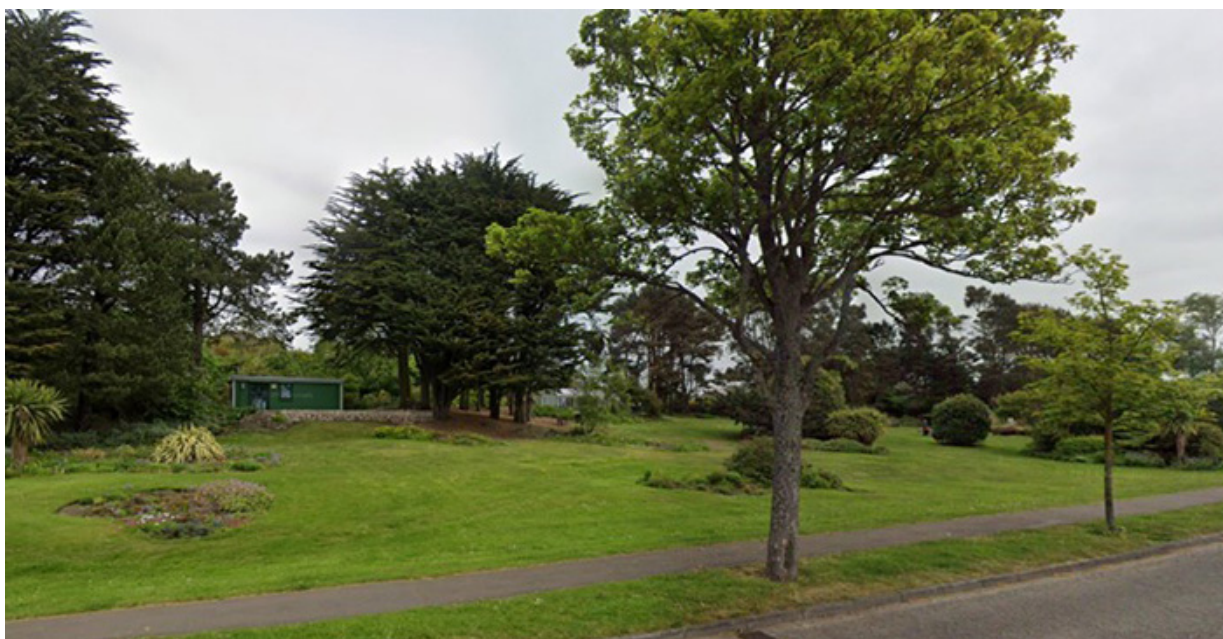
- 11 The tree had fallen from within Barnhill Rock Gardens, part of a public park situated to the left of the railway between the railway boundary and the shore of the Firth of Tay. The gardens include tree species which are native and non-native to the United Kingdom. The tree that fell onto the railway was a Monterey cypress tree which grows naturally in North America (figure 3).

Figure 3: Google Street View image of Barnhill Rock Gardens (courtesy of Google).

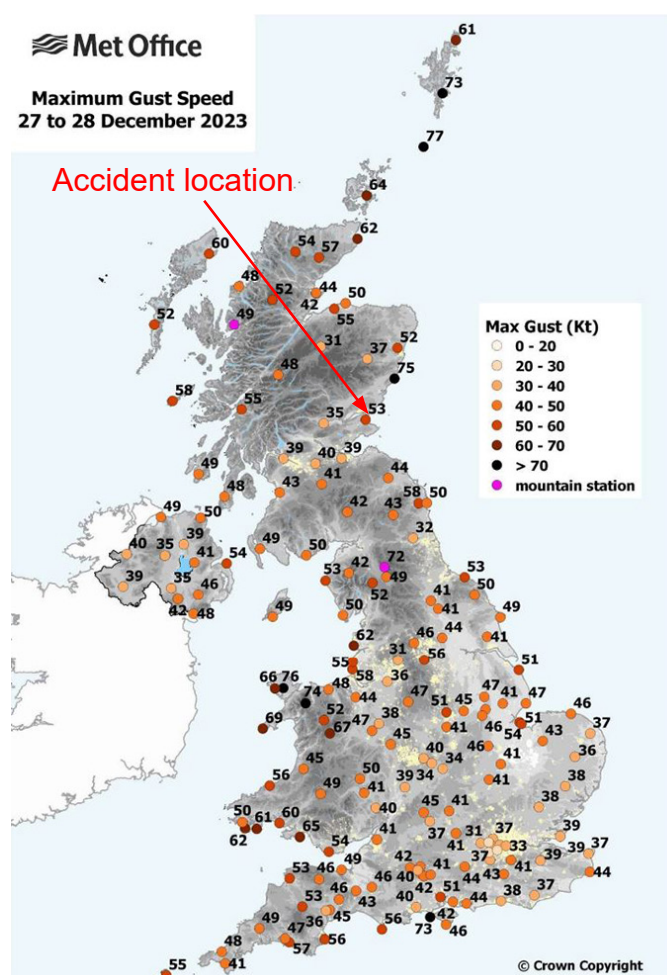
- 24 At the time of the accident, the Met Office had issued a weather warning associated with named Storm Gerrit. This warning was for high winds and heavy rain which extended across the country. The subsequent Met Office report stated that '*Storm Gerrit brought damaging winds and heavy rain to the United Kingdom from 27 to 28 December with Wales, north-west England and Scotland worst affected. In the most exposed locations, winds gusted at over 70 Knots (130 km/h) while heavy rain led to increased flooding concerns.*' The maximum gusts recorded during the storm are shown in figure 5.

Figure 5: Met Office chart indicating 53 Knots (98 km/h) maximum wind gusts associated with Storm Gerrit near accident location (courtesy of the Met Office).

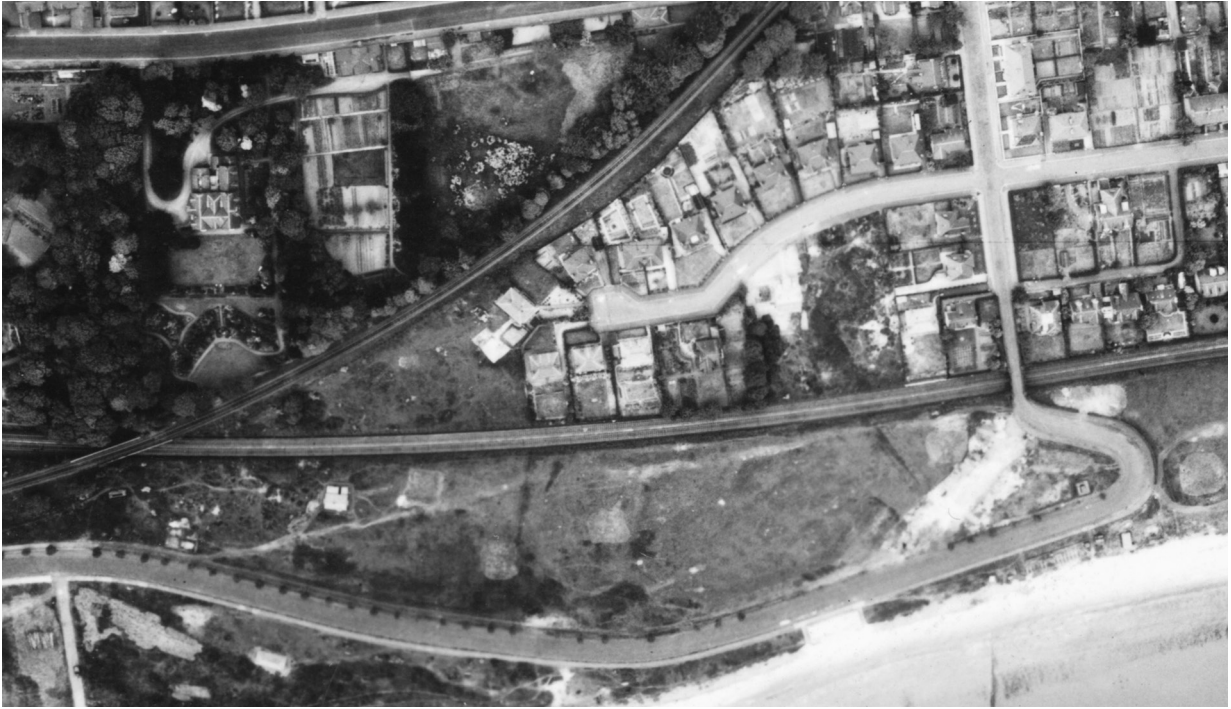
- 46 The tree was a Monterey cypress (*Cupressus macrocarpa*), a species only native to the coastal areas of California, which was growing in a small group of trees of the same species. Historic imagery from the National Collection of Aerial Photography shows no trees in the location of the fallen tree in 1941 and a collection of established trees in 1969. Barnhill Rock Gardens is the responsibility of DCC and its website states that the garden was started in 1955 on the site of a former golf course. Therefore, it is likely the tree was planted in the gardens sometime between 1955 and 1969.

Figure 7: Site of the future Barnhill Rock Gardens in 1941 (courtesy of NCAP/ncap.org.uk).

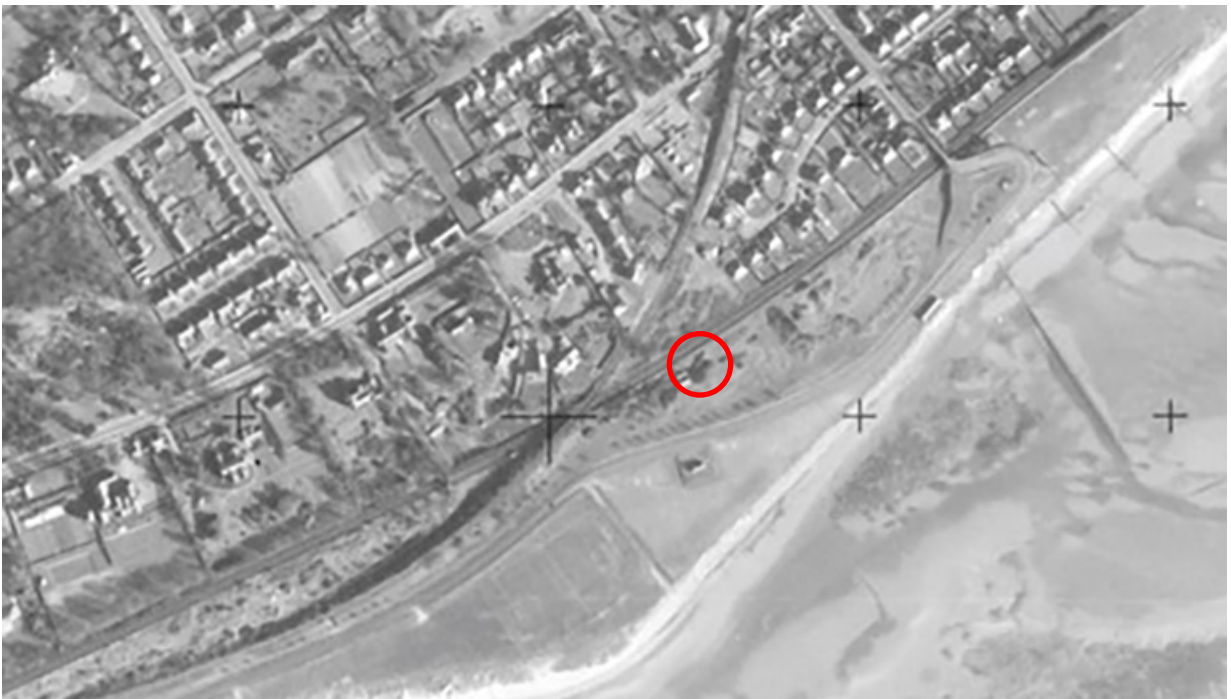
Figure 8: Barnhill Rock Gardens in 1969 with RAIB annotation (courtesy of NCAP/ncap.org.uk).
