## Accident

<b>Aircraft Type and Registration:</b>	Socata TB-20 Trinidad, N33NW	
<b>No &amp; Type of Engines:</b>	Lycoming IO-540 SER piston engine	
<b>Year of Manufacture:</b>	1990 (Serial no: 1073)	
<b>Date &amp; Time (UTC):</b>	10 October 2023 at 1535 hrs	
<b>Location:</b>	Langham Airfield, Norfolk	
<b>Type of Flight:</b>	Private	
<b>Persons on Board:</b>	Crew - 1	Passengers - 2
<b>Injuries:</b>	Crew - 1 (Serious)	Passengers - 2 (Serious)
<b>Nature of Damage:</b>	Aircraft destroyed	
<b>Commander's Licence:</b>	Private Pilot's Licence	
<b>Commander's Age:</b>	47 years	
<b>Commander's Flying Experience:</b>	121 hours (of which 27 were on type) Last 90 days - 3 hours Last 28 days - 1 hour	
<b>Information Source:</b>	Aircraft Accident Report Form submitted by the pilot and further enquiries by AAIB

## Synopsis

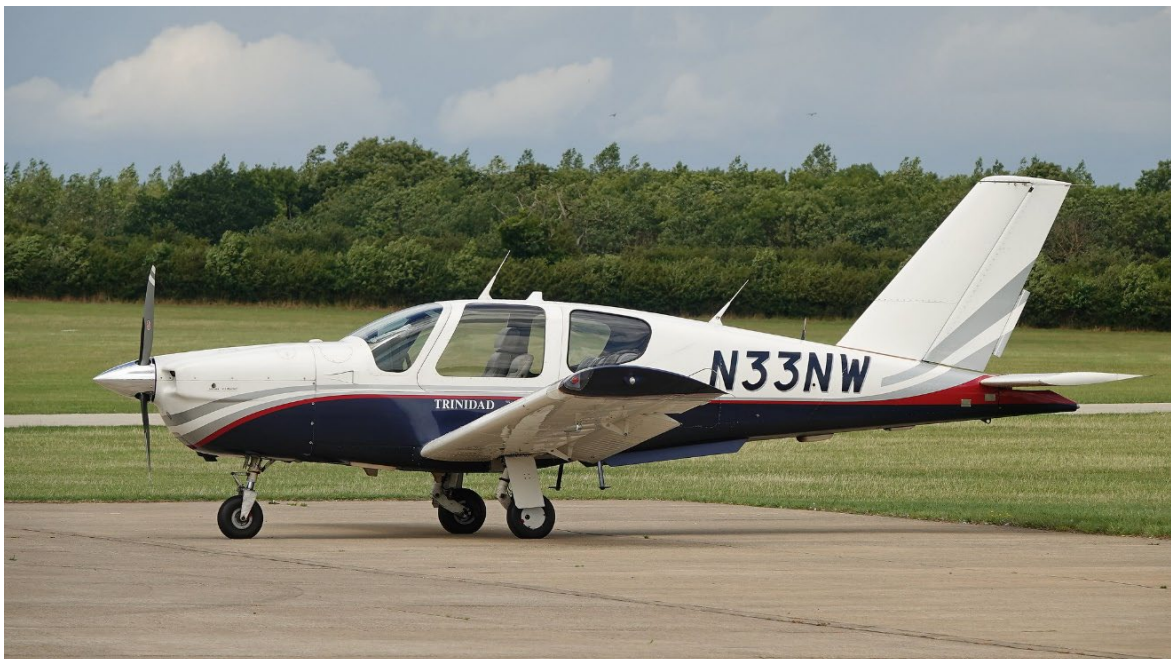
**Figure 2**

The Socata TB-20 is a low-wing, single engine piston aircraft with seating for up to four passengers (Figure 2). It has a 9.85 m wingspan and retractable landing gear.

Socata TB-20 N33NW (used with permission)
