Report on the investigation of
the capsizing and foundering of the fishing vessel
***Njord* (SH 90)**
resulting in one fatality
150 miles north-east of Peterhead, Scotland
on 6 March 2022

The capsized and foundering of the fishing vessel *Njord* (SH 90), resulting in one fatality, 150 miles north-east of Peterhead, Scotland, on 6 March 2022

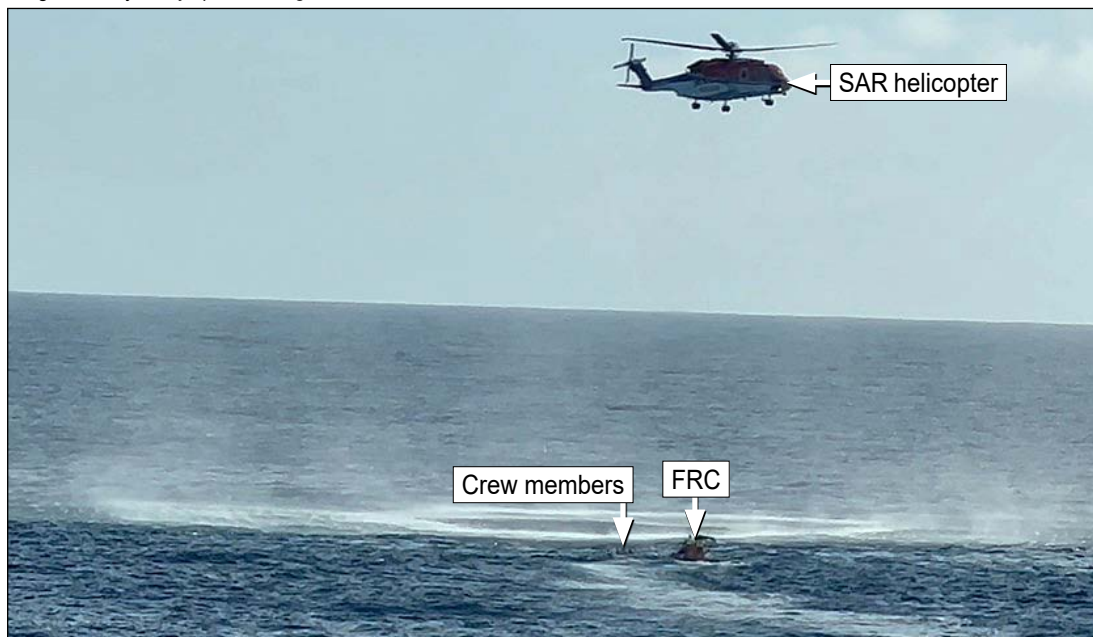
The SAR helicopter contacted *Olympic Challenger* and requested that its FRC rescue the remaining five crew members from the water. By 1441, the FRC had recovered the remaining five crew members and was heading back to *Olympic Challenger*. The SAR helicopter remained at the scene until all five crew members were safely on board the FRC (**Figure 5**) and then departed.

Figure 5: SAR helicopter and *Olympic Challenger* FRC at the scene
