AAIB Bulletin

2/2025

Published: 13 February 2025.

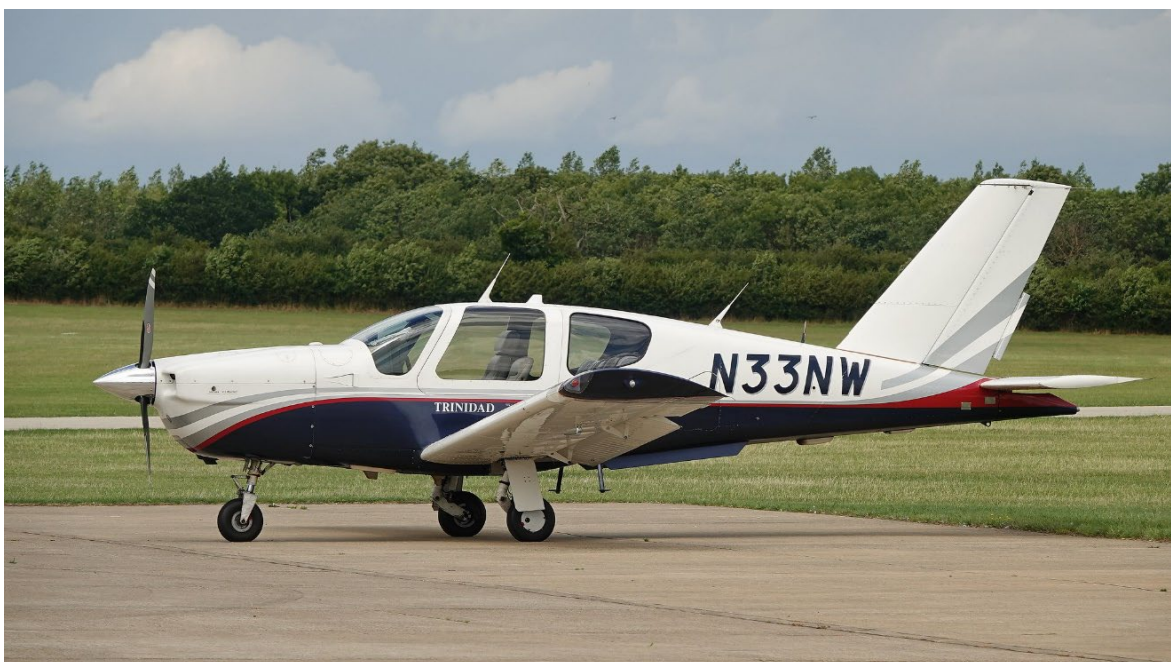
Figure 2

The Socata TB-20 is a low-wing, single engine piston aircraft with seating for up to four passengers (Figure 2). It has a 9.85 m wingspan and retractable landing gear.

Socata TB-20 N33NW (used with permission)
