Rail Accident Investigation Branch

Rail Accident Report

Derailment of a passenger train near Walton-on-Thames, Surrey 4 March 2024

Report 04/2025
February 2025

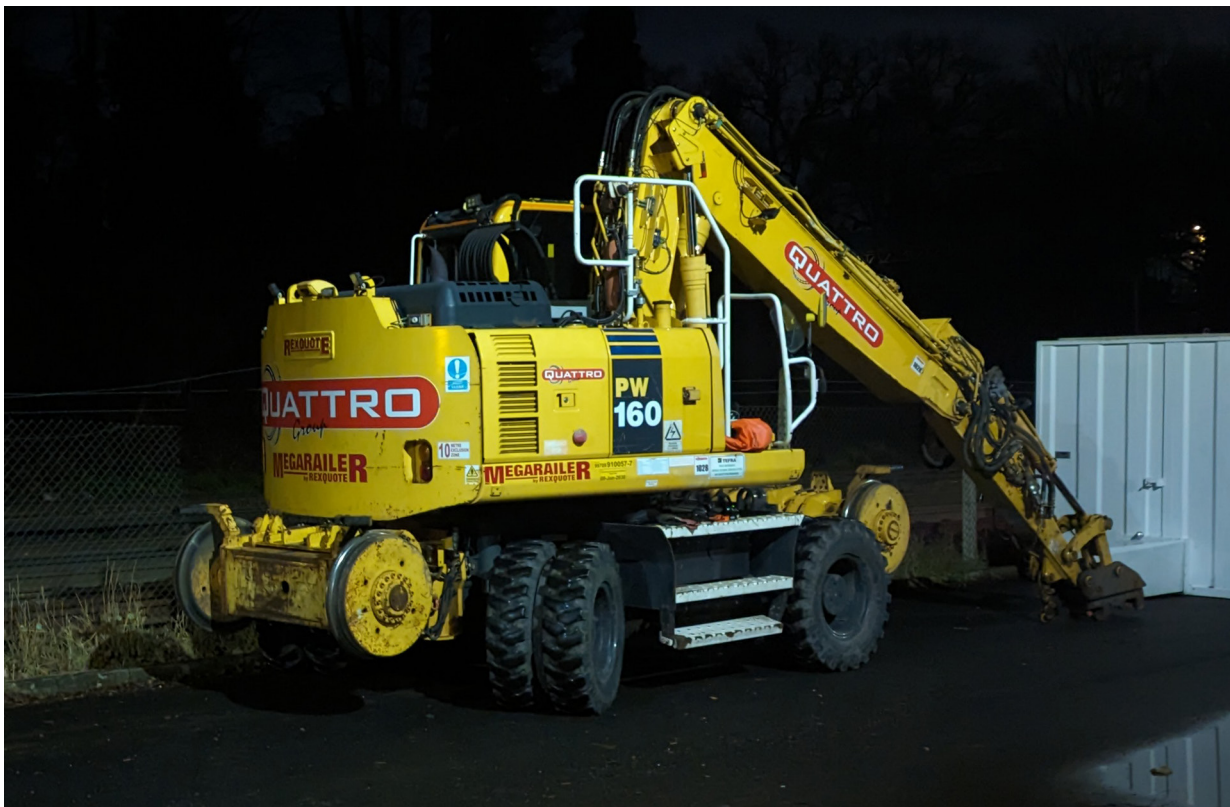
- 17 The RRV used on the work site near Walton-on-Thames station was a Crane/Excavator (figure 4) and was fitted with a log clamp (model NR 1945). This type of equipment is generally used to collect logs but can also be used to collect redundant rail. The RRV can also be fitted with chains and a camlock (a type of rail lifting clamp that is attached to the railhead to securely lift rail), which were also used to collect the redundant rail (figure 5).

Figure 4: RRV used at the work site near Walton-on-Thames.

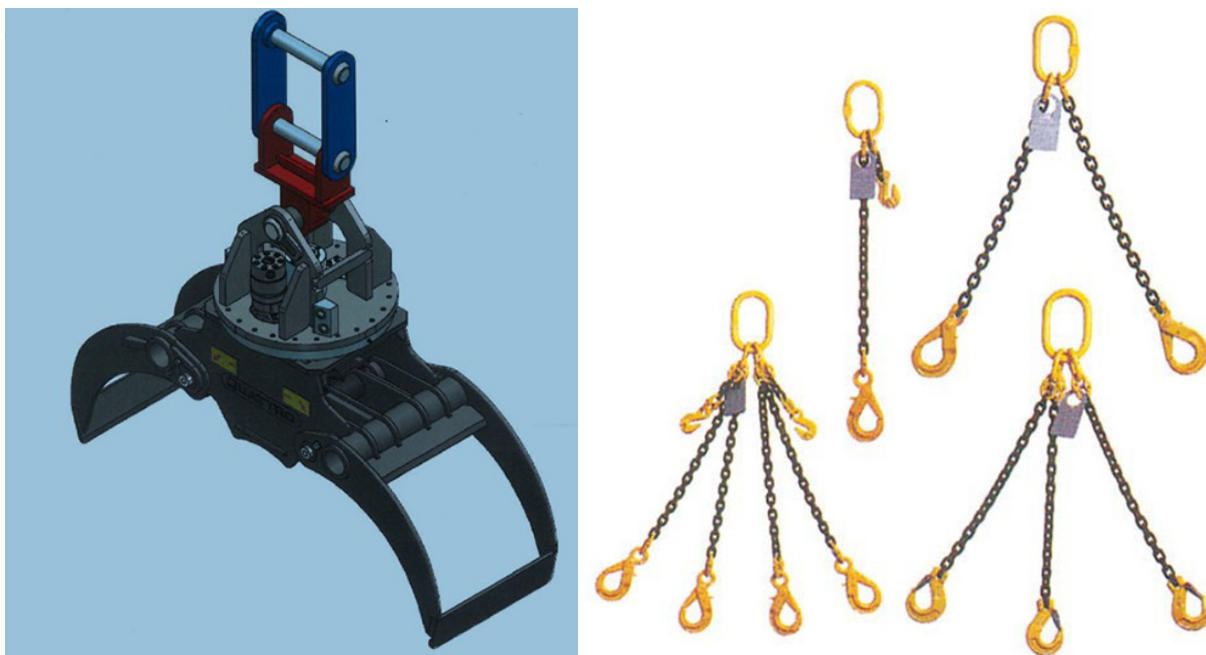
Figure 5: The left-hand image shows a schematic drawing of the type of log grab used at the work site near Walton-on-Thames and the right-hand image shows an example of the chains similar to that used.

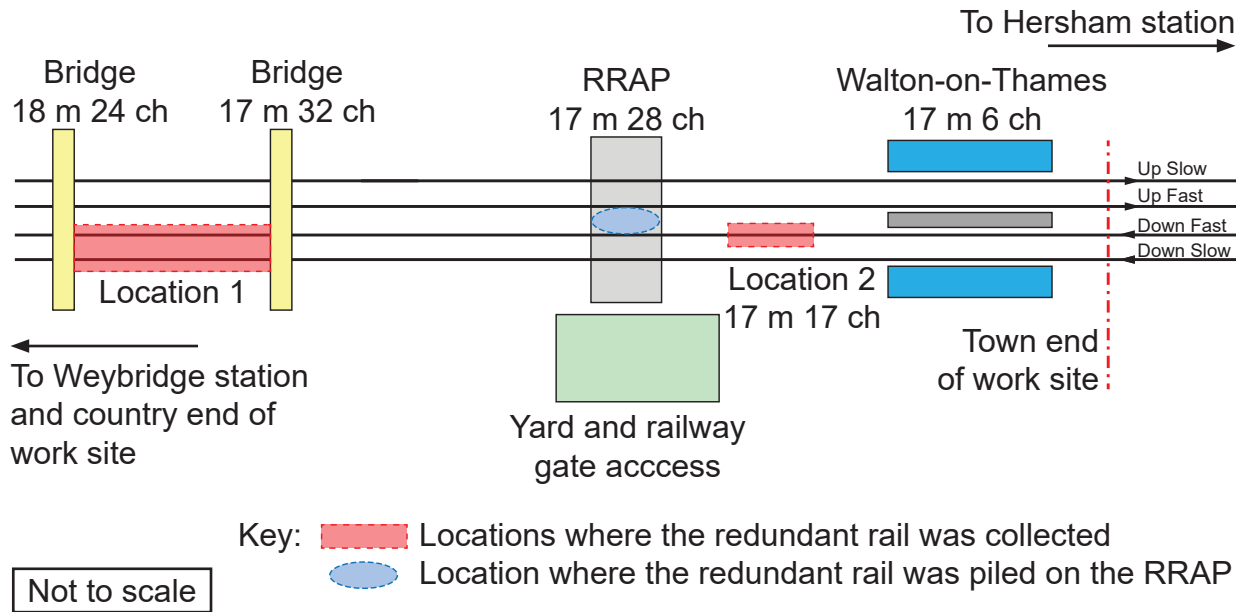
- 41 After the RRV was off-tracked and the other redundant material had been deposited in the yard, the RRV was on-tracked on the Down Fast line and moved to location 2 without the trailer. The RRV was then used to collect the cut sections of redundant rail from the four-foot of the Down Fast line and the ten-foot (the space between two pairs of running lines) using the log grab. The redundant rail was placed in a pile on the RRAP.

Figure 8: Diagram of work site, showing the approximate locations where the redundant rail was collected (red shaded rectangle area) and piled on the RRAP (blue shaded oval area) during the morning shift at the work site near Walton-on-Thames station.

42 There is conflicting witness evidence around which part of the RRAP the redundant rail sections were piled, with some witnesses reporting that the rails were deposited in either the ten-foot or the four-foot of the Down Fast. The RRV was then off-tracked and used in road mode to move the sections of redundant rail piled on the RRAP into the yard.

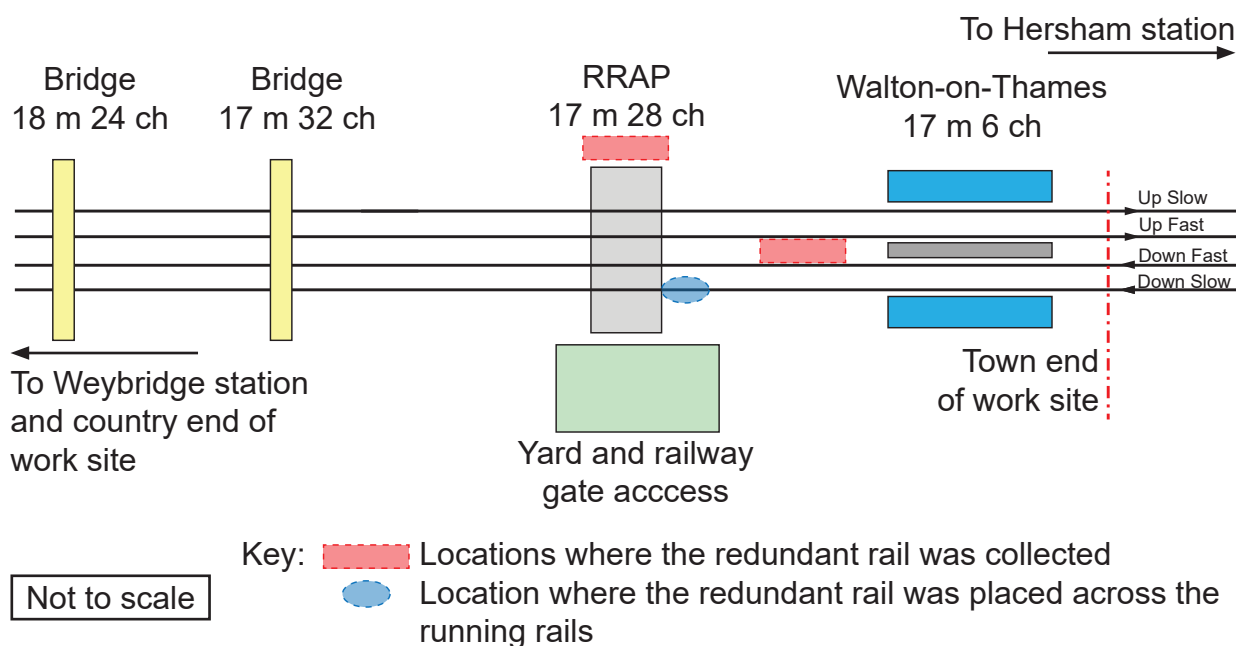
- 44 Sometime between 13:30 and 15:00, the machine operator and machine controller off-tracked the RRV at the RRAP and collected four sections of redundant rail from the up cess using the log grab, lifting two at a time. They drove the RRV across the RRAP to take the redundant rail from the up cess to the yard.

Figure 9: Diagram of work site, showing the approximate locations where the redundant rail was collected (red shaded rectangle areas) and placed on the railhead (blue shaded oval area) during the evening shift at the work site near Walton-on-Thames station.

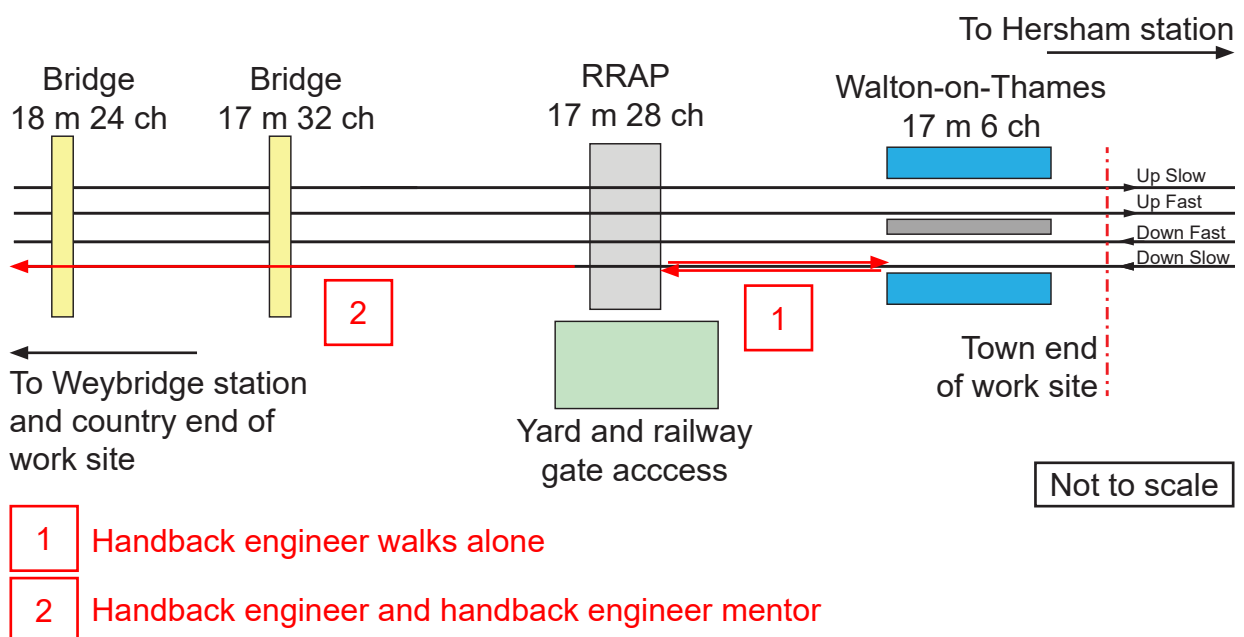
- 51 After this briefing, the handback engineer began the inspection, walking from the RRAP to the town end of the work site, near to Walton-on-Thames station (figure 10). Witness evidence shows that the handback engineer undertook this visual inspection walking in the four-foot of the Down Slow line to check the track geometry. In parallel, the handback engineer also looked for redundant rail in the Down Slow line and looked across to the Down Fast line for any redundant rail that had been left foul of the running line. Witness evidence also shows that this part of the inspection was completed without the handback engineer mentor being present and that the handback engineer used a handheld torch to illuminate the track around them (see paragraph 156).

Figure 10: Diagram of work site, showing the routes walked by the handback engineer and handback engineer mentor from 23:00 on 2 March.
