Grounding and capsizing of the creel fishing vessel *Lexi Rose* (BF 370) on Melrose Point, north-east Scotland resulting in one fatality on 21 September 2023

SUMMARY

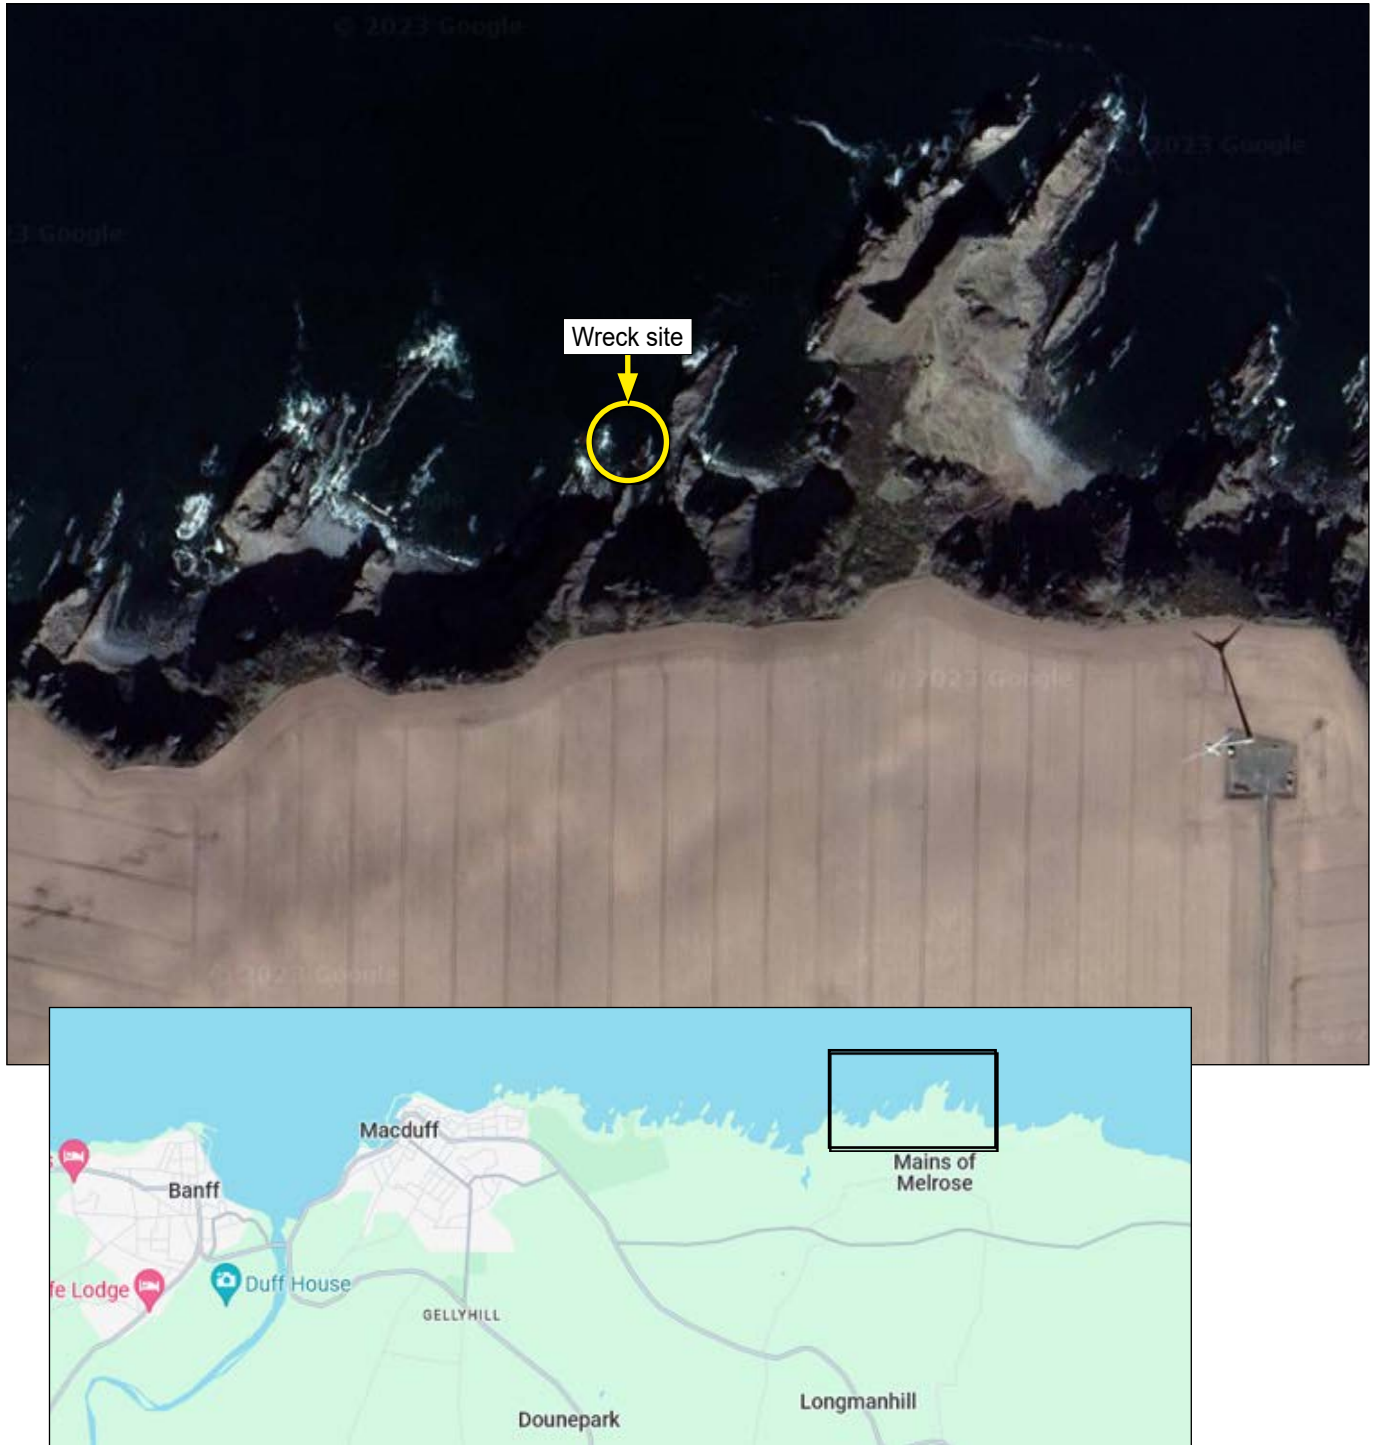
Figure 1: Area where *Lexi Rose* was fishing before the accident

On 21 September 2023, Sandy Alexander, the skipper of the fishing vessel *Lexi Rose* left his home in Fraserburgh, Aberdeenshire, Scotland and drove to Banff to prepare his vessel for a day's fishing. At 0837, *Lexi Rose* left Banff harbour, and about 3 minutes later the skipper was called by a relative who had seen the vessel leaving. They discussed the weather and their individual plans for the day: the forecast was Beaufort force 5 winds from the south-south-west with a 1m residual swell from the north; weather permitting, the skipper indicated that he intended to check his pots. Visibility was good and the sea was smooth. The skipper steamed *Lexi Rose* towards his usual fishing area to the east of Macduff (**Figure 1**), and then started to work the creels from west to east along the coast.
