Report on the investigation of  
the contact made by the paddle steamer  
***Waverley***  
with Brodick pier, Isle of Arran, Scotland  
on 3 September 2020

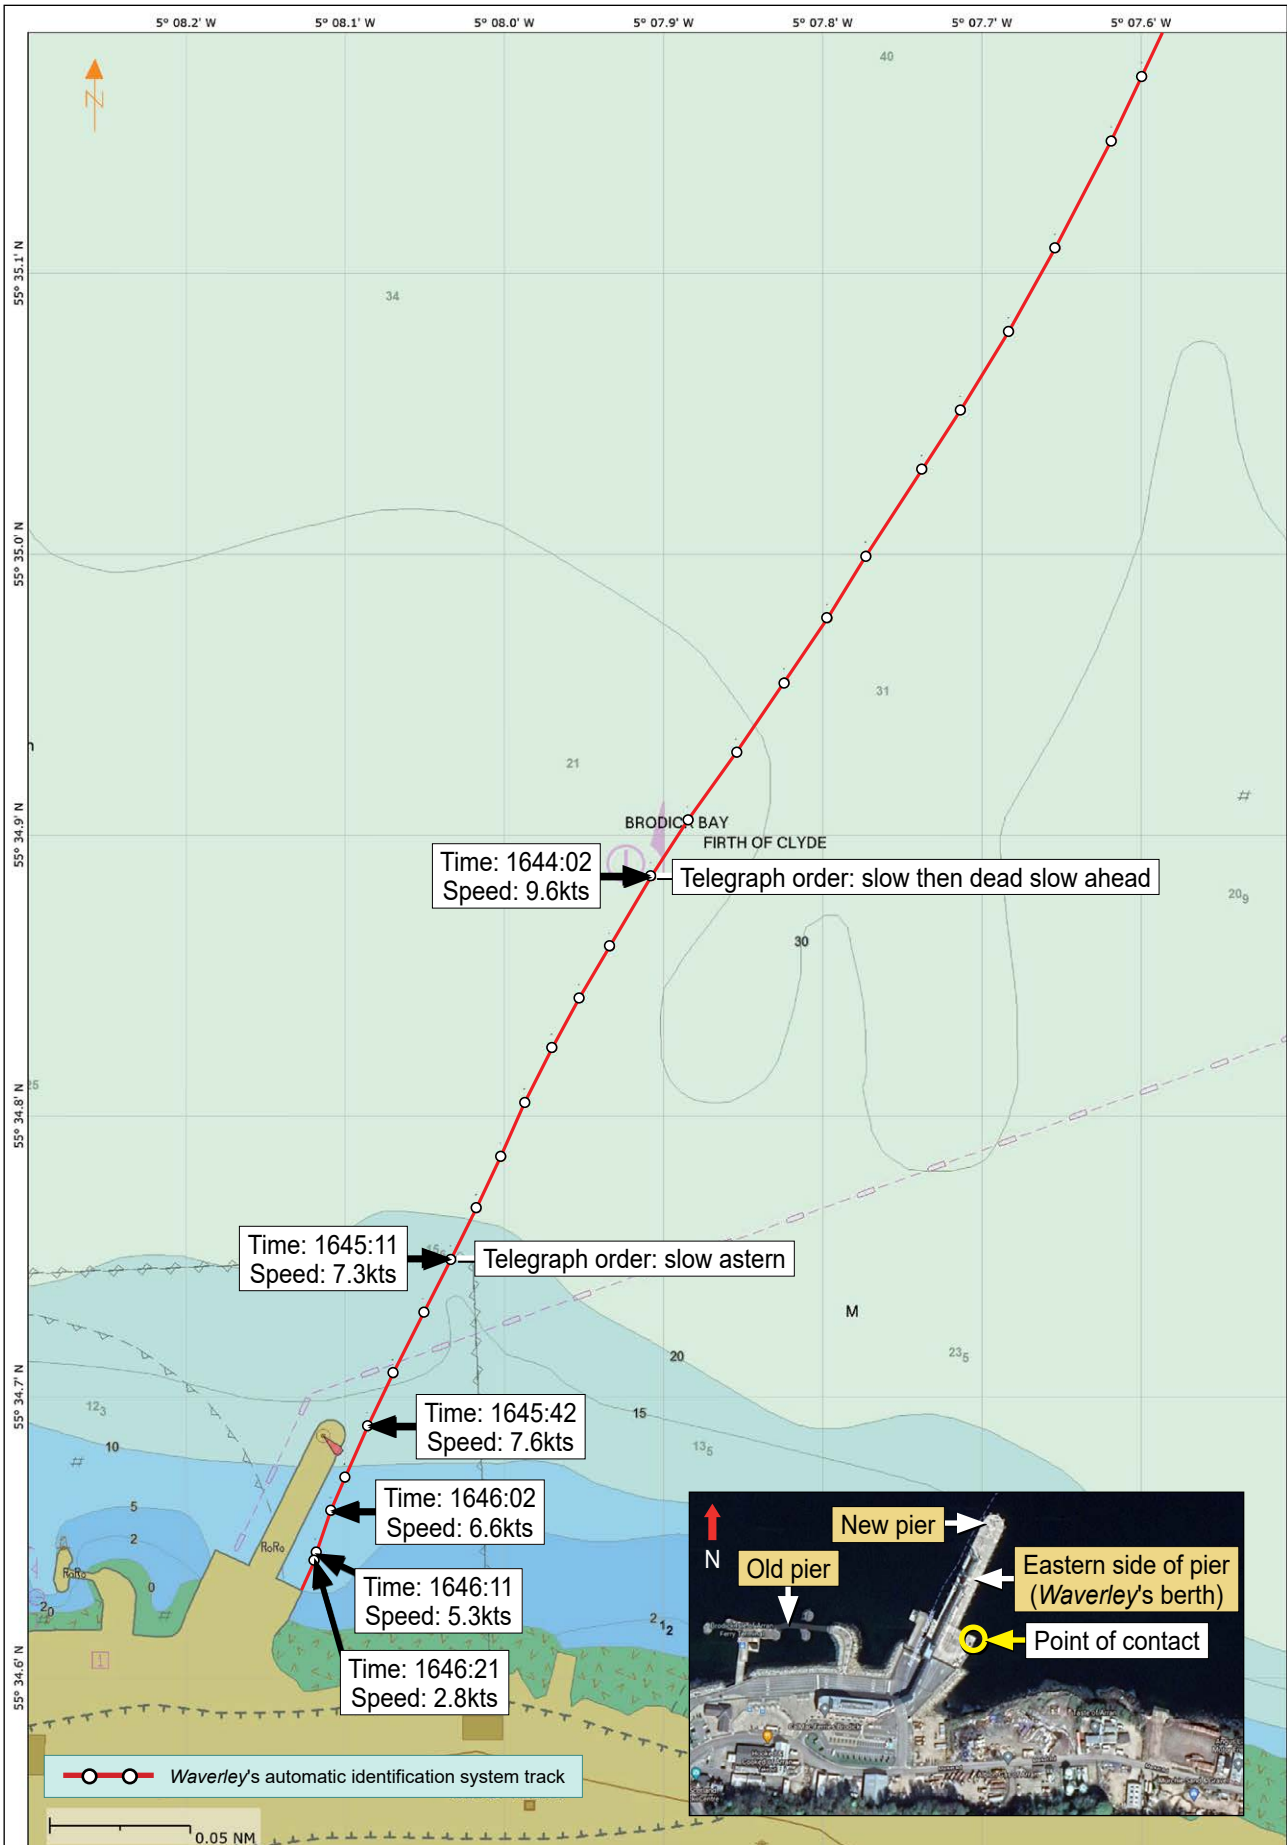
**Figure 4:** *Waverley's* approach to Brodick pier on 3 September 2020 and (inset) aerial image of Brodick new and old piers

At 1640, *Waverley* entered Brodick Bay making 13kts over the ground; the relief master was standing next to the QM at the helm in the enclosed wheelhouse; and the chief officer (C/O) and master were on the open starboard bridge wing (**Figure 3**). At about 1644, with *Waverley* travelling at 9.6kts, the master ordered slow ahead on the engine order telegraph<sup>2</sup>. The master then ordered dead slow ahead as the vessel shaped a course to approach the berth at the closed end<sup>3</sup> of the eastern pier and *Waverley* slowed down. The master ordered slow astern when the vessel was 100m away from the berthing position and, as planned, ordered the QM to apply a 10° turn to port as *Waverley* passed the end of the pier (**Figure 4**).

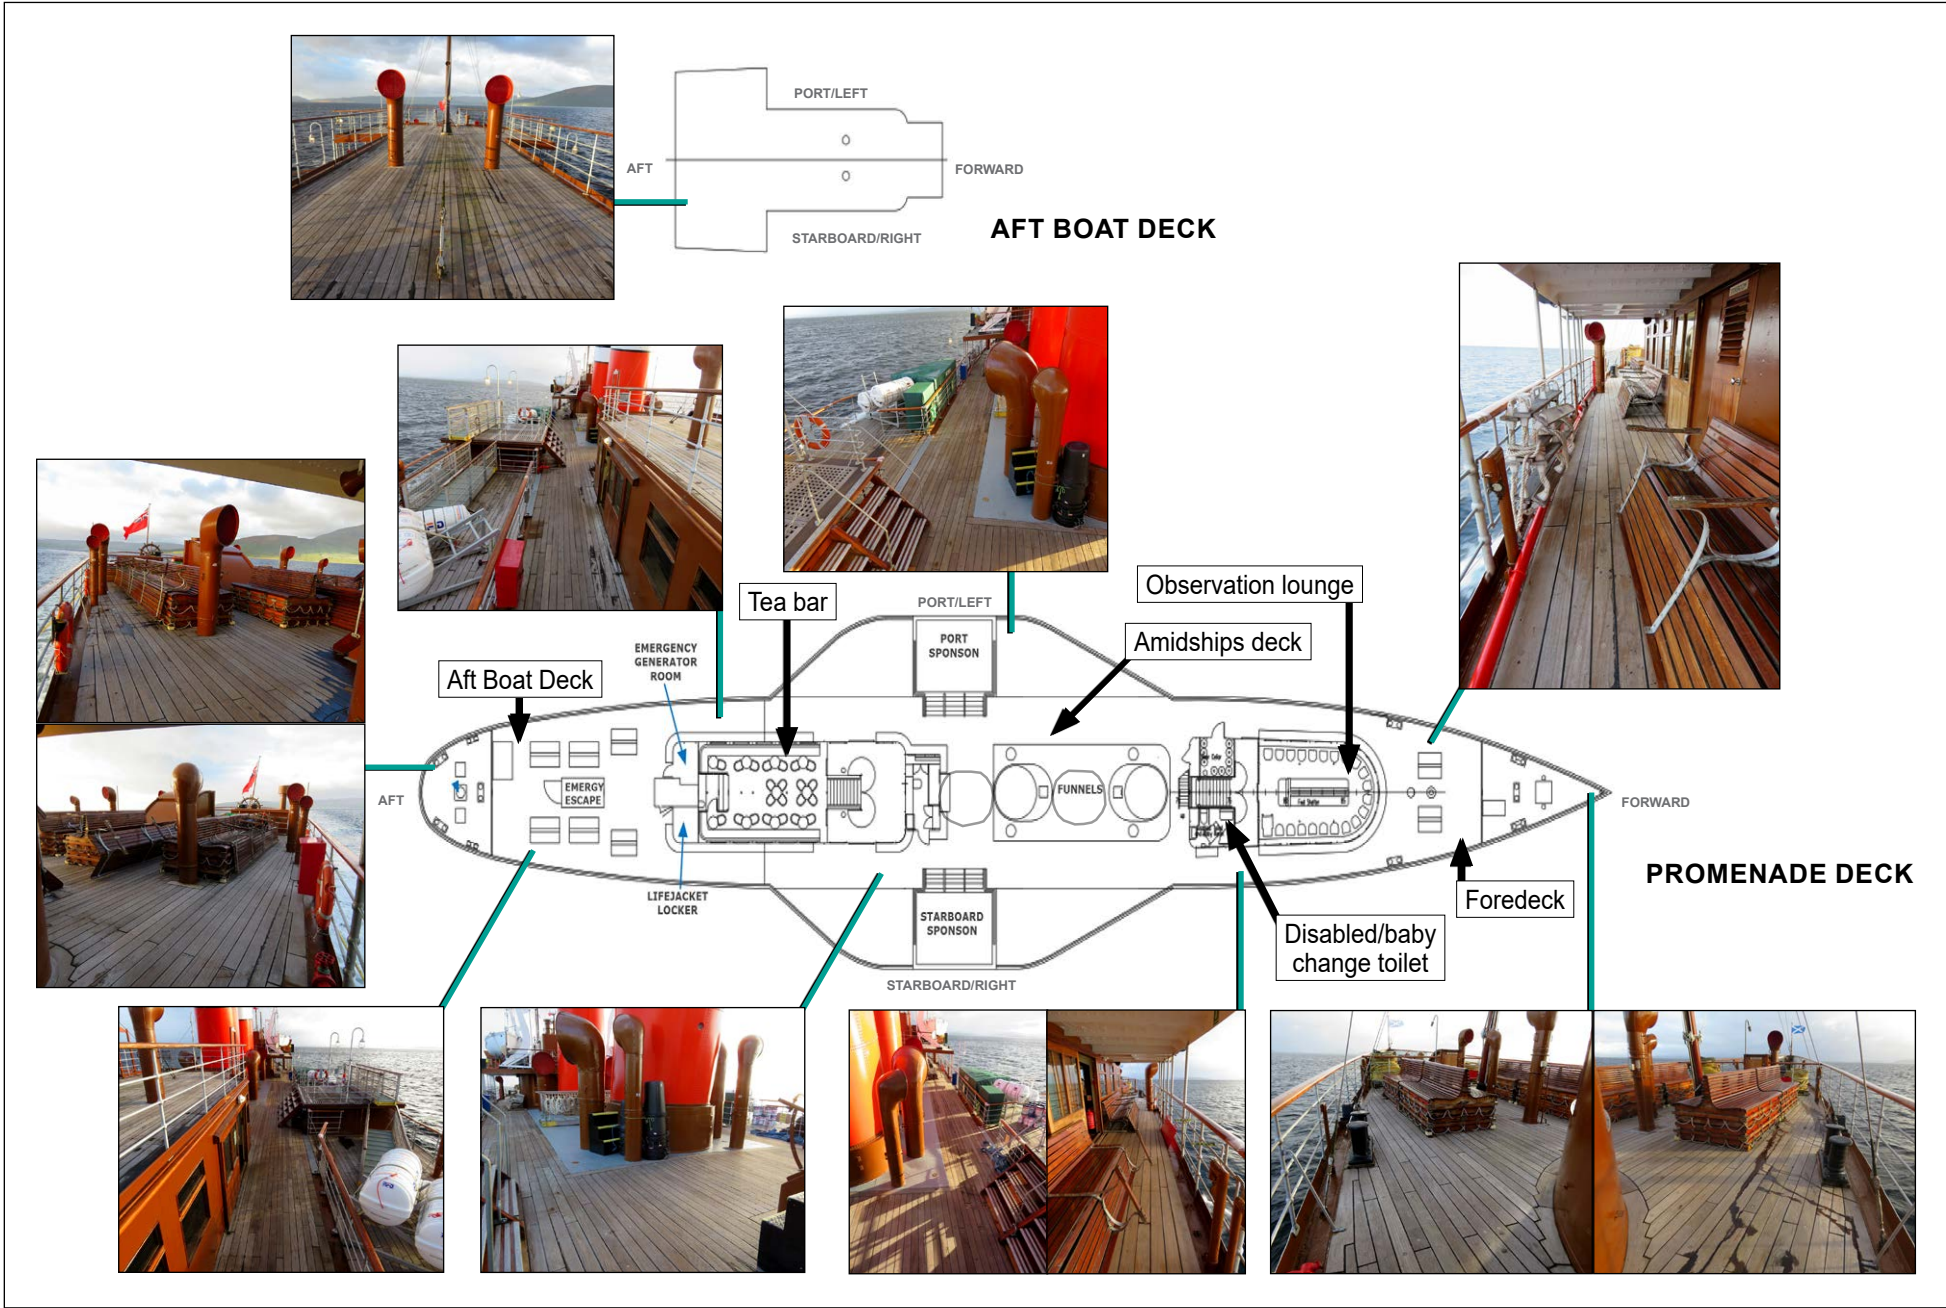
**Figure 6:** Layout of *Waverley's* Promenade Deck and Aft Boat Deck (above Promenade Deck) with views of external areas after the accident with deck furniture stowed

When *Waverley* struck the pier many of its passengers and crew were standing up to watch the arrival from positions on the open Aft Boat Deck and Promenade Deck (**Figure 6**) and they either fell to the deck or made contact with the vessel's structure or fixtures and fittings as they were thrown forward. The engine continued to operate astern just after the collision, propelling *Waverley* backwards along the pier. The master stopped the engine and ordered the crew to pass the vessel's mooring lines ashore. The C/O left the bridge to conduct a damage assessment of the bow and the crew passed mooring lines from the deck, which were then secured to bollards on the quay by the waiting linesmen. The vessel was made fast at 1650. The QM made an announcement to reassure the passengers, and crew members who were not involved in the berthing operation provided first aid support to the injured passengers. The master coordinated the immediate incident response with Brodick's port manager and staff. The C/O returned to the bridge and advised the master that the forepeak had been breached above the waterline and that there were no signs of flooding.

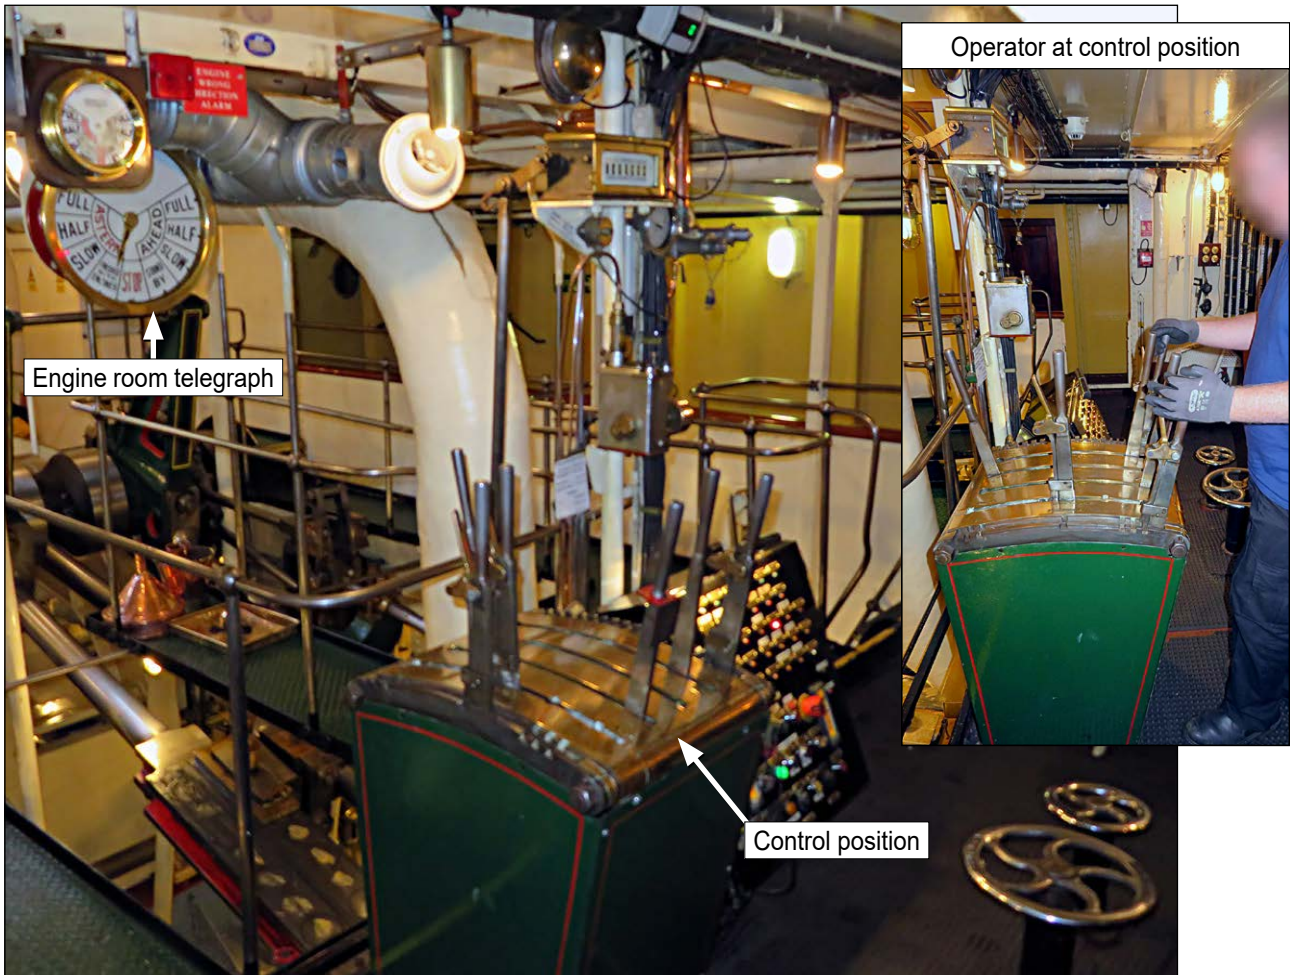
**Figure 10:** View of the engine room looking forward to starboard and (inset) an operator at the engine control position

The on-watch engineer operated the engine directly from the engine control station in the after end of the engine room overlooking the engine (**Figure 10**). This required the use of six control levers, three primary and three secondary (**Figure 11**), to manually direct the flow of steam through the cylinders to achieve the required direction of crankshaft rotation to provide forward or astern propulsion.

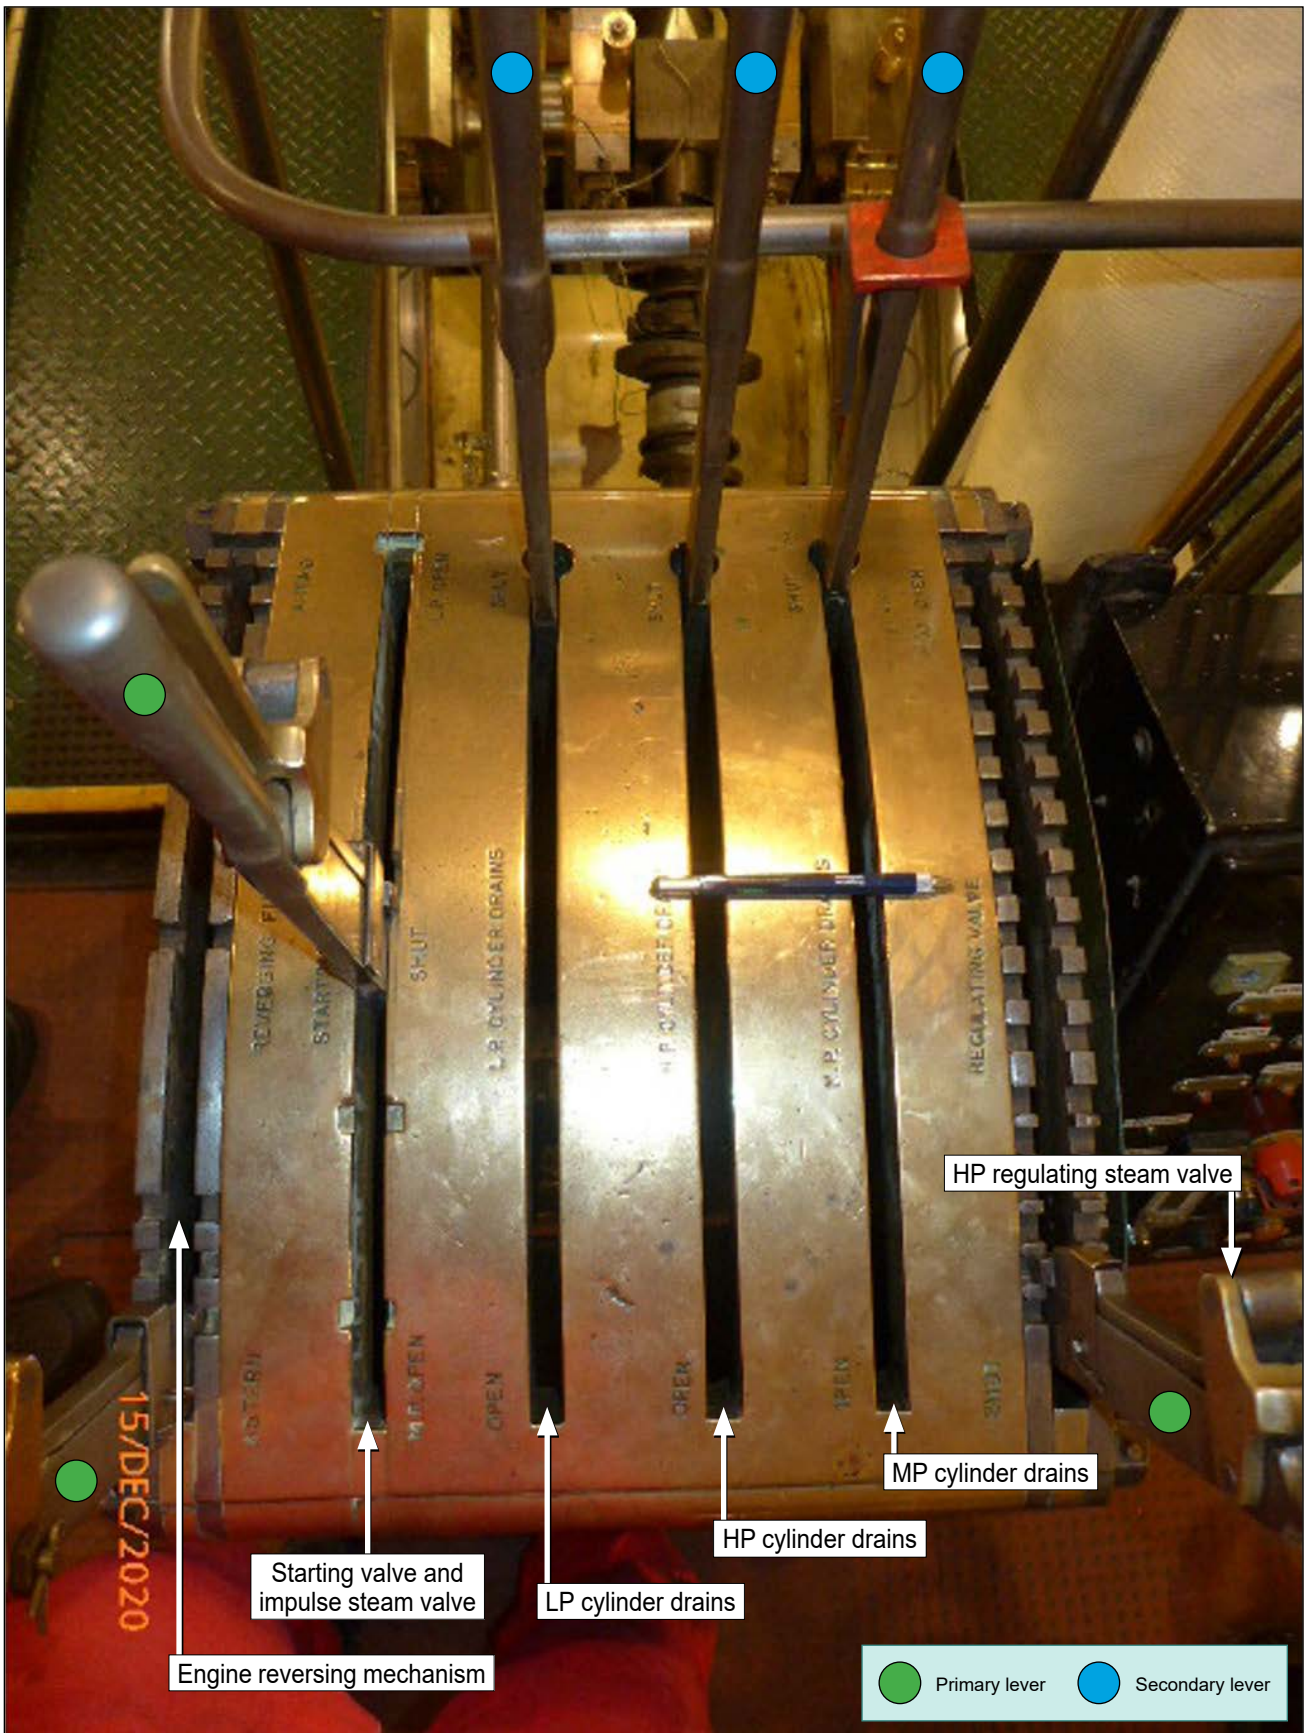
**Figure 11:** Engine control levers at the engine control position

When a new engine order was received from the bridge, the on-watch engineer adjusted the HP regulating steam valve lever (**Figure 11**) to manage the amount of steam entering the HP cylinder and in turn control the speed of the crankshaft and the paddle wheels.
