# ***AAIB Bulletin***

***3/2025***

Published by the Air Accidents Investigation Branch, Department for Transport

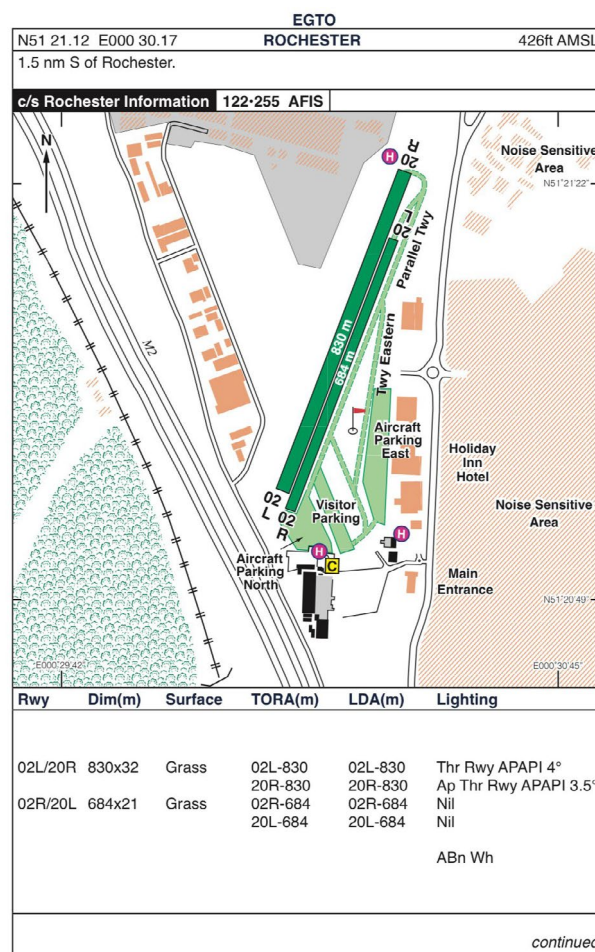
**Figure 5**

Rochester Airport's main grass runway 02/20 has 830 m landing distance available (Figure 5). The standard circuit pattern is bounded by the River Medway to the West and North. The airport offers an AFIS provided by licensed FISOs for the purpose of giving advice and information useful for the safe and efficient conduct of flights.

Rochester Airport plate (courtesy Pooley's)
