# ***AAIB Bulletin***

# ***2/2025***

## **AAIB Correspondence Reports**

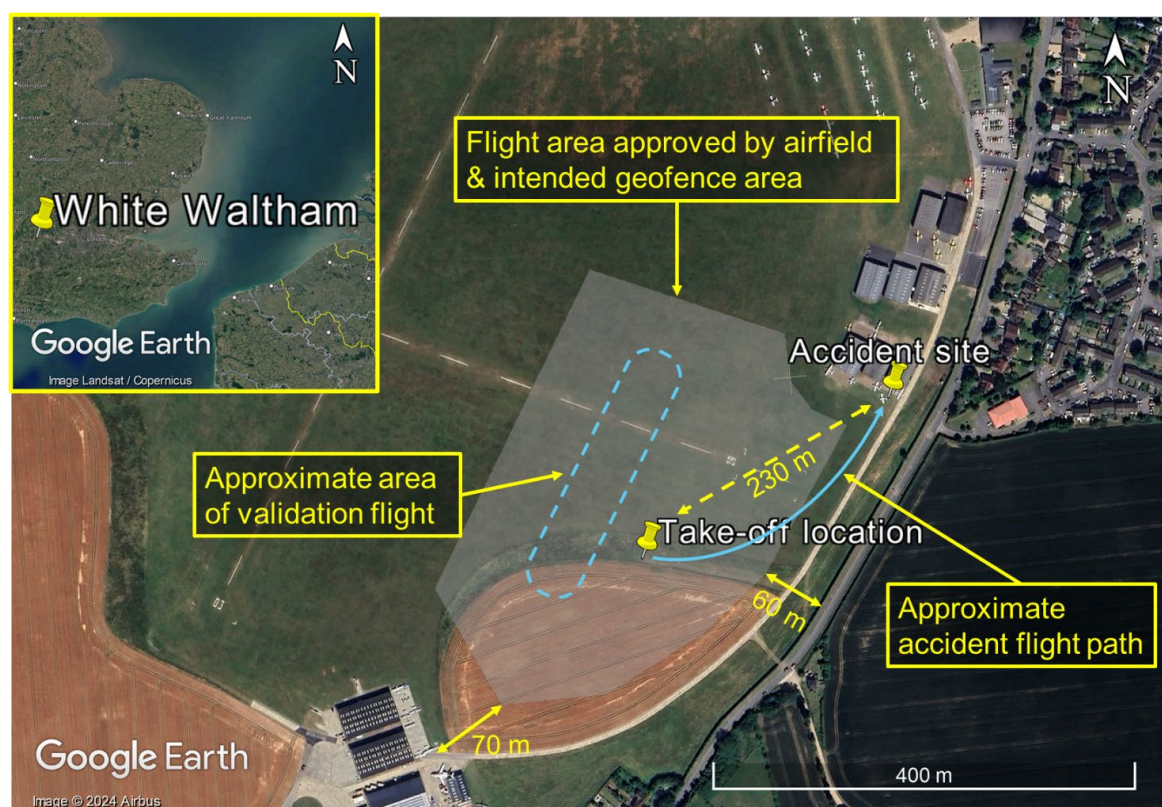
**Figure 1**

The flight was planned to take place at White Waltham Airfield, within the area (shown in white in Figure 1) designated for use as a UA site by the airfield and at least 150 m away from any buildings. After the airfield granted the operator permission for the flight, the operator's flight team prepared the UA and conducted a team briefing and a set of pre-flight checks.

After being powered on, the UA was unable to acquire a GNSS signal, preventing a geofence, which mirrored the white area shown in Figure 1, from being applied. The RP decided to proceed with the flight on the basis that several means to activate the Flight Termination System (FTS) were available in case of an emergency.

White Waltham Airfield and designated UA area
