Accident

Aircraft Type and Registration:	ATR 72-212 A, G-CMJM	
No & Type of Engines:	2 Pratt & Whitney Canada PW127M turboprop engines	
Year of Manufacture:	2017 (Serial no: 1464)	
Date & Time (UTC):	31 October 2023 at 0917 hrs	
Location:	On departure from Edinburgh Airport	
Type of Flight:	Commercial Air Transport (Passenger)	
Persons on Board:	Crew - 4	Passengers - 55
Injuries:	Crew - None	Passengers - None
Nature of Damage:	Fractured nose landing gear axle	
Commander's Licence:	Airline Transport Pilot's Licence	
Commander's Age:	61 years	
Commander's Flying Experience:	9,530 hours (of which 150 were on type) Last 90 days - 148 hours Last 28 days - 54 hours	
Information Source:	AAIB Field Investigation

Synopsis

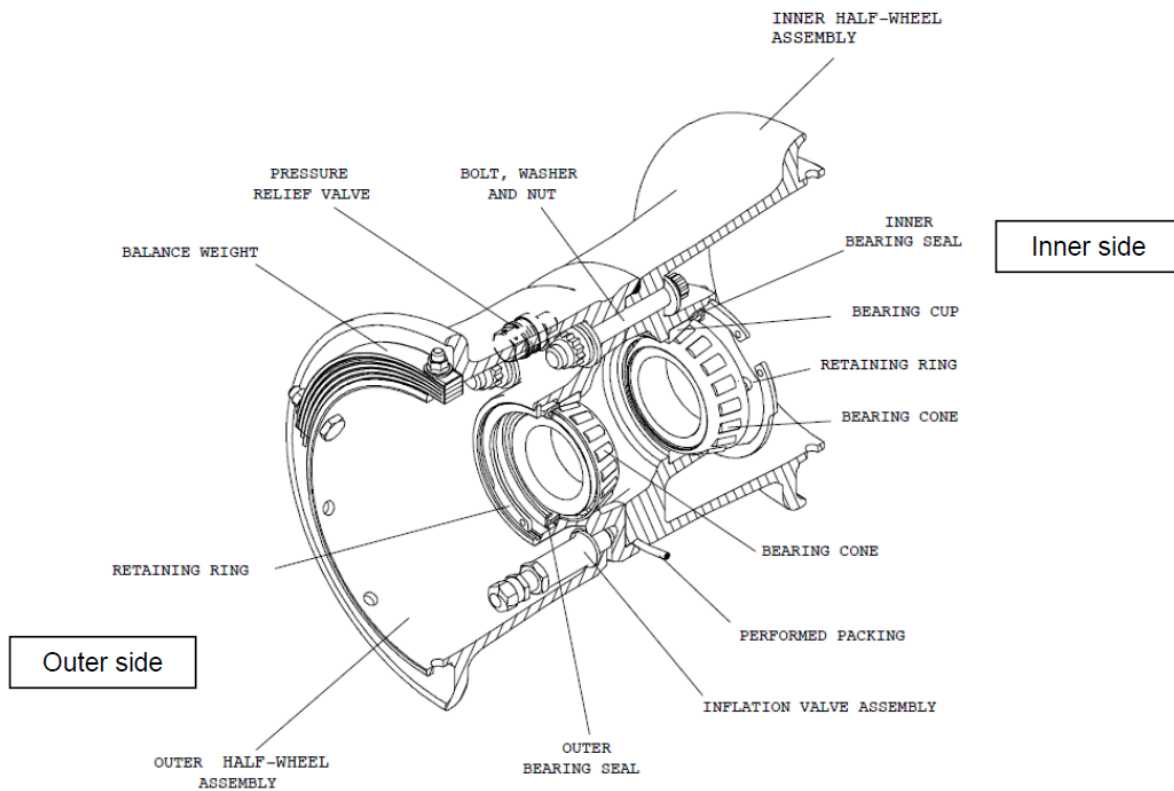
Figure 4

Design of the NLG wheel assembly (Image used with permission)

The right NLG wheel (design shown at Figure 4) was inspected and disassembled with the following main findings:

- The right NLG wheel assembly was found assembled with all tie bolts loose.
- No balancing weights were found fitted on either the outer or inner half-wheel sections¹.
- The outer half wheel hub was found fractured.
- There was an interposition product found on the mating faces of the two half-wheels (Figure 5); this product is not allowed in this area² as it can lead to micro displacements of the two faces and tie-bolt loosening.
- Evidence of bearing grease indicated over-greasing of both bearings.
