SAFETY DIGEST

Lessons from Marine Accident Reports

1/2025

MARINE ACCIDENT INVESTIGATION BRANCH

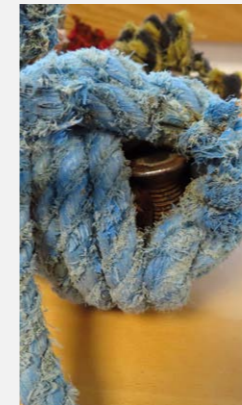
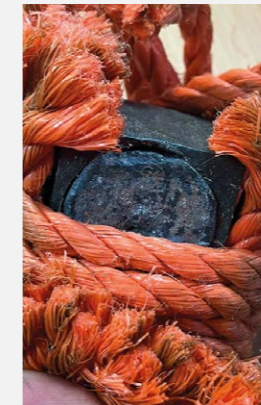
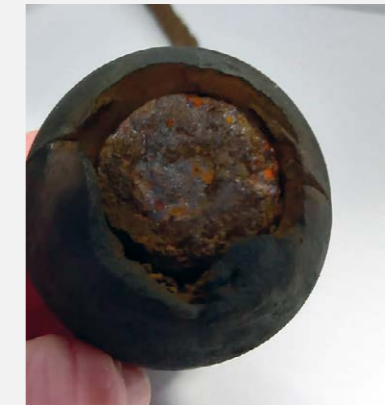
▲ Rubber weight (metal core)

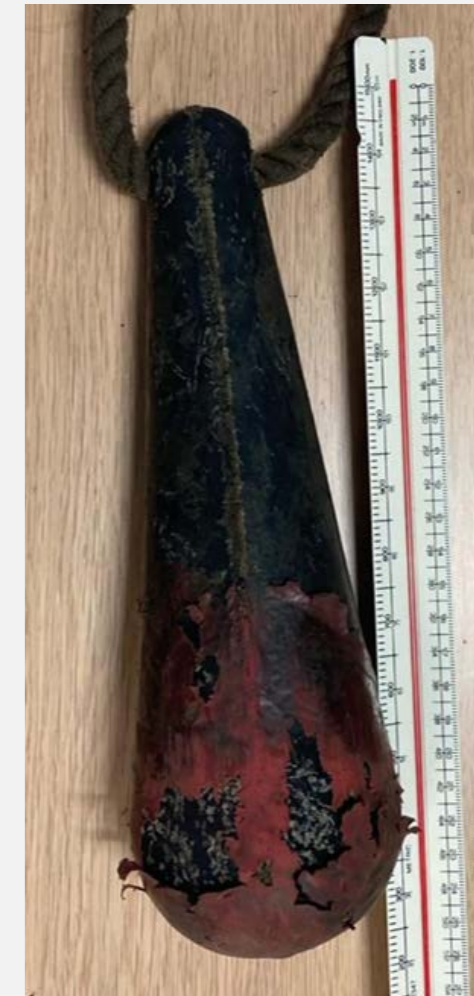
▲ Iron weight

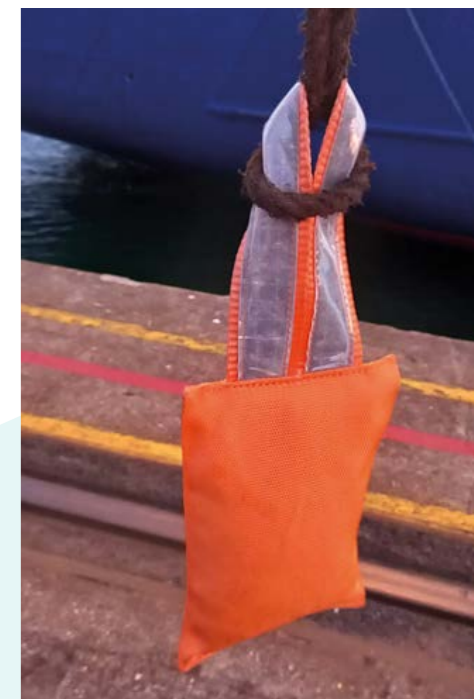
Safe, highly visible sandbag ▶

Many ports in the UK are willing to provide safe alternatives such as sandbags to replace dangerously weighted heaving lines.

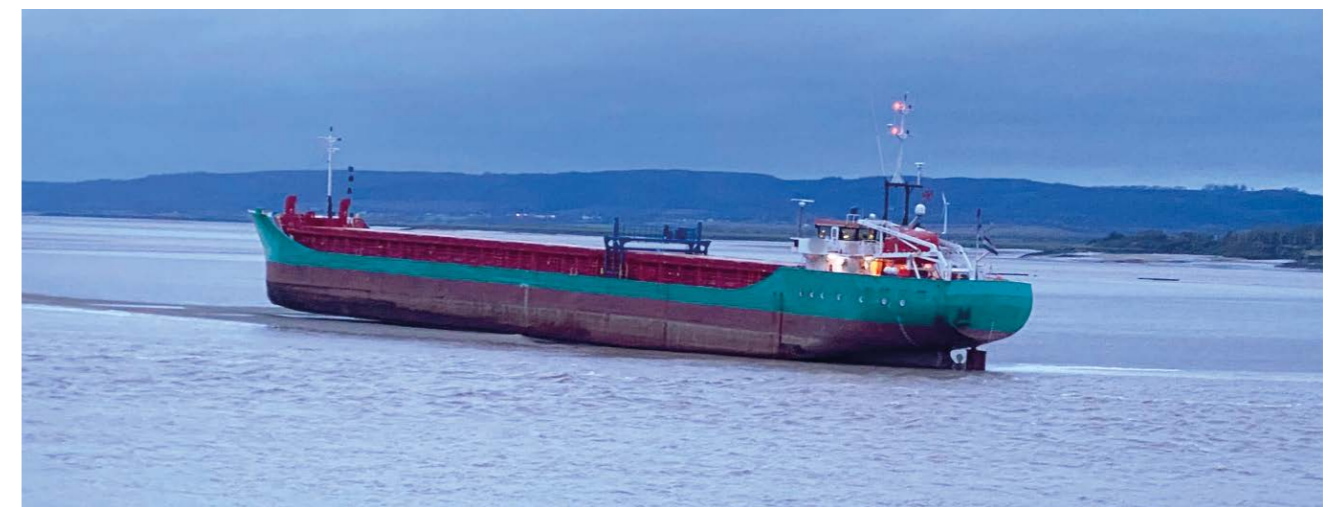
The pilot tried to extricate the ship from the apparent grounding by using maximum power astern but, aside from making the ship's stern pivot around more to port, this had little impact other than to point the bows further towards the new sandbank (Figure 1). The ship's team sounded their tanks and found no water ingress. With the tide now ebbing, it became clear that the bulk carrier was firmly aground. Having informed all the relevant local authorities and examined towing options it was inevitable that the pilot and ship's crew would have to wait until the next high tide to free themselves. The pilot stayed on board as a contingency measure during the long wait. At low water it was seen that the sandbank on the inside of the river bend had extended almost 200m further out into the river than it had

previously, and that it was this that had caught the bulk carrier unawares (Figure 2).

Figure 2: The bulk carrier firmly aground and waiting for high water

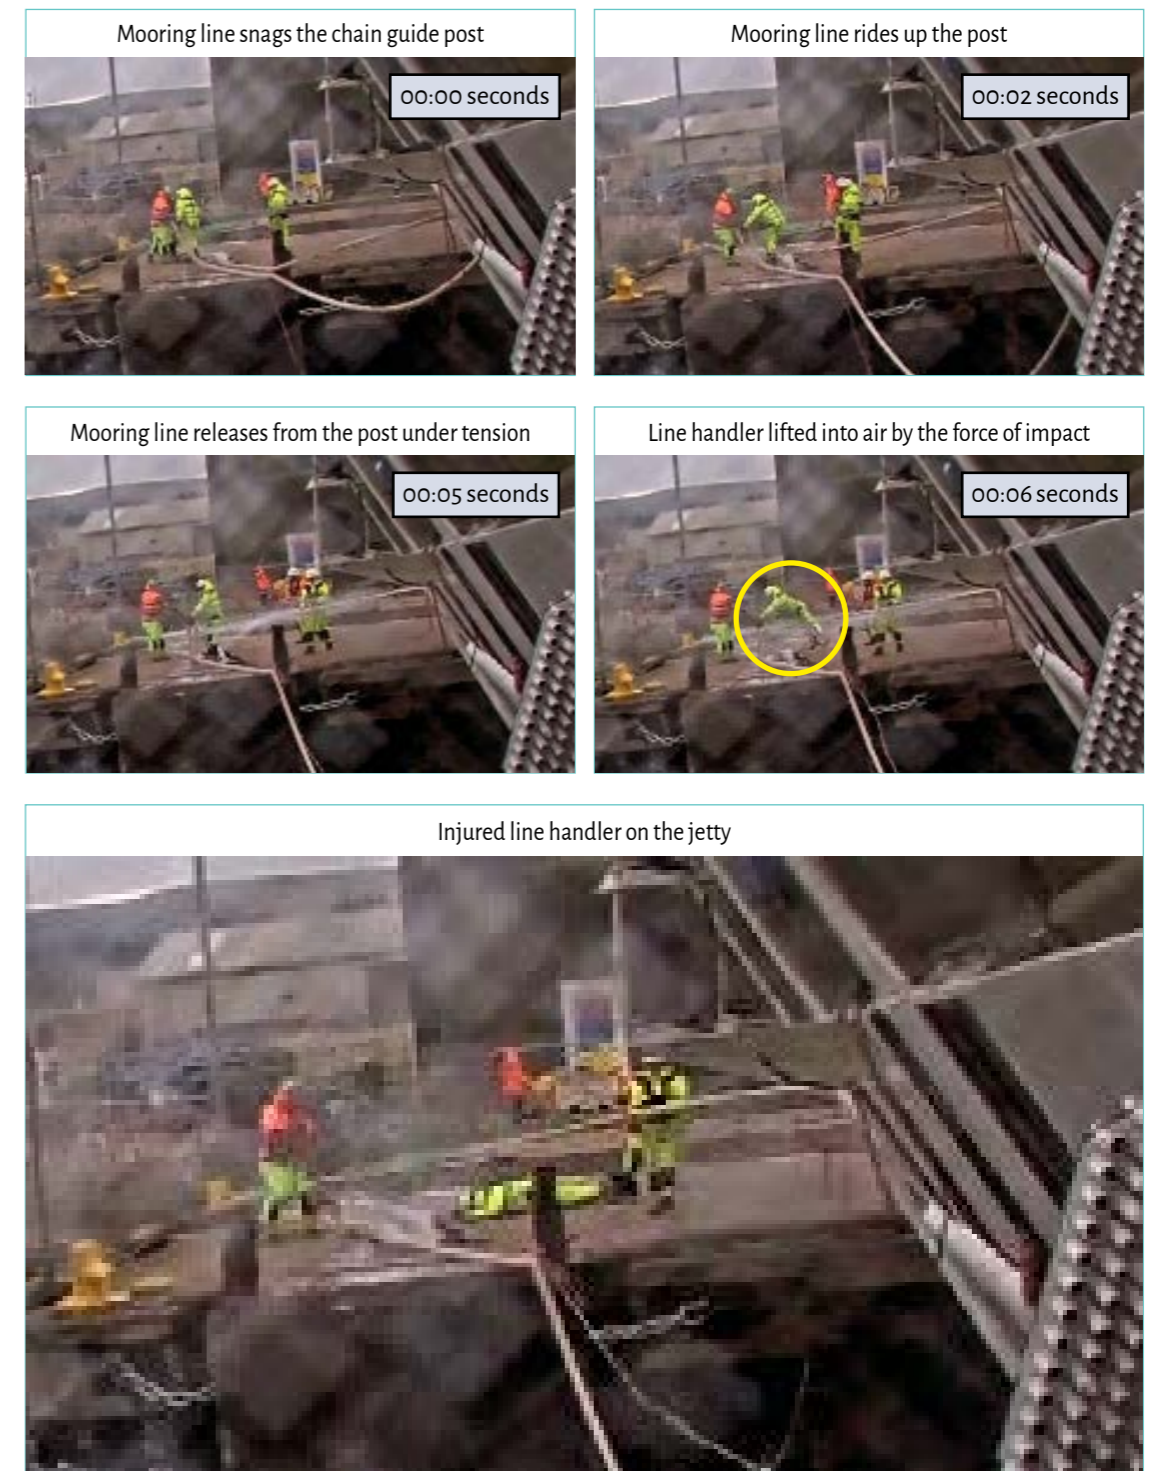
The first mooring line slipped up the vertical post and held briefly at the top before releasing, striking and lifting the line handler into the air and causing serious injury. It had taken 5 seconds for the mooring line to snag on the vertical post and then release (Figure 2).

Figure 2: The sequence of events

- Aware** → Everyone involved in the dynamic environment of mooring operations should recognise the hazards posed by heavy lines that are moving and coming under tension. Be alert to the ever-present danger of snap-back on mooring decks and ashore and take appropriate steps to avoid being in a snap-back zone when mooring lines are under tension.

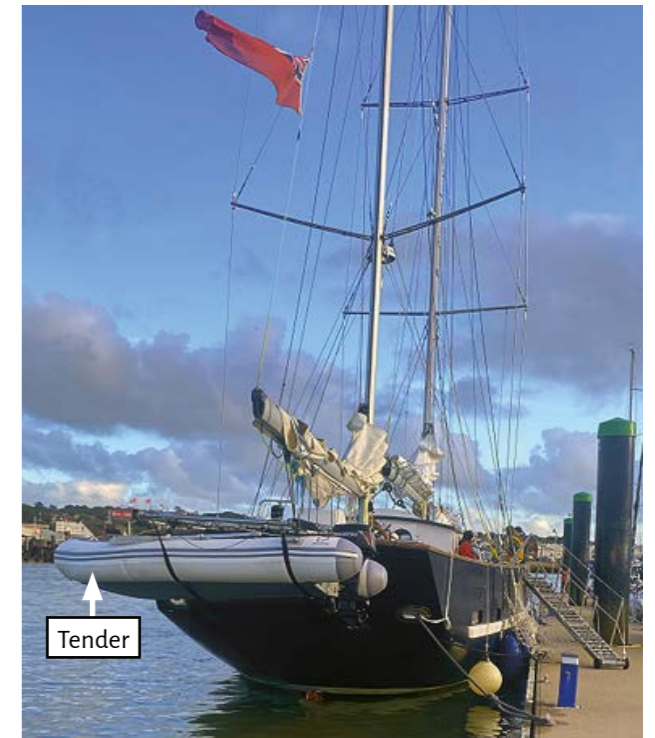
The yacht had cleared the berth and was waiting to recover the yacht's tender and its two crew, who had assisted in the unmooring operation. The tender's coxswain positioned the boat beneath the yacht's stern and attached the tender to slings rigged to the yacht's davits (see figure). The yacht was beam on to the tide and passing waves.

A ladder had been rigged to allow the tender crew to embark the yacht. As the two crew moved towards the ladder a combination of the weight shift and the action of the waves inverted the tender, throwing the crew into the water. Unharmed, they were able to hold on and safely climbed the ladder. The tender was righted using the slings it was attached to, and was recovered to the yacht without damage.

Figure: The tender in its stowed position

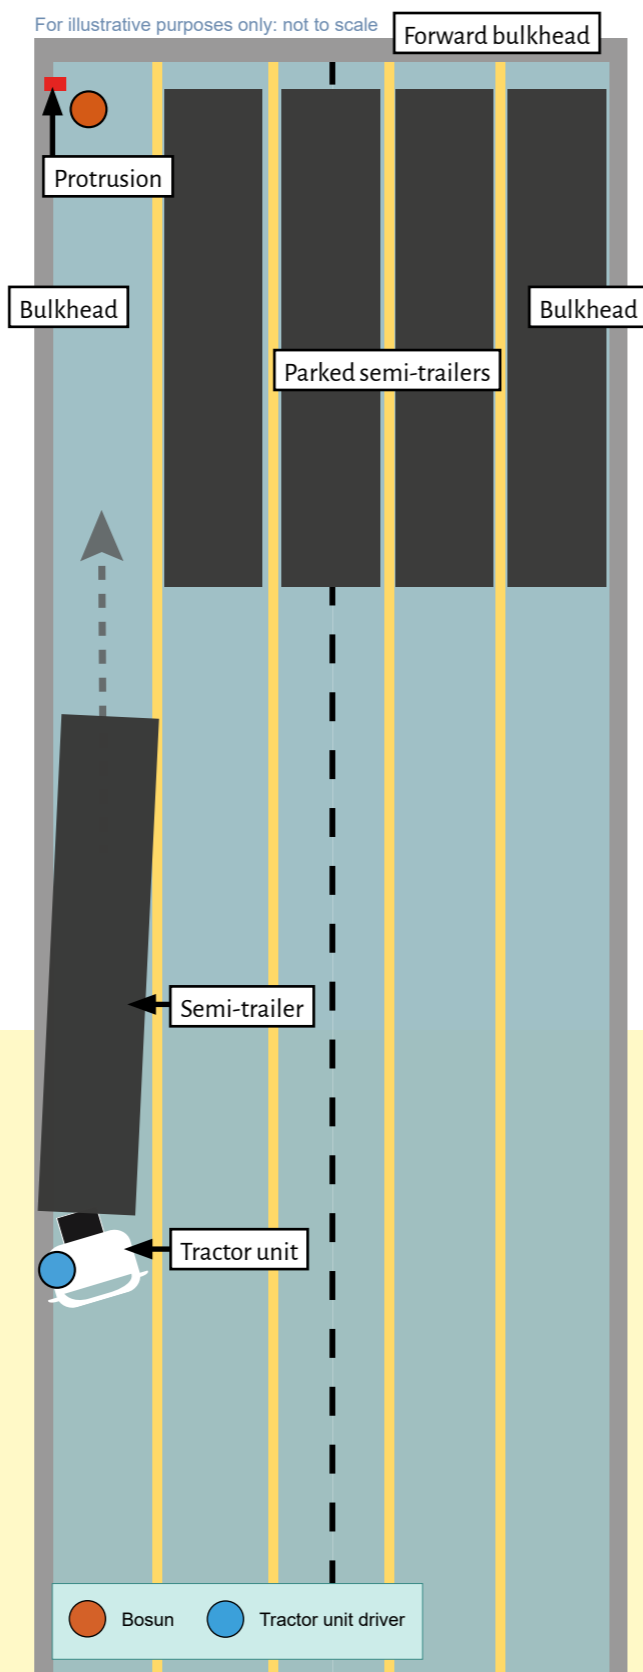
The bosun directed the first four semi-trailers into their designated parking spaces, leaving a gap in the corner for the final trailer to be parked next to the bulkhead (Figure 1). The fifth semi-trailer arrived on deck shortly after, and the driver waited for instructions from the bosun. While waiting, the driver rotated their tractor unit seat assembly by 180° so they were facing the direction of travel. This adjustment allowed the driver to lean out of the window to observe the side of the semi-trailer while pushing it into position rather than relying solely on mirrors.

Figure 1: The fifth semi-trailer being pushed into the corner parking space

- Hazard** → Standing in the path of a moving vehicle poses a significant risk of being struck. Although it has become commonplace for deck crews to work close to moving vehicles on ferry decks, the danger is no less real. A crew member performing marshalling duties must avoid the driver's blind spots and the path of any moving vehicle. Instead, marshallers stand in a safe location that presents no risk of being crushed.
- Check** → The driver lost sight of the bosun during the manoeuvre and failed to check whether the bosun was in a safe location. Never assume that crew members will remain out of the way, especially when they are in a blind spot position. Terminal operators must ensure that these unsafe practices do not happen and should reconsider their operating practices, including the role and position of marshallers to ensure they are kept out of harm's way.

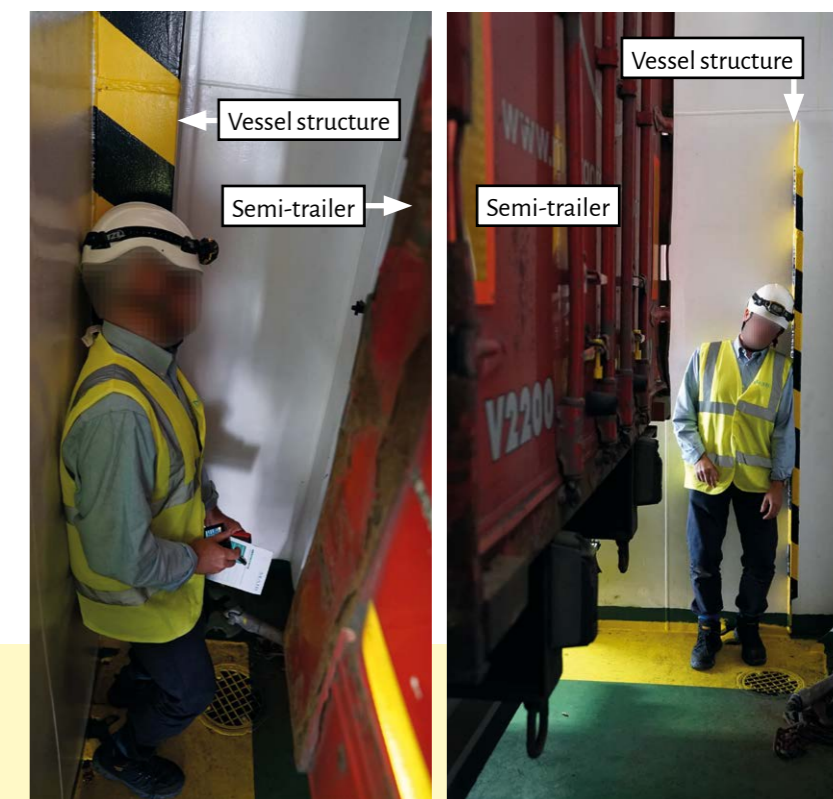
As one of the deckhands started to secure the front of the semi-trailer to the deck, they noticed the bosun trapped between the rear of the semi-trailer and a protrusion from the vessel's structure (Figure 2). The deckhand attempted to reach the bosun from both sides of the semi-trailer, but the gaps were too narrow. Finding an alternative route along the forward bulkhead, the

Figure 2: Reconstruction of the bosun's trapped position

- Teamwork** → Safety comes first. The two deckhands did not monitor the bosun as the semi-trailer approached the corner parking space, focusing instead on other tasks to load the cargo quickly and efficiently. This practice was contrary to the procedures that required them to work together and in sight of each other. In this case, a critical safety barrier that could have warned them of the impending accident was overlooked.

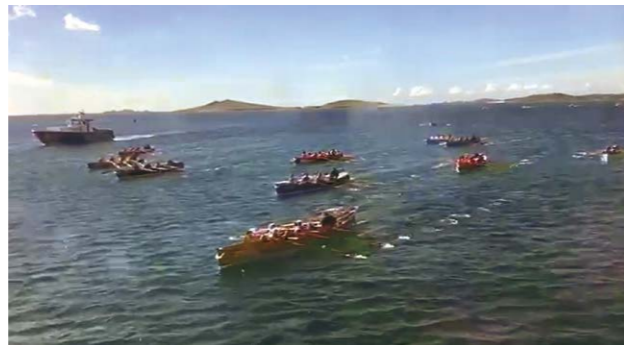
Just as the ferry started backing away from the berth, another group of rowing boats hove into view, racing quickly and headed straight for the finishing line. It quickly became obvious that the ferry would only just make it away from the berth before the rowing boats crossed the finish line, so the master increased the speed astern. Some of the rowing boats were concerned about the proximity of the ferry and altered course towards the end of the berth. Despite a few of the rowing boats getting very close indeed to the ferry (see figure) all passed clear, and the ferry made its turn and then departed on its way, leaving some relieved but irate rowers in its wake.

Figure: Rowing boats passing down the starboard side of the ferry

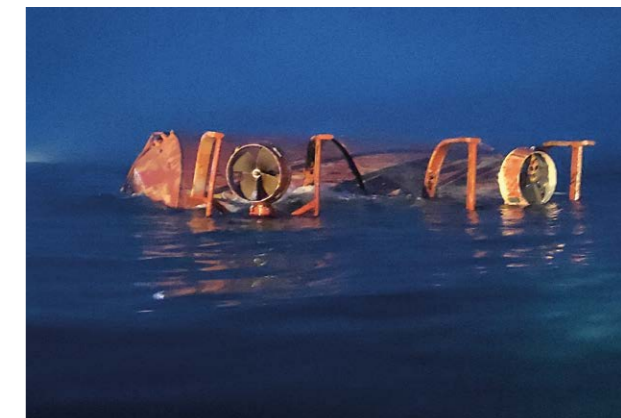
Neither of the watchkeepers saw or recognised the new danger and the cargo ship and dredge spoil barge subsequently collided. The force of the collision overturned the dredge spoil barge (Figure 2) and its two crew did not survive.

Figure 2: Upturned hull of the dredge spoil barge

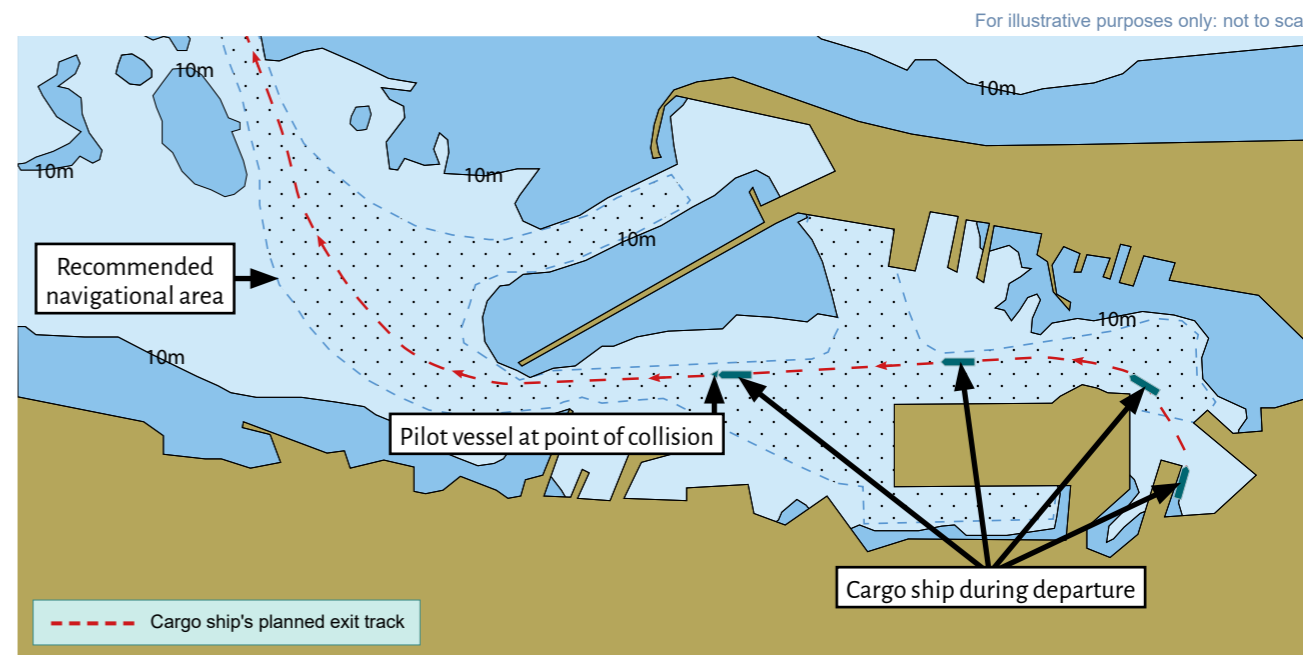
Figure 1: Schematic showing the departure plan

Twenty minutes into the departure, and just as they were approaching the narrowest point of the channel (Figure 1), the master realised that the pilot vessel was now very close on the port bow.

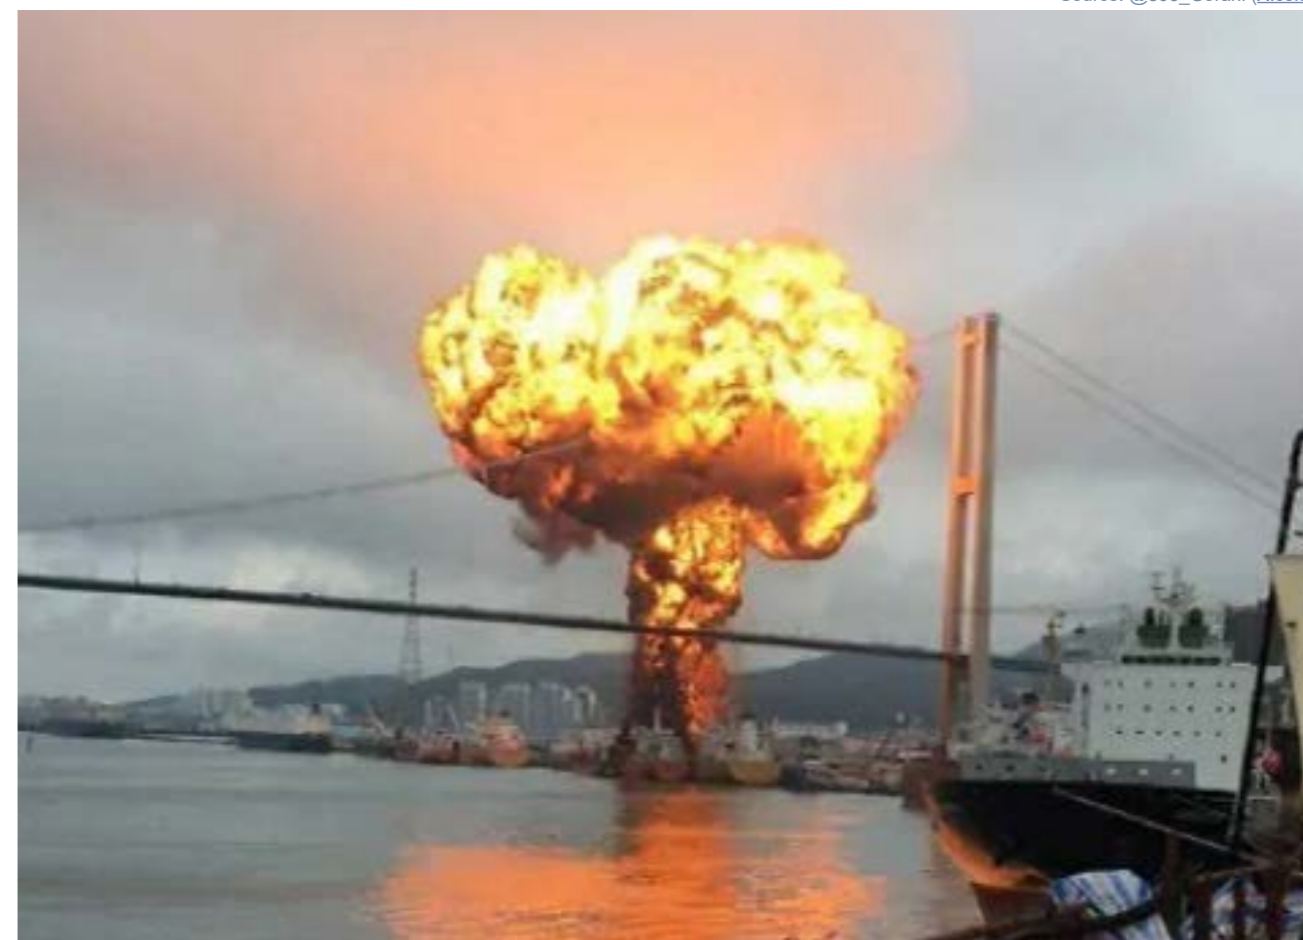
Figure 1: The major road bridge

Unfortunately, the heated cargoes in this case were adjacent to cargoes that readily absorbed heat and transferred it to the styrene monomer cargo. The raised temperatures affected the polymerisation inhibitor, reducing its time-limited efficacy. The ineffective inhibitor had triggered a thermal runaway incident that caused high pressure to breach the tank and ignite, likely due to static electricity.

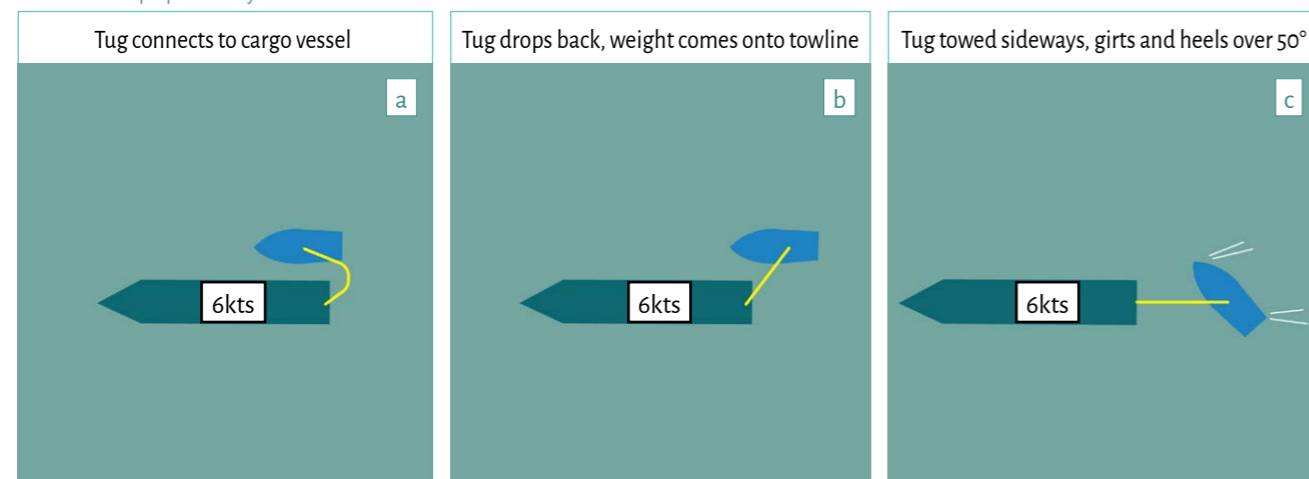
A few minutes later, the tug master lost concentration and inadvertently dropped back, causing the towline to come under tension (Figure 1b). The tug was towed sideways, girted and heeled over to 50° (Figures 1c and 2). The tug master was unable to control the tug and tried unsuccessfully to operate the tow release from within the wheelhouse, simultaneously calling the cargo vessel's pilot on very high frequency (VHF) radio.

Figure 1: Sequence of events that led to the tug girting

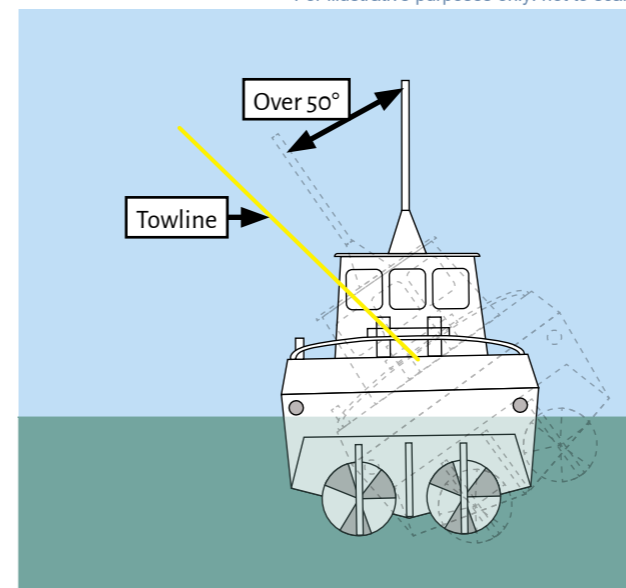
Figure 2: Tug girted and heeling to over 50°

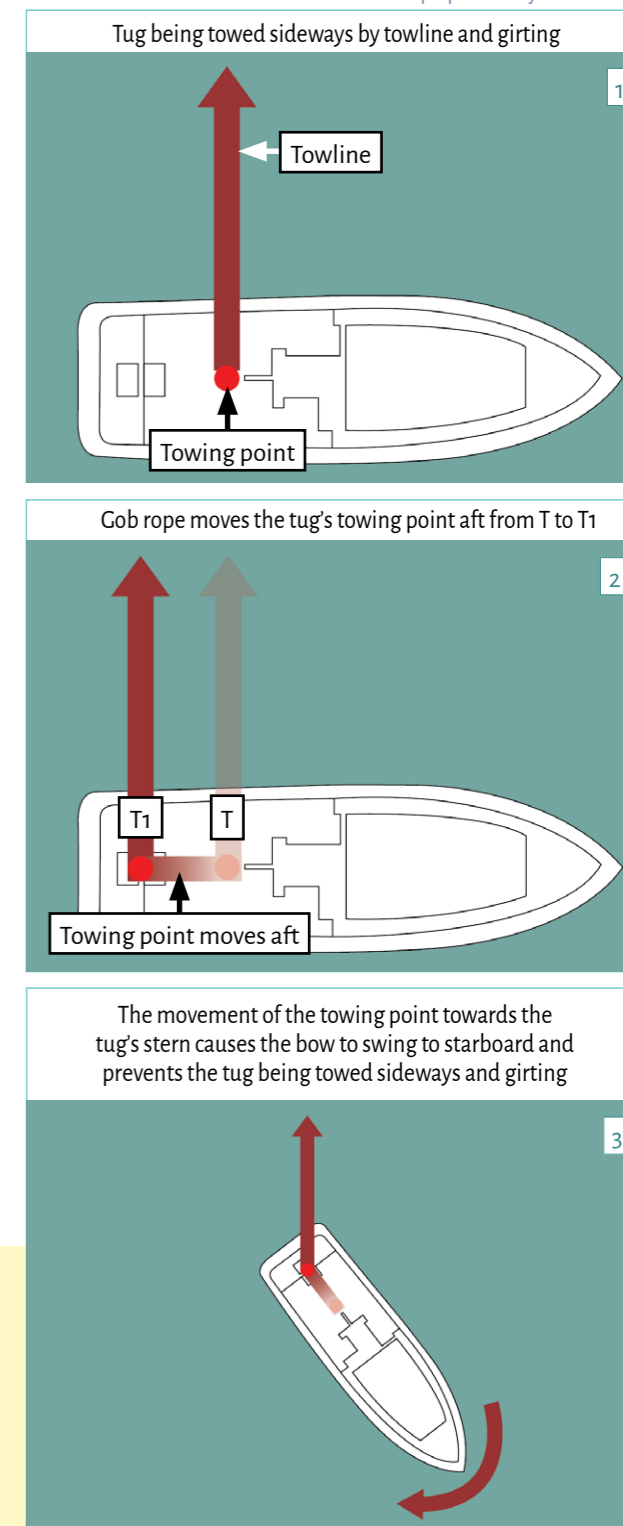
Figure 3: The effect of a gob rope or wire in preventing a tug being towed sideways and girted

- Procedure** → Conventional tugs should almost always use a gob rope or wire. The purpose of the gob rope is to move the tug's towing point aft. Had the gob rope been correctly used on this occasion, it is likely that the tug would have been safely towed backwards by the cargo vessel when the weight came onto the towline. This in turn would have prevented the tug's girting and near-capsizing and minimised the risk to its crew (Figure 3).

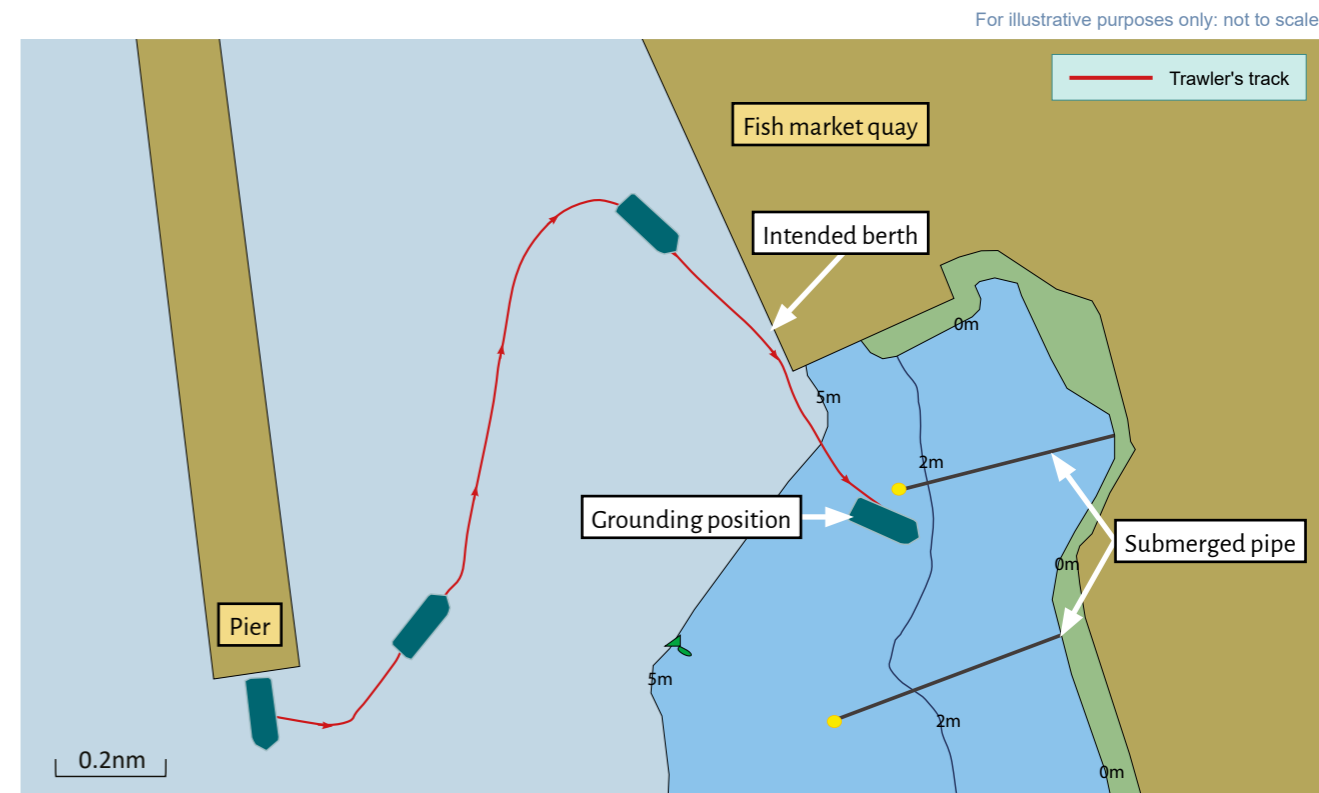
The fishing vessel made a hard glancing blow on the fish market quay before continuing past the end of the quay (Figure 1). The skipper ran around the bridge hitting all the emergency stops for the engines. This slowed the trawler a little but it went aground in the mud and shingle 120m off the end of the quay, narrowly missing a buoy and a submerged pipe (Figure 2). The trawler listed hard over to starboard but there was no water ingress. Tugs managed to pull the trawler off the mud and berth it back on the quay after 90 minutes. Fortunately, no one was injured and the damage was slight.

Figure 1: The trawler's path

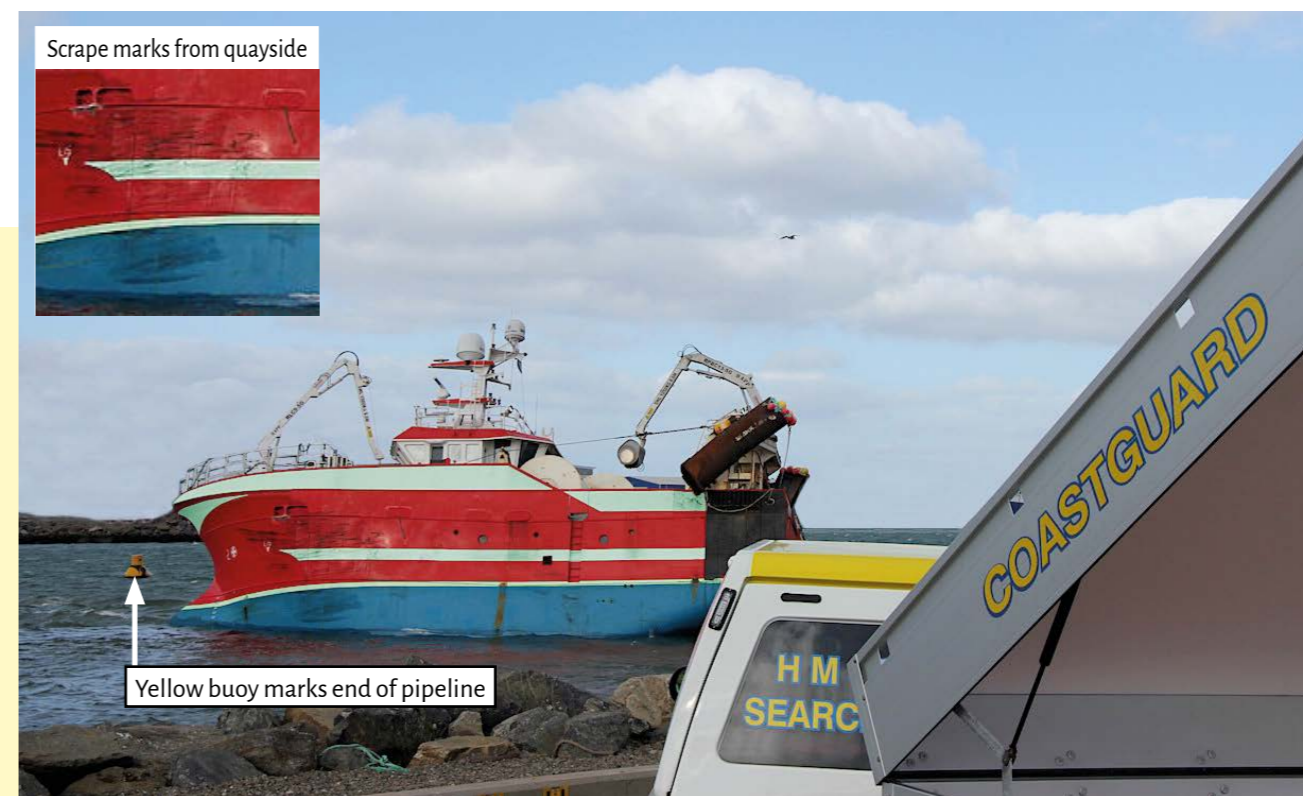
Figure 2: The trawler aground and listing to starboard

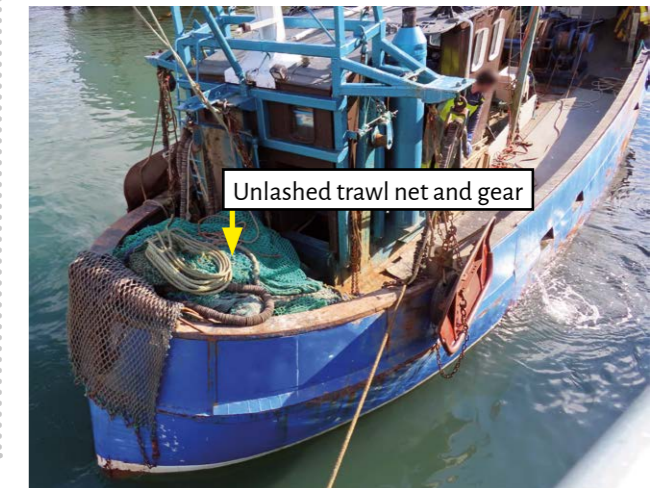
The wind picked up and the vessel started to roll and pitch in the choppy seas. One particular heavy roll caused some of the unlashed trawl net stowed aft (see figure) to fall overboard. The skipper noticed this and put the engine in neutral, shouting to the two deckhands to help retrieve the net. None of the crew put on a personal flotation device (PFD) before they rushed to help.

Figure: Net stowed at stern after the accident

- Risk** → Sea conditions can change rapidly and without notice. The trawl net involved in this case had not been lashed for the relatively short voyage back to port and the unprepared crew put themselves in immediate danger when attempting to retrieve it back on board. Regardless of the forecast or distance, it is always safer to expect bad weather and stow equipment properly .

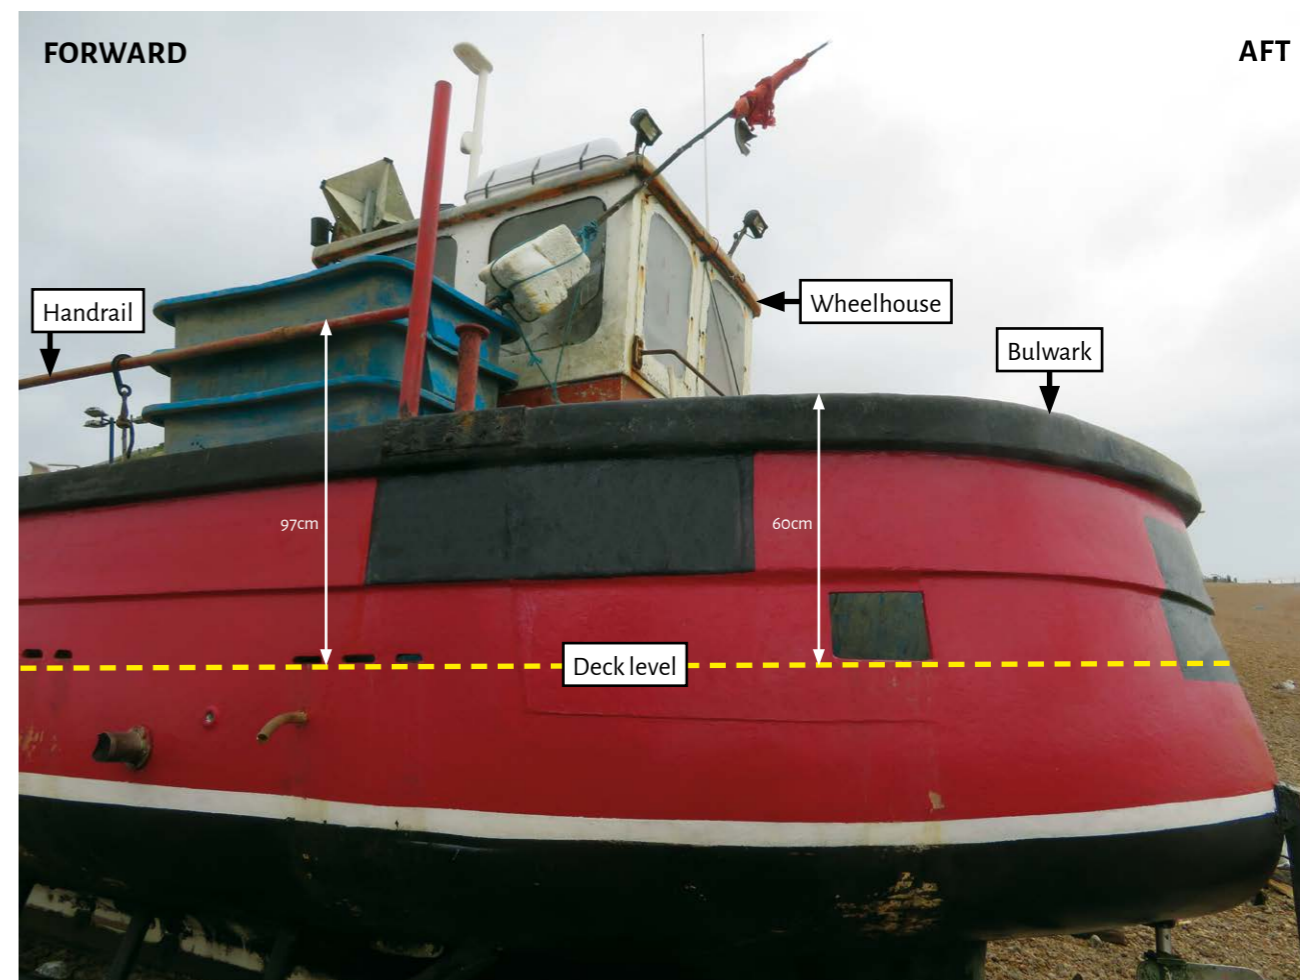
Figure 1: The low bulwark on the fishing boat

- Risk** → The skipper and the deckhand had worked together for decades and were familiar with the vessel and each other. The obvious risk presented by a low bulwark on a small boat in rough seas was overlooked simply because they 'always did it that way.' Risk assessment does not need to be complicated: a simple step-by-step walk through of a routine on board task can help highlight hazards that might otherwise go unnoticed.

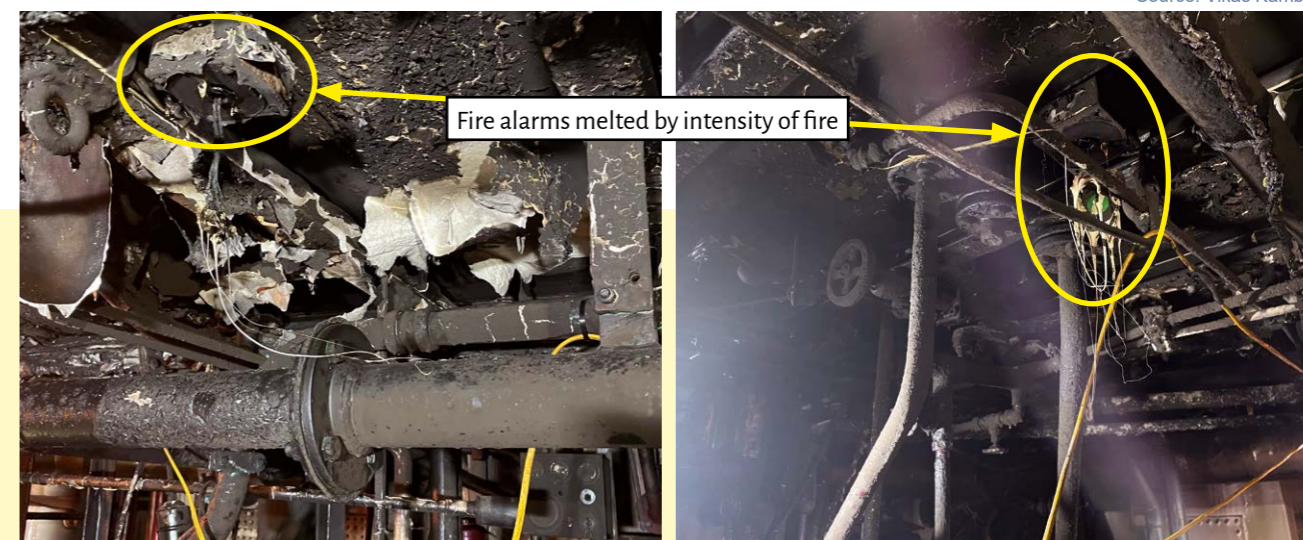
Figure 2: Smoke blackened deckhead and the remains of the fire alarms

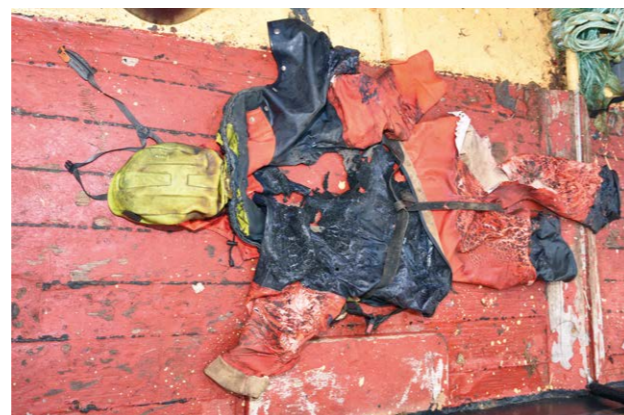
The fire alarm sounded and smoke filled the accommodation spaces. Crew there tried to escape through a hatch onto deck but found it obstructed by vegetable boxes stowed on the other side (Figure 1). They were able to make their way out safely by another route. The location of the fire prevented the deckhand from using the usual access ladder out of the engine room, forcing them to exit by climbing on top of the main engine through the flames, and using an open emergency escape hatch onto deck. Once out, the deckhand was doused with water by their fellow crew members. They had sustained serious burns to around 40% of their body (Figure 2).

Figure 2: The deckhand's burnt clothing

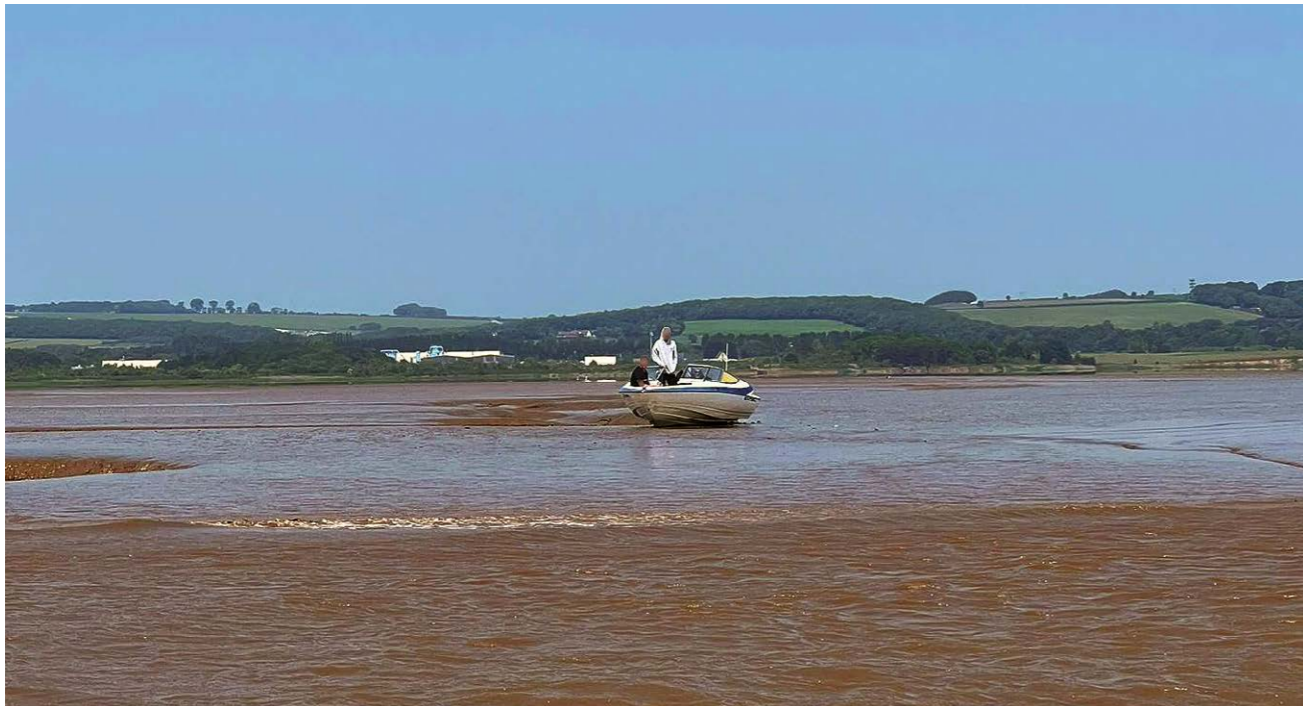
Figure 1: The motorboat viewed from the lifeboat

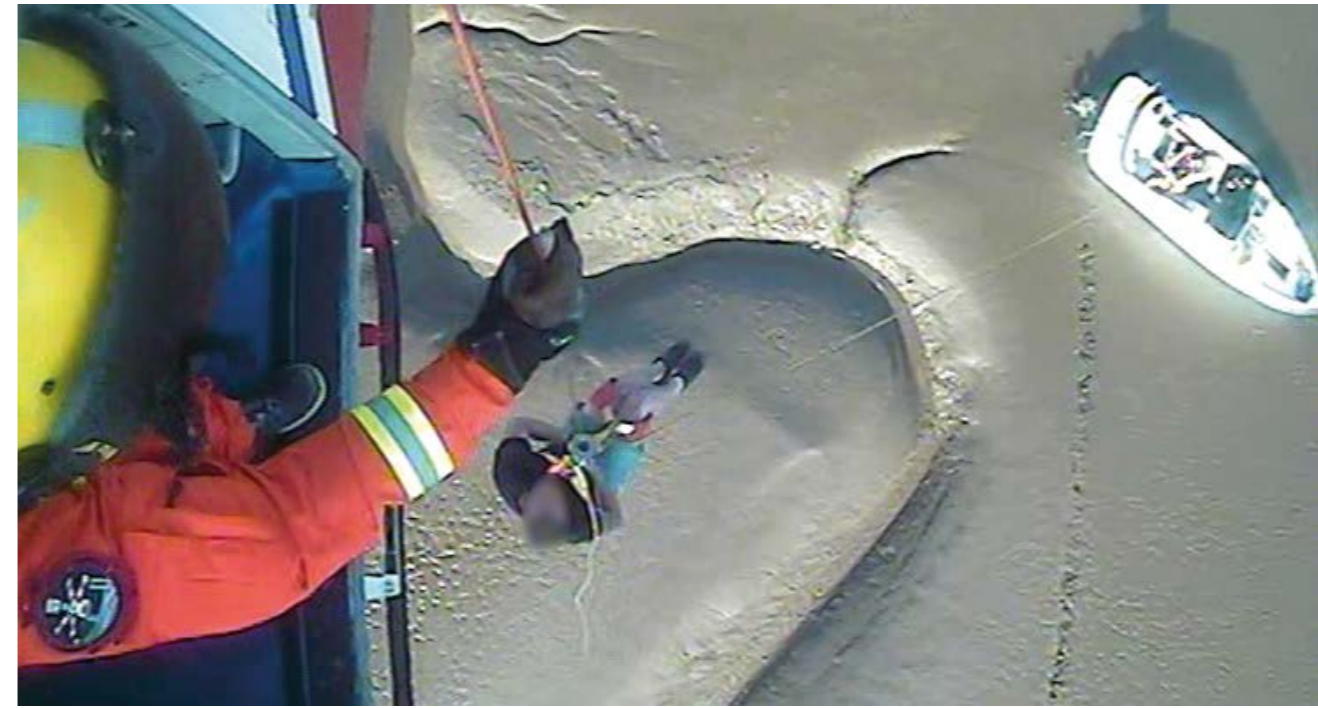
What started as a sunny day out on a boat ended with four sunburned and cold friends dangling below a helicopter as they were hoisted aboard one at a time (Figure 2), leaving their boat to be recovered once it had refloated. A day to remember for all the wrong reasons.

Figure 2: Lifting the friends aboard the helicopter

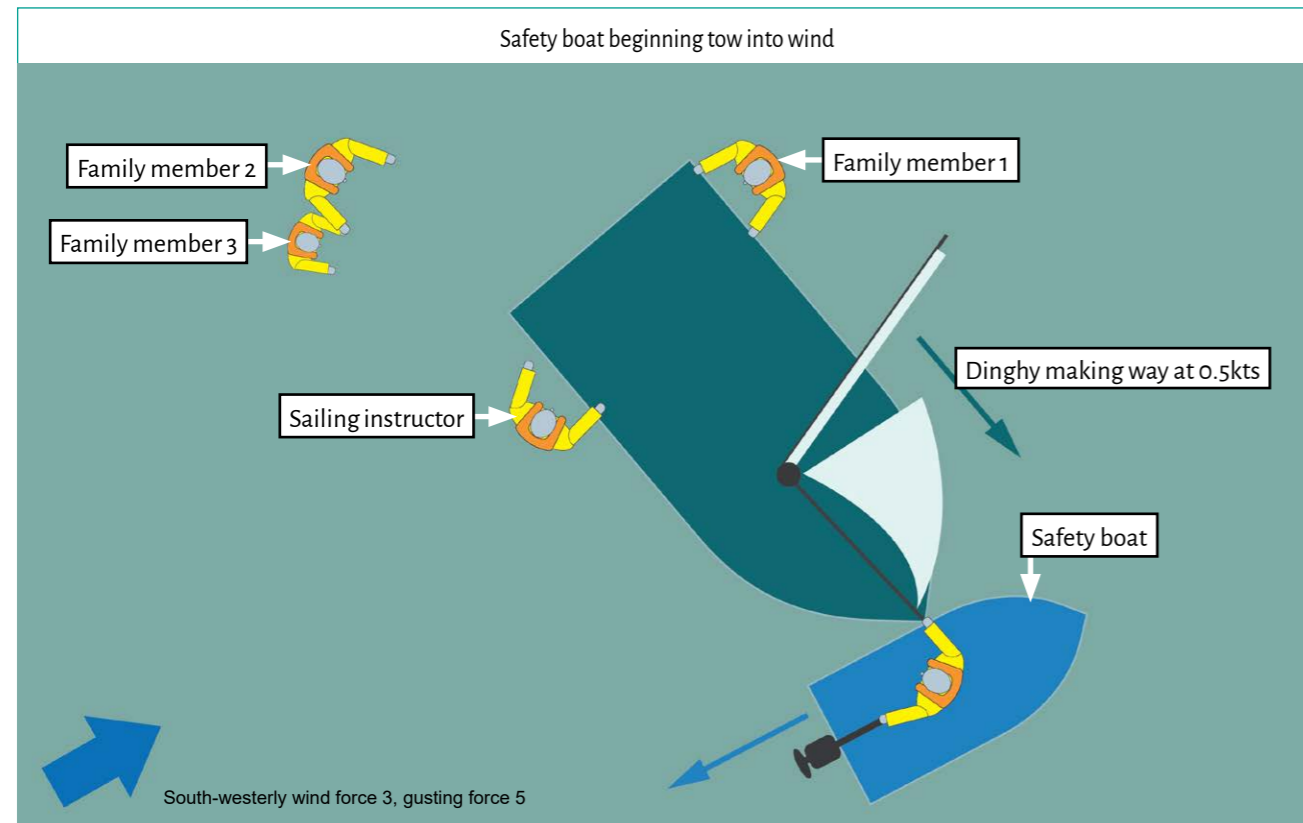
Figure 1: Safety boat starting the tow

The sailing instructor set out for the afternoon with a family of three novices. During this session the dinghy capsized once more. The dinghy was righted, but the jib sheet had been put on a cleat, so as soon as the dinghy came upright it started to sail away from all in the water. The sailing instructor was in the water on the windward side at the aft end of the dinghy and called over to the safety boat for help. When the safety boat arrived, the sailing instructor told its crew to approach the bows of the dinghy stern to the wind. The plan was to tow the dinghy's bows into the wind with the safety boat's lone coxswain holding the forestay in their right hand and controlling the safety boat's outboard engine with their left hand (Figure 1).

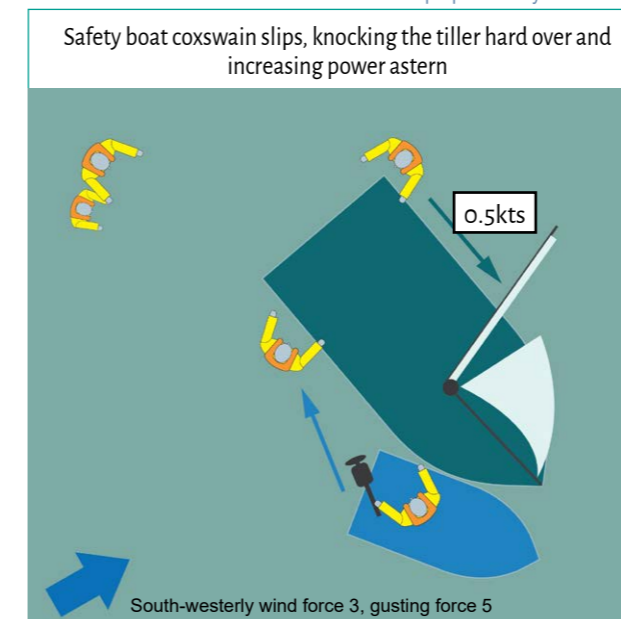
Figure 2: Safety boat coxswain slips

The safety boat coxswain slipped as they tried to grab the forestay, twisting the throttle on the outboard engine and pushing it away as they fell (Figure 2). This brought the stern of the safety boat along the windward side of the dinghy. The safety boat's propeller slashed through the sailing instructor's wetsuit, cutting their leg. The safety boat coxswain pulled the kill cord and stopped the outboard engine (Figure 3) before recovering the sailing instructor into the safety boat and administering first aid. The sailing instructor was transferred to hospital by ambulance, where their leg wound was treated and stitched. They made a full recovery but were off work for a while.

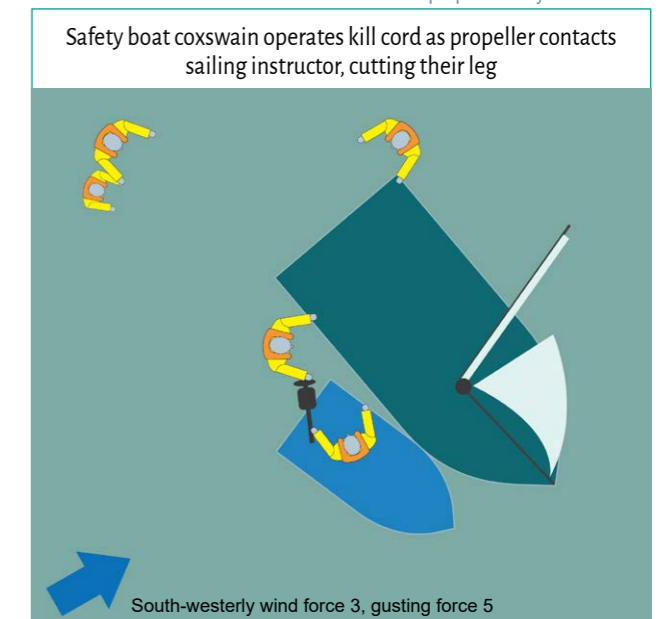
Figure 3: Propeller strike

- Risk** → There is much debate about the benefits of propeller guards. Had one been fitted in this case it is highly likely the sailing instructor's injuries would have been less serious. Procedures and training need to be suitably adapted for the equipment fitted; for example, take great care when near people in the water in a boat without propeller guards and consider reaction times and the need for manoeuvrability at speed when in a boat with propeller guards. Managing risk is a thinking person's game.

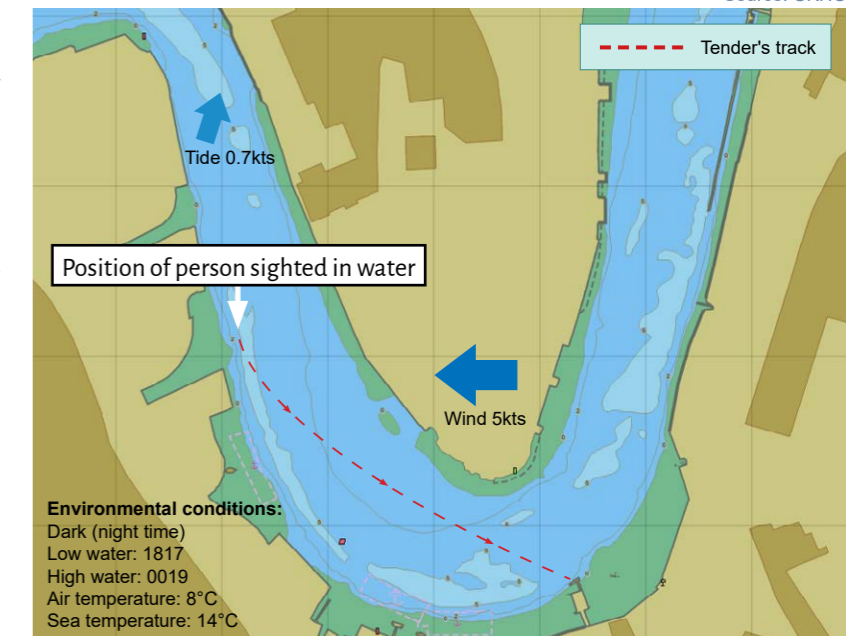
Figure 2: MOB from tender
