SAFETY DIGEST

Lessons from Marine Accident Reports

1/2025

MARINE ACCIDENT INVESTIGATION BRANCH

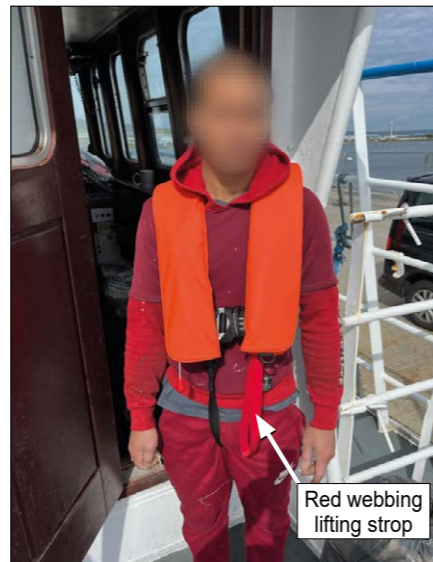
Figure: The red webbing lifting strop on the PFD

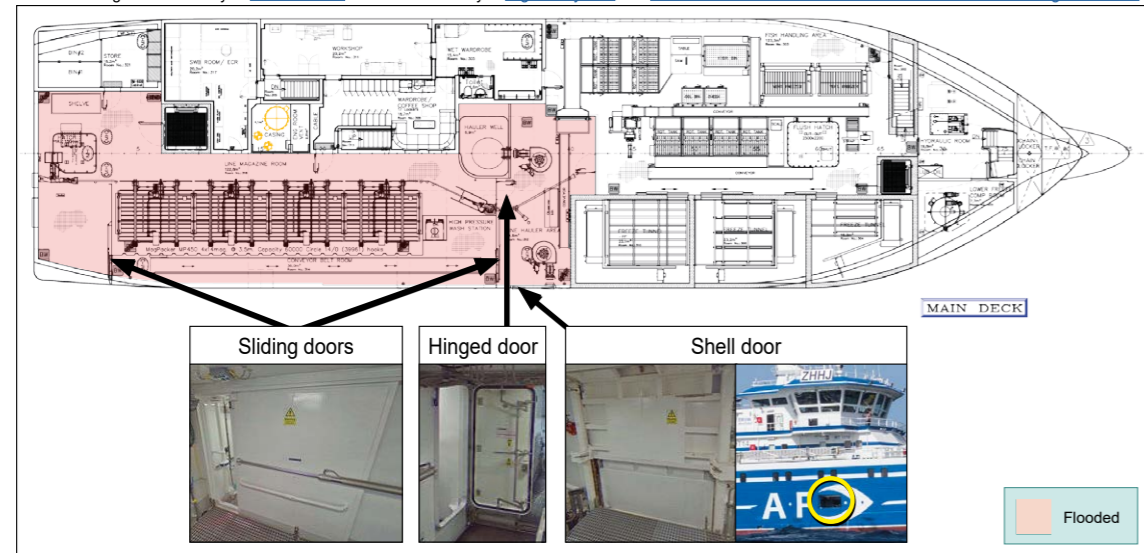
At about 1230¹, in a position approximately 190 nautical miles east of Port Stanley, *Argos Georgia* suffered an uncontrolled ingress of water through the shell door into the hauling compartment on its starboard side. Water then entered other areas aft of the hauling compartment (see **Figure**) and the vessel took on a starboard list. *Argos Georgia* was turned into the weather and the master raised the alarm via a colleague on a fishing vessel operating in the same region. This alarm was relayed to the authorities in the Falkland Islands and a SAR operation initiated using air and sea assets, supported by other fishing vessels.

Figure: Plan of *Argos Georgia* main deck, showing the extent of the initial flooding

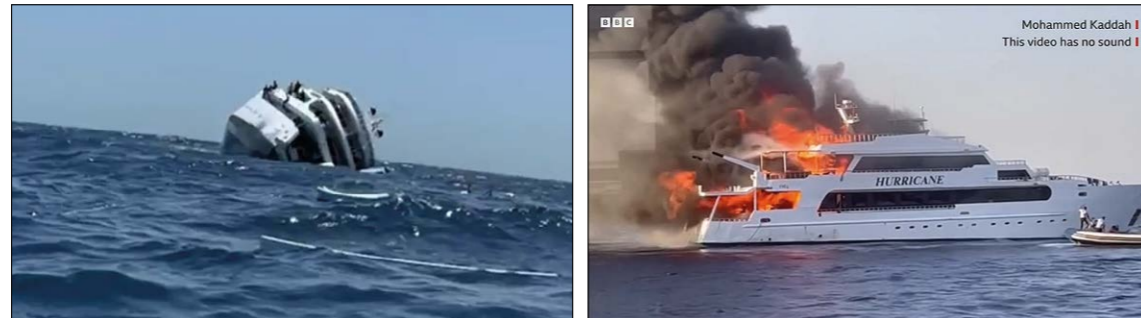
Figure 1: *Carlton Queen* capsized and *Hurricane* on fire

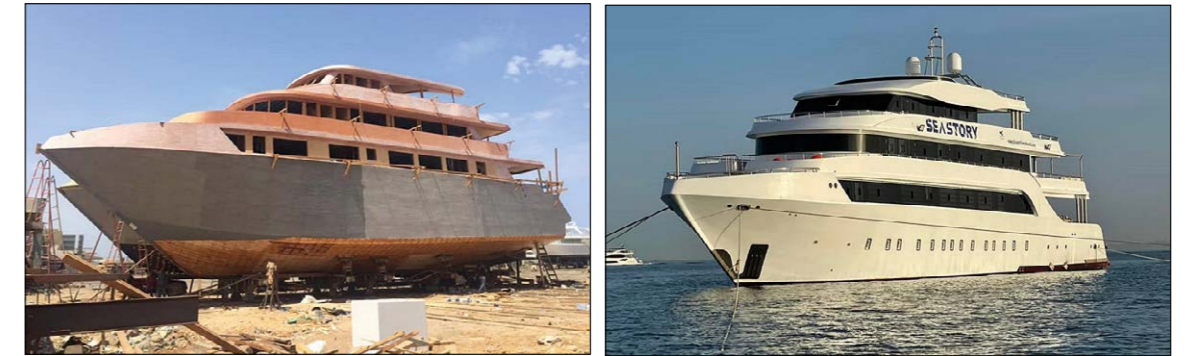
- Emergency escape routes were via lockable doors, had no emergency lighting and were unmarked.
- Safety briefings to passengers were of a poor standard or not conducted at all.
- Crews appeared poorly trained and were unfamiliar with their vessels.

Figure 2: *Sea Story* before and after modification, including extension

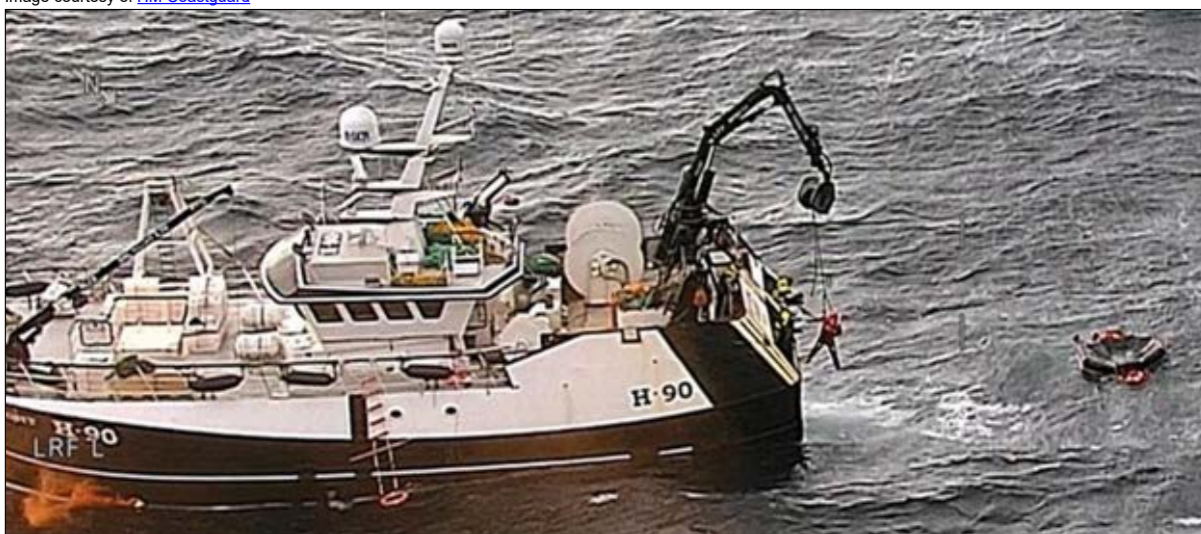
HM Coastguard helicopter footage following the collision, showing the overturned liferaft and a member of *Guiding Star*'s crew being recovered from the water using *Guiding Light*'s power block

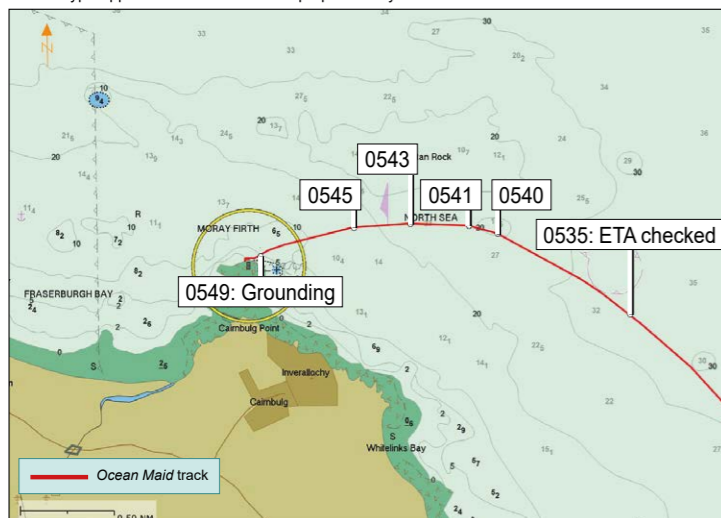
Ocean Maid was on passage from Eyemouth to Fraserburgh for pre-arranged maintenance and was being navigated by a lone watchkeeper. The navigation equipment in the wheelhouse included three chart plotter displays, one of which the watchkeeper used to navigate by following the past tracks displayed on it and cross-checking these with external visual indicators to judge the vessel's position. In the final few minutes before the grounding the watchkeeper left the wheelhouse at least twice to make tea for the crew, which was a normal task on the vessel's approach into port. Between these visits to the galley, the watchkeeper made several course adjustments that gradually moved *Ocean Maid* towards Cairnbulg Point (see **figure**). The watchkeeper was absent from the wheelhouse at the time of grounding.

Figure: Chart showing the four course alterations leading up to the grounding

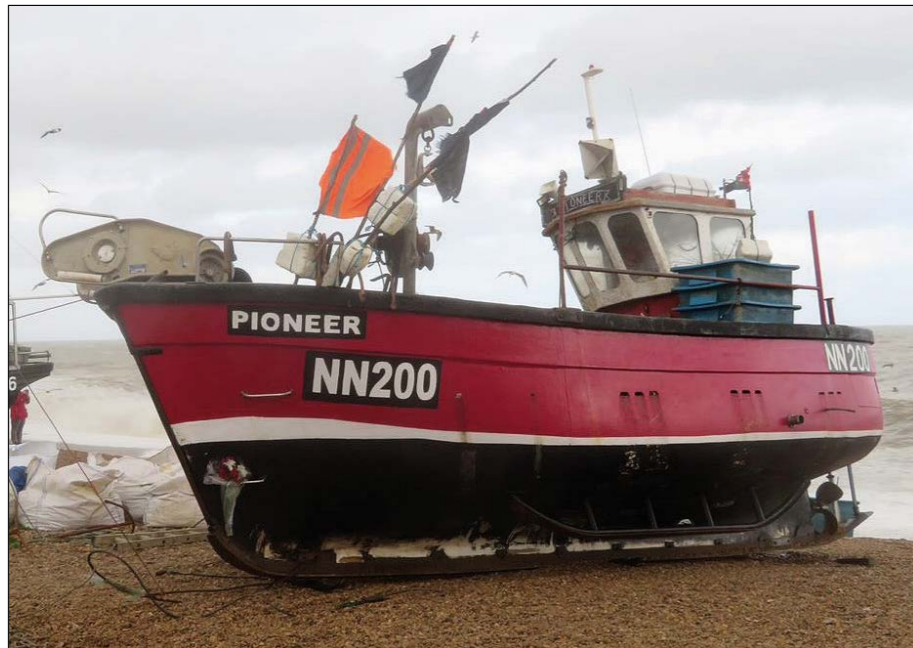
Pioneer

At about 0853 on 29 July 2021, the skipper of the UK registered fishing vessel *Pioneer* fell overboard from the aft deck of the vessel. At the time of the accident, *Pioneer* was returning from its fishing grounds to its beach landing at Hastings in moderate sea conditions with a 2m swell.

The investigation found that the bulwark around *Pioneer*'s aft deck was low and the vessel's wheelhouse windows were semiopaque and cracked, restricting visibility from inside. Some items of mandatory safety equipment were missing, damaged or out of date, the Seafish risk assessment had not been completed, emergency drills had not been conducted and the skipper had not undertaken mandatory safety awareness training.

2. Risk assessments provide the opportunity to take stock of a fishing vessel's normal working activities, identify hazards and put in place measures to mitigate them. Had *Pioneer* had a guardrail of adequate height, or had the skipper been wearing a tethered safety harness in this case, either would have offered protection against the risk of falling overboard. Make sure you have attended the Seafish Safety Awareness course and refer to the Maritime and Coastguard Agency publication *The Fishermen's Safety Guide* for advice on how to prepare risk assessments for your vessel.

3. The wearing of a PFD while working on deck improves the likelihood of survival should the unexpected happen and you fall overboard. PFDs are designed to keep you afloat with your airway clear of the water.

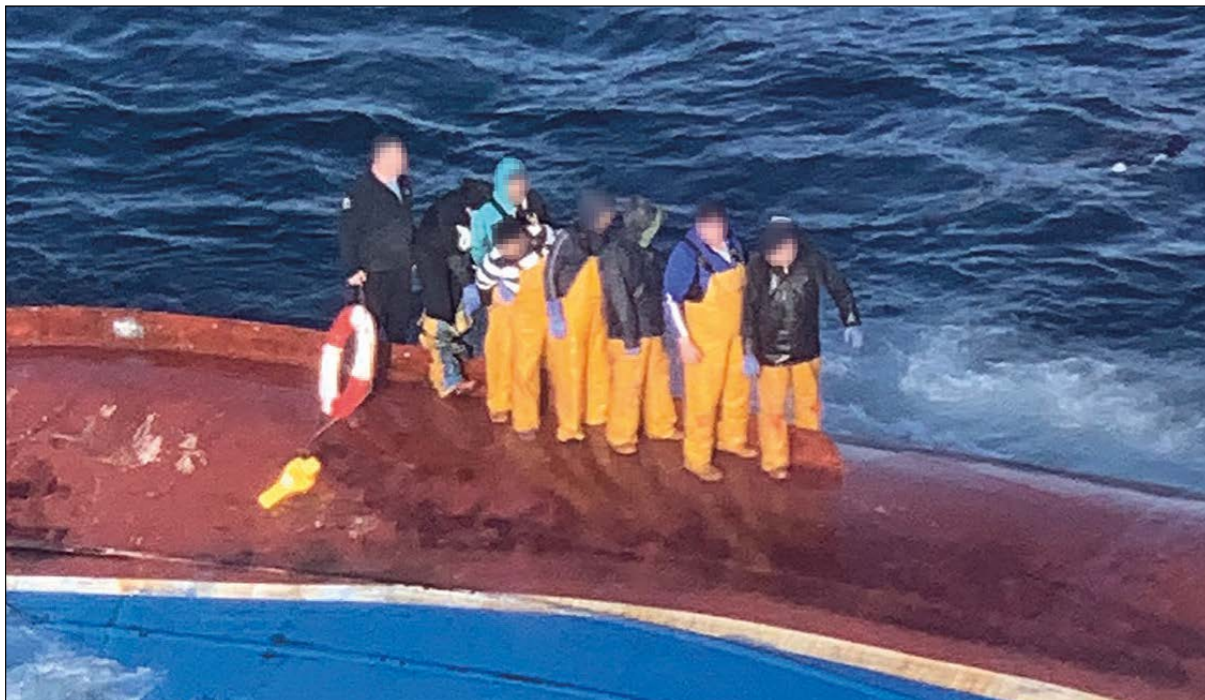
The crew standing on the upturned hull of *Njord*

On 6 March 2022, the 26.56m stern trawler *Njord* (SH 90) capsized and foundered 150 miles north-east of Peterhead, Scotland while processing a very large haul of fish. The MAIB investigation found that the weight of catch, which was secured to the starboard trawl winch and acting on a handrail high up on the vessel's starboard side, caused it to list to starboard to an angle where downflooding occurred. A drain valve had been left open in the starboard weathertight bulkhead on the vessel's working deck, which allowed downflooding into *Njord*'s internal spaces. The starboard list subsequently increased further, resulting in the capsizing of the vessel.

The combination of a reduced margin of stability due to the modifications and the vessel's operational conditions during the incident directly contributed to *Njord*'s capsizing.

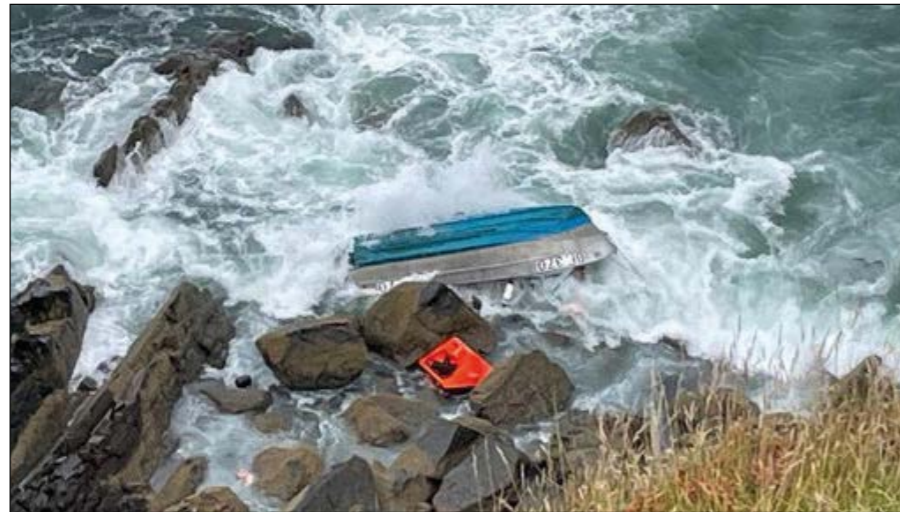
Lexi Rose and liferaft after the recovery of the skipper

Lexi Rose's skipper was found approximately 5m from his vessel in shallow water by emergency services personnel. He was recovered by helicopter but declared deceased on the way to hospital. The skipper could not swim and he was not wearing a personal flotation device (PFD) or carrying a
