Rail Accident Investigation Branch

Rail Accident Report

**Passenger train collision with a road vehicle at
Redcar level crossing, Redcar and Cleveland
1 May 2024**

Report 05/2025
April 2025

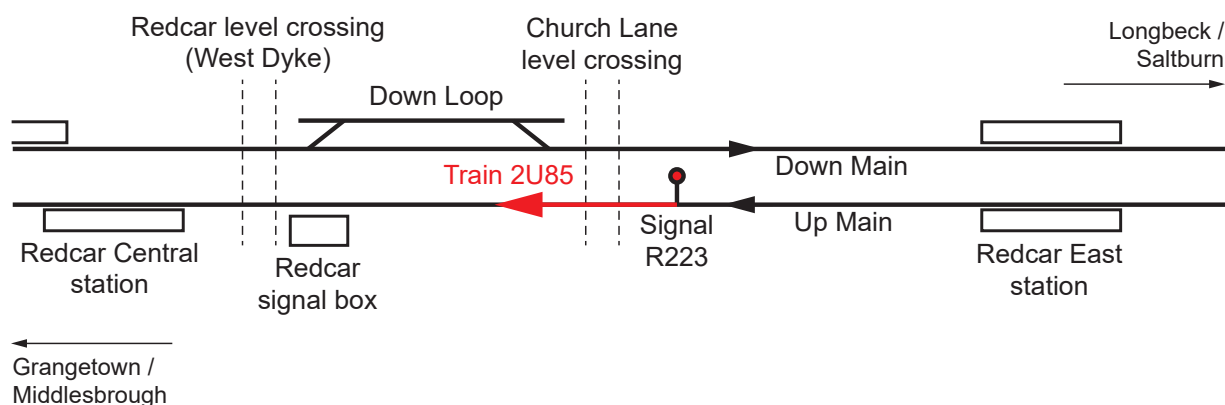
Figure 3: Track layout through Redcar.

- 23 On the day of the accident, the signaller started their shift at 06:00. At 09:10, the preceding train to that involved in the accident arrived at Redcar Central station. This was train 2D11, the 08:59 Northern service from Saltburn to Bishop Auckland. As train 2D11 passed signal R223 (figure 3) the signal automatically reverted to showing a red aspect. The signaller observed the associated indicator lamps on the signalling panel flicker and go out.

- 73 The signaller did not use the route cards when setting the route for train 2U85. The signaller had previously used the route cards as an aide-memoire when authorising unusual train movements, such as putting a train into the down loop at Redcar (figure 3). However, because the movement of train 2U85 on the day of the accident required the same actions and checks as almost every passing train, the signaller did not consider that they needed to use the route card to set the route.

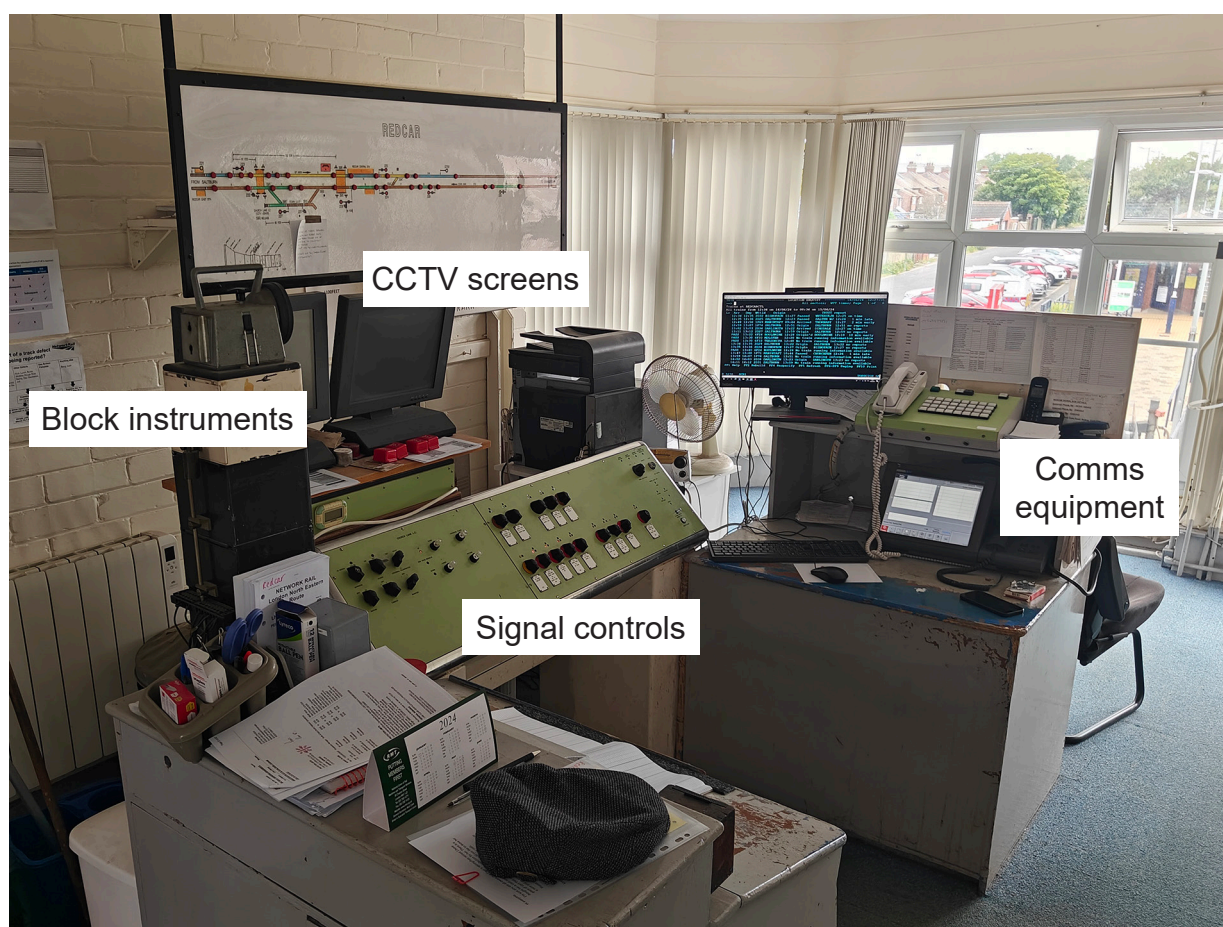
Figure 4: Signal box overview.

37 The railway at Redcar is double track, and trains arrive from and depart towards the adjacent signal boxes at Grangetown, to the west, and Longbeck, to the east. The signalling for the section between Redcar signal box and Longbeck signal box is operated using the absolute block system (paragraph 9). Signals capable of showing red aspects and green aspects control the entry and exit of trains from each block section. The line from Redcar to Grangetown signal box uses the track circuit block system. This breaks the line down into smaller sections and uses track circuits to identify the location of trains.

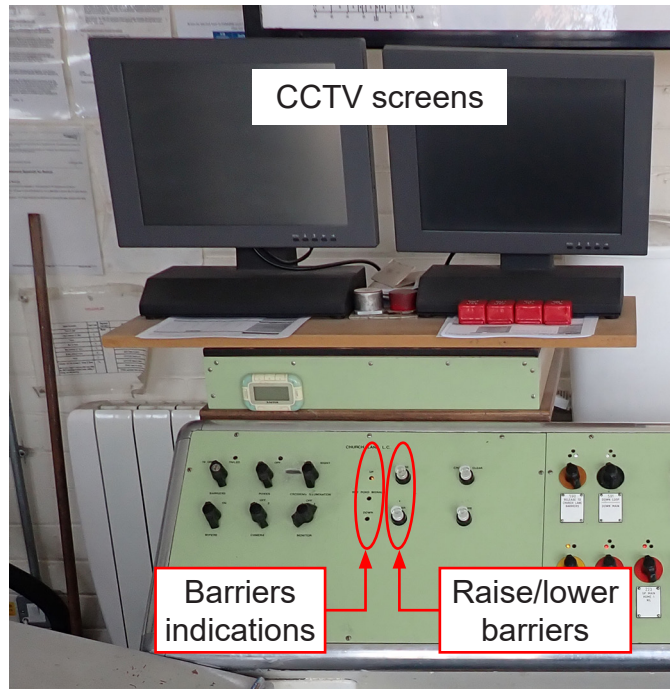
Figure 5: Church Lane level crossing controls and CCTV.

38 Redcar signal box controls two level crossings, both of which are situated between Redcar Central station and Redcar East station (paragraph 8, figures 2 and 3). Westbound trains, on the Up Main line, from Longbeck arrive first at Church Lane level crossing. It is about 600 metres east of Redcar signal box and is not directly visible to the signaller due to the track curvature. It is therefore monitored by the Redcar signaller using CCTV cameras and screens (figures 4 and 5). It is fitted with raising barriers and flashing wig-wag lights to manage road traffic access. The signaller has controls on the signalling panel to operate the opening and closing of the crossing and small indicator lamps to confirm that the barriers have been detected as fully raised or fully lowered.

- 121 The controls for Church Lane level crossing, including the CCTV display, are located at the signalling panel (figure 5 and paragraph 38). The controls for Redcar level crossing are located away from the signalling panel at the end of the signal box, meaning that the signaller has to walk across the box floor to reach them every time they are operated, or the crossing status needs to be checked (figure 14 and paragraph 39). This allows a signaller to have a clear view of the road and pavement while operating the Redcar level crossing controls.

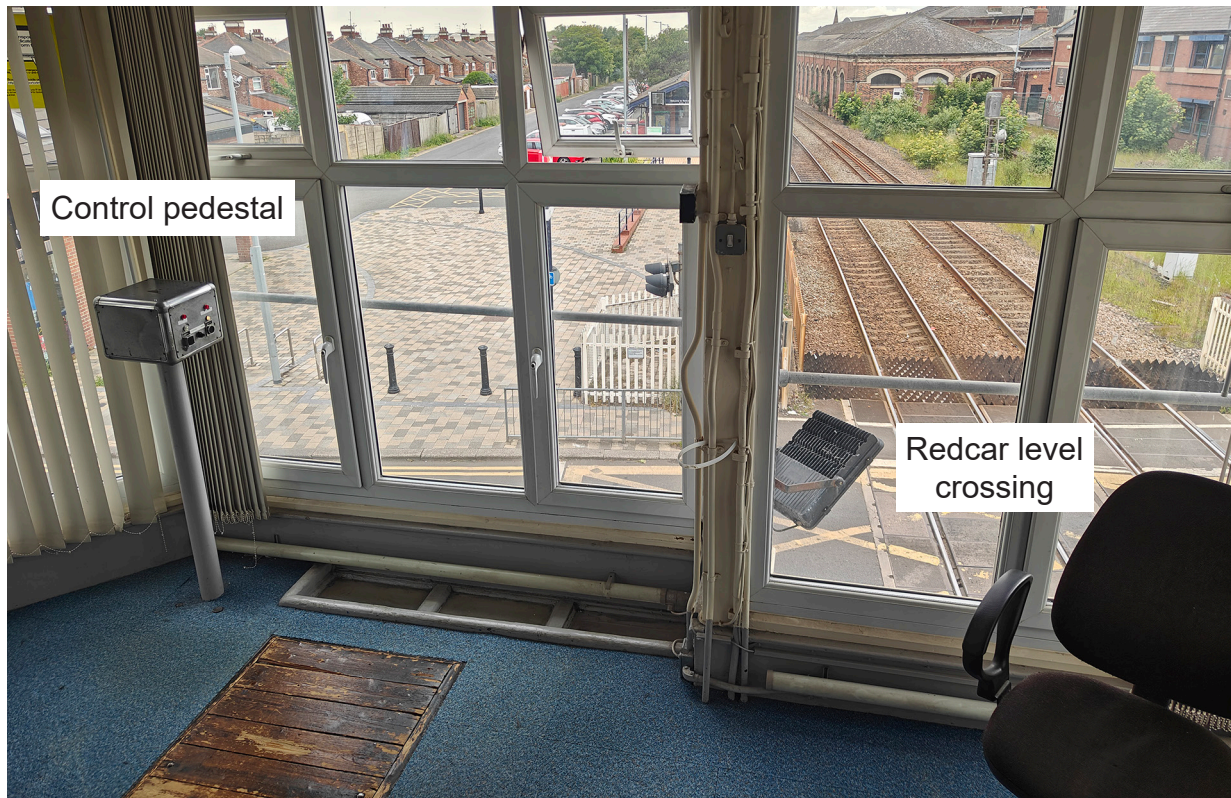
Figure 6: Redcar level crossing and control pedestal.

39 The second crossing which westbound trains will encounter is Redcar level crossing. This is adjacent to the signal box and is fitted with horizontally sliding gates (see paragraph 94). It is controlled by the signaller from a pedestal located by the window in the signal box, overlooking the crossing (figure 6, see paragraph 121). This crossing is not visible from the signaller's seat at the signalling panel and can only be seen by the signaller if they walk over to the end window.

94 The level crossing gates at Redcar are of a unique design on Network Rail's infrastructure. They each consist of a horizontally extending, cantilevered gate (figure 12) that is motor-driven and operated from the pedestal in Redcar signal box (figures 6 and 9). These gates were installed in 2016 and replaced a set of wooden, motor-driven, swung gates. These swung gates had suffered from a history of unreliable operation, partly down to the wind that tends to blow in from the sea at Redcar. Network Rail was unable to replace them with conventional lifting boom barriers because the position of the signal box did not allow sufficient space for the necessary equipment. Unlike Church Lane level crossing barriers, those at Redcar do not rise into the air and so are not visible from a distance when they are open to road traffic (figure 13).

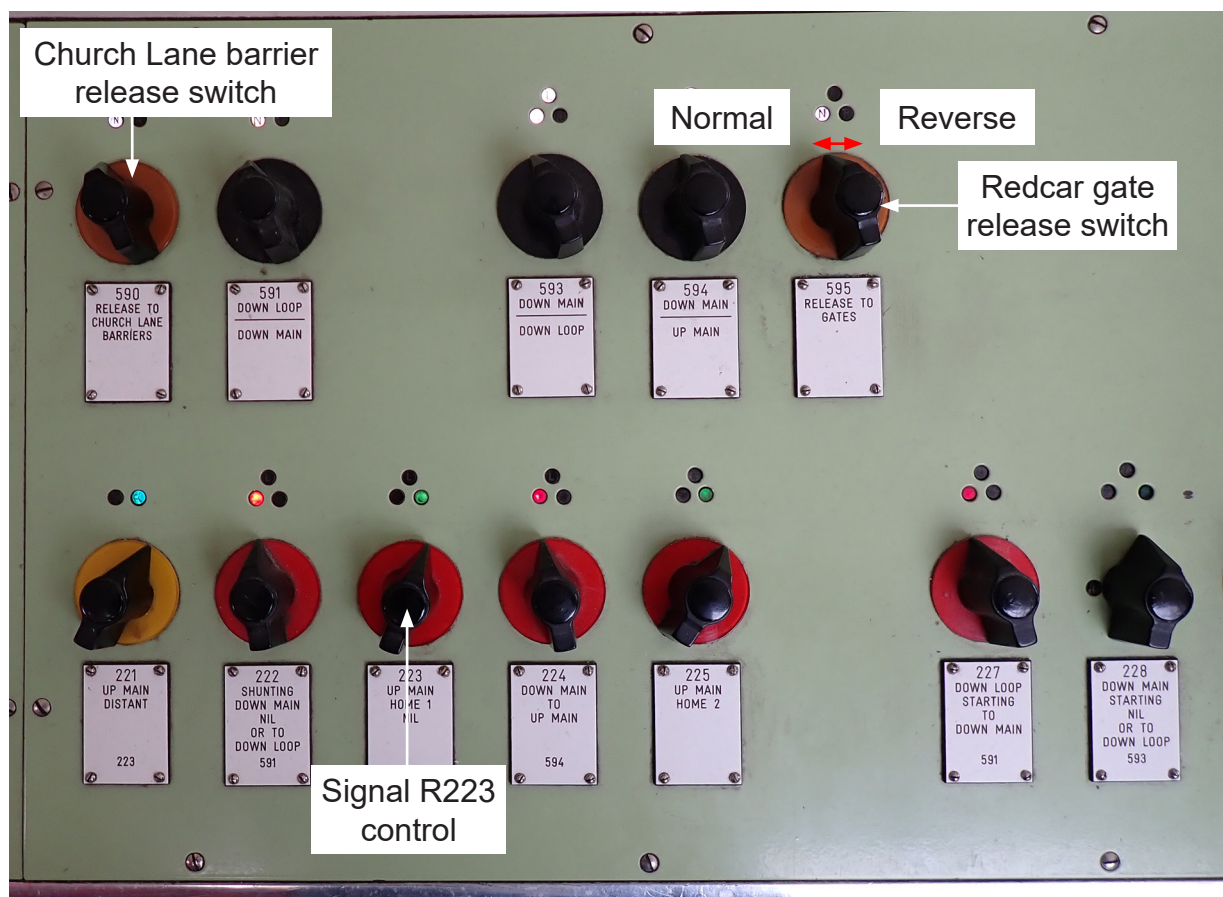
Figure 8: Signalling controls, showing crossing releases and signal R223.

- The first step is to set the crossing release switch on the signalling panel for Redcar to the reverse position (figure 8). This enables the operator controls at the pedestal by the window overlooking the crossing.

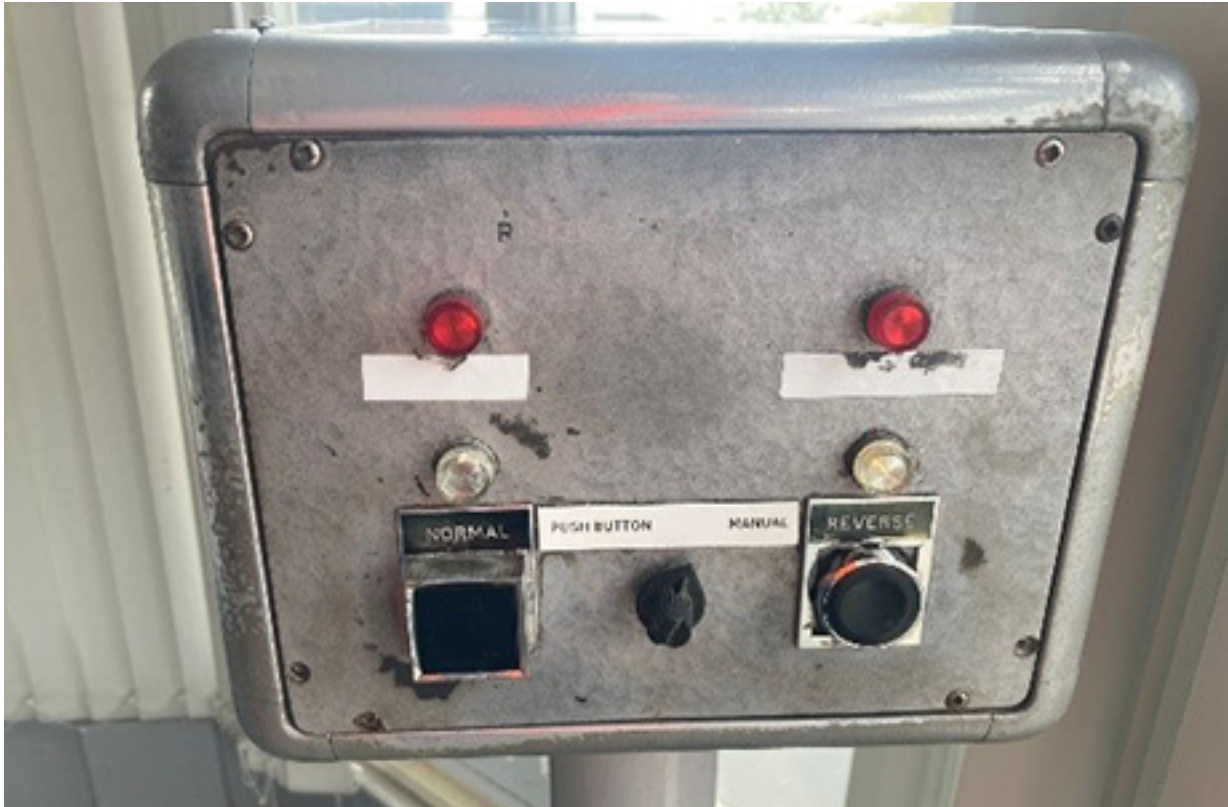
Figure 9: Redcar level crossing gates controls at the pedestal.

- The signaller gets up from the seat at the signalling panel and walks over to the crossing pedestal (figure 9). They then operate the close control (labelled 'Normal' on the pedestal) and keep it pressed while watching the crossing for pedestrians and vehicles. The wig-wag lights and an audible alarm activate for 7 seconds before the gates then start to move across, and fully close off, the road. The signaller holds the close button pressed until the gates have fully closed and the crossing is confirmed to be clear of pedestrians and vehicles. The audible alarm ceases to sound once the gates are closed, although the wig-wag lights remain active until the road is reopened.
