Report on the investigation of  
the double fatality and subsequent loss  
of the small commercial vessel

## ***Calypso 2***

near West End, Anguilla

REPORT NO 6/2025

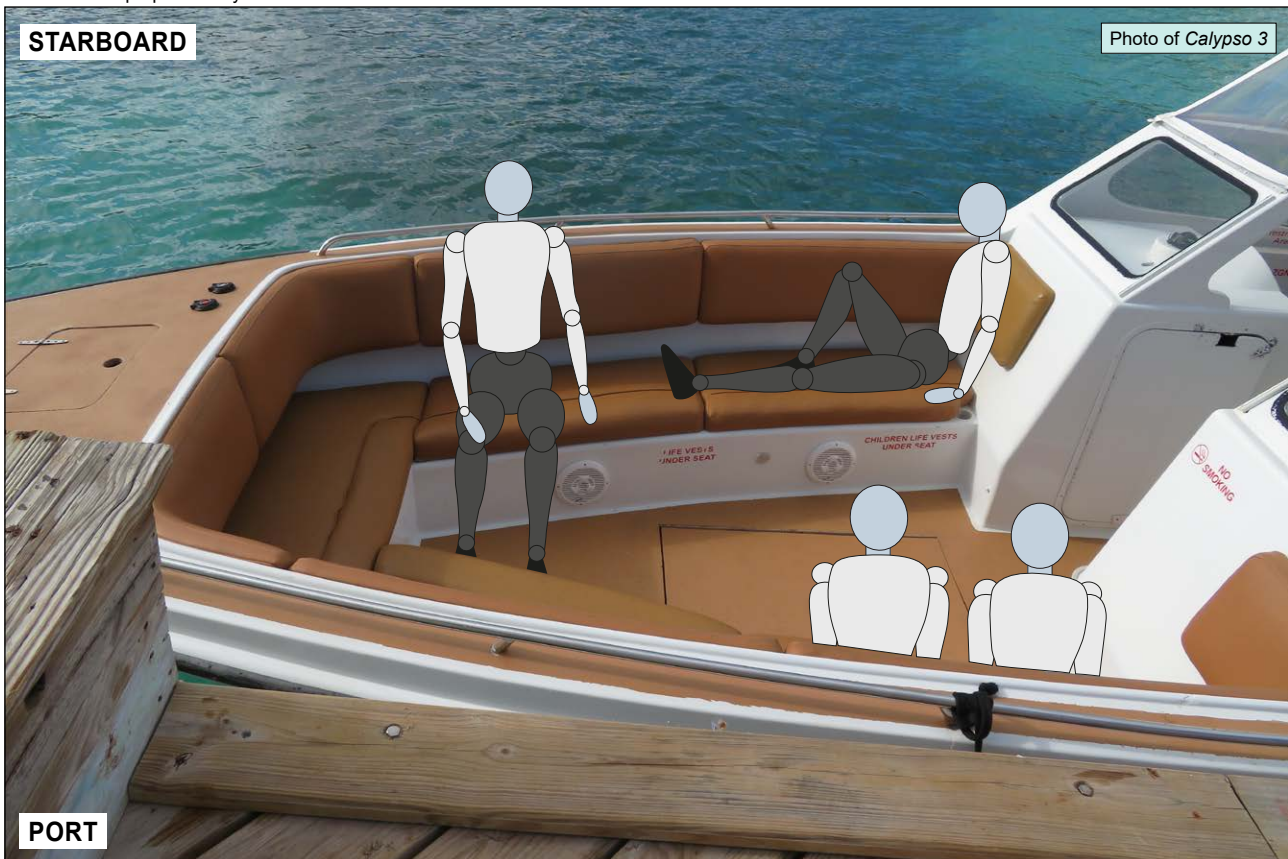
Figure 3: Passengers' seating positions on the foredeck

The family settled in the seating area on the open foredeck, with the two parents sitting on the port side and their son and daughter on the starboard side (**Figure 3**). The skipper manoeuvred the vessel in a south-westerly direction, intending to follow the coast around the southernmost point of the island then along Anguilla's northern coast to the popular tourist location of Crocus Bay (see **Figure 1**).

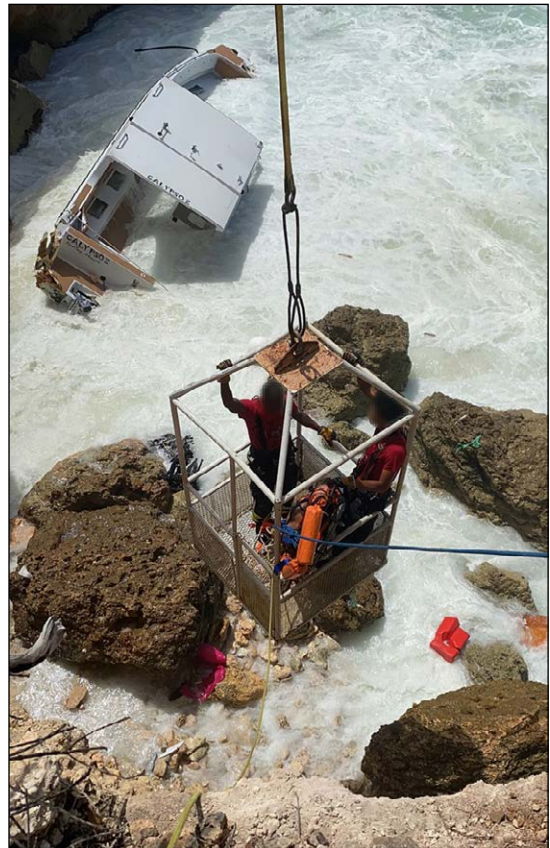
**Figure 5:** Cliff rescue personnel basket

Shortly afterwards, an AFRS fire appliance arrived on scene and its crew descended the cliff. They found the mate at the cliff base and recovered her to the cliff top in a personnel basket (**Figure 5**) using a locally sourced mobile crane. The mate was subsequently declared deceased at the scene.

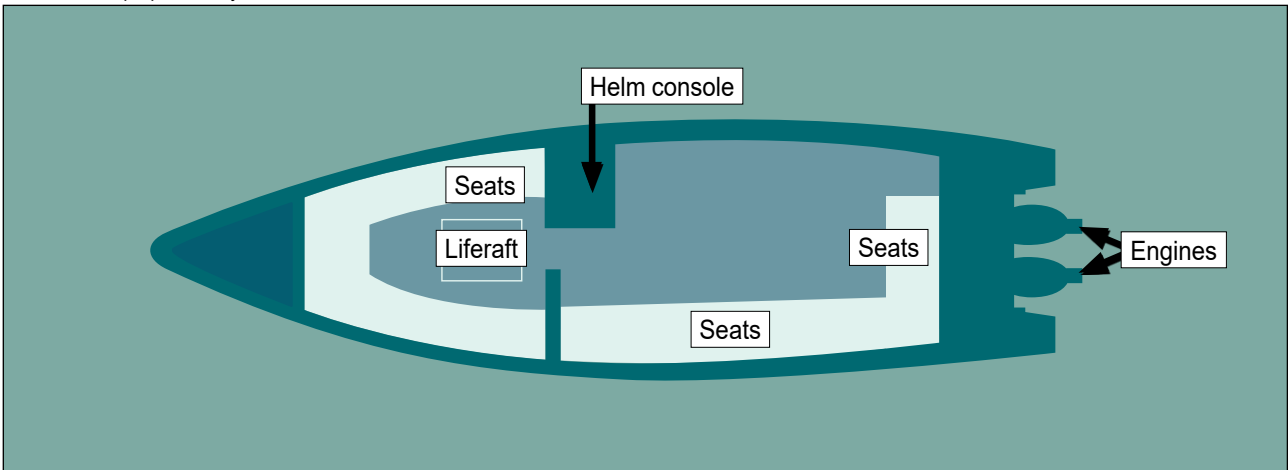
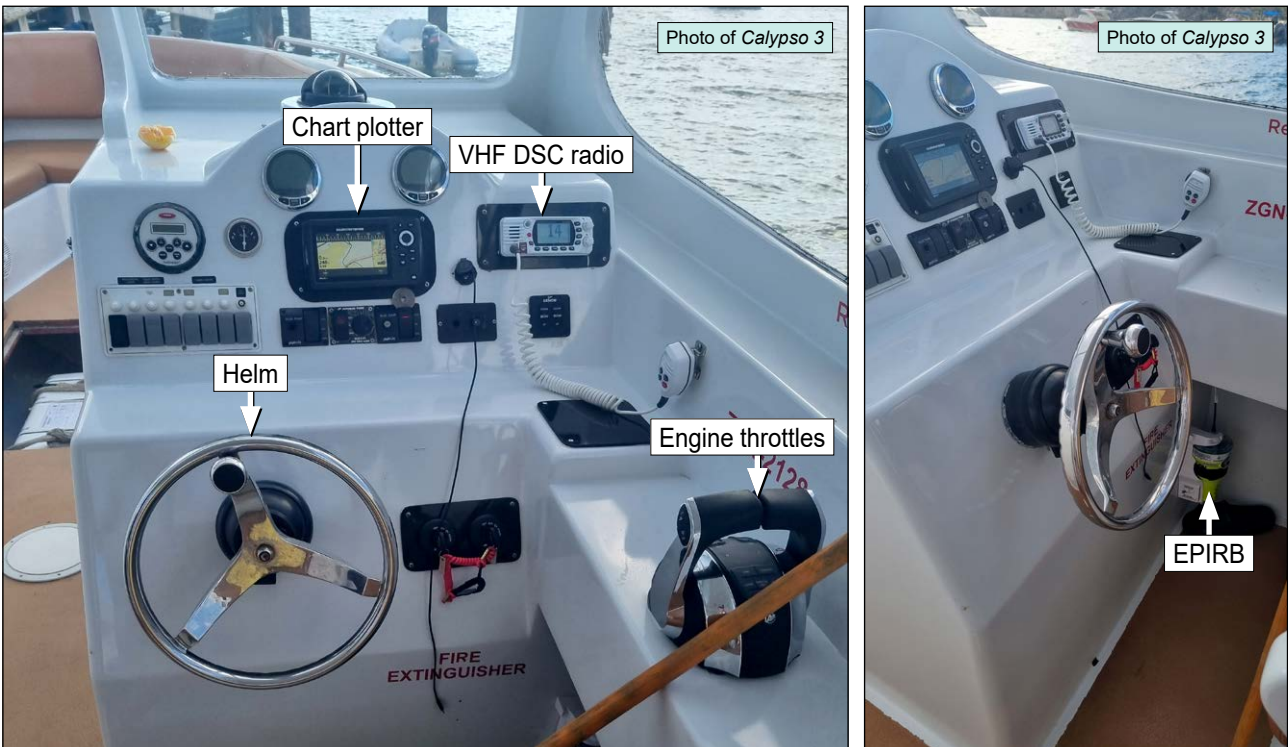
Figure 6: Calypso 2 general arrangement and helm console

*Calypso 2* was built for CCL in Trinidad in 2011 by an unknown manufacturer. The vessel had a planing hull constructed from glass reinforced plastic and twin 350 horsepower outboard engines that had been fitted in December 2022. There were passenger seating areas around the foredeck and across the stern. Approximately one third of the vessel's length from the bow there was a partially enclosed cabin area that included the helm controls on the starboard side, the on board toilet, and a seating area on the port side (**Figure 6**). The stern had a low transom to facilitate boarding from the water.

An Emergency Position Indicating Radio Beacon (EPIRB) arranged for manual release and activation was stowed below the helm console (see **Figure 6**).

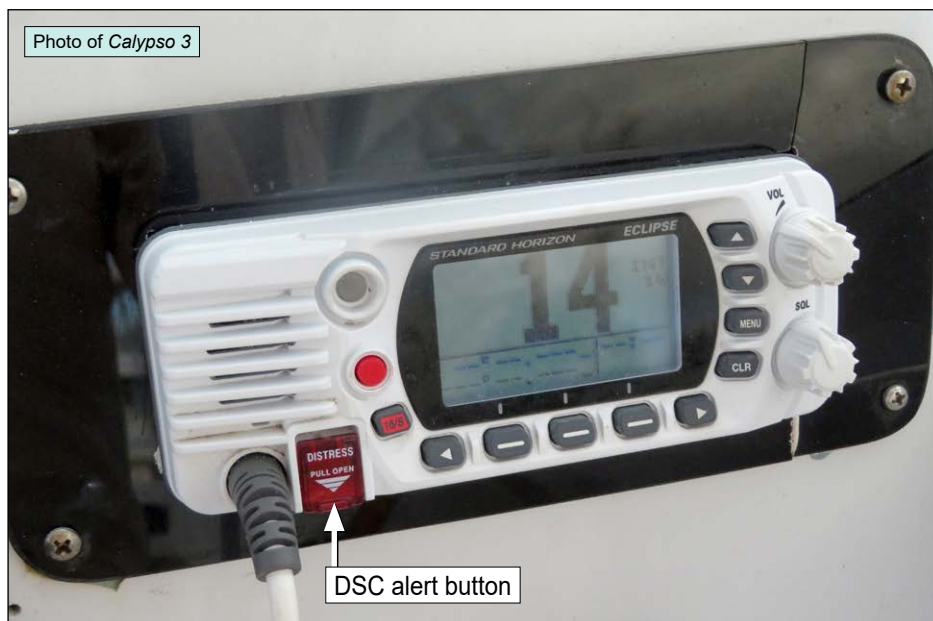
Figure 7: VHF DSC radio

The helm was equipped with engine throttles; engine start-stop buttons; a global positioning system chart plotter; a compass; a bilge pump control; and a very high frequency (VHF) digital selective calling (DSC) radio with an alert button (**Figure 7**). *Calypso 2* also carried a copy of the Imray A24 paper chart.

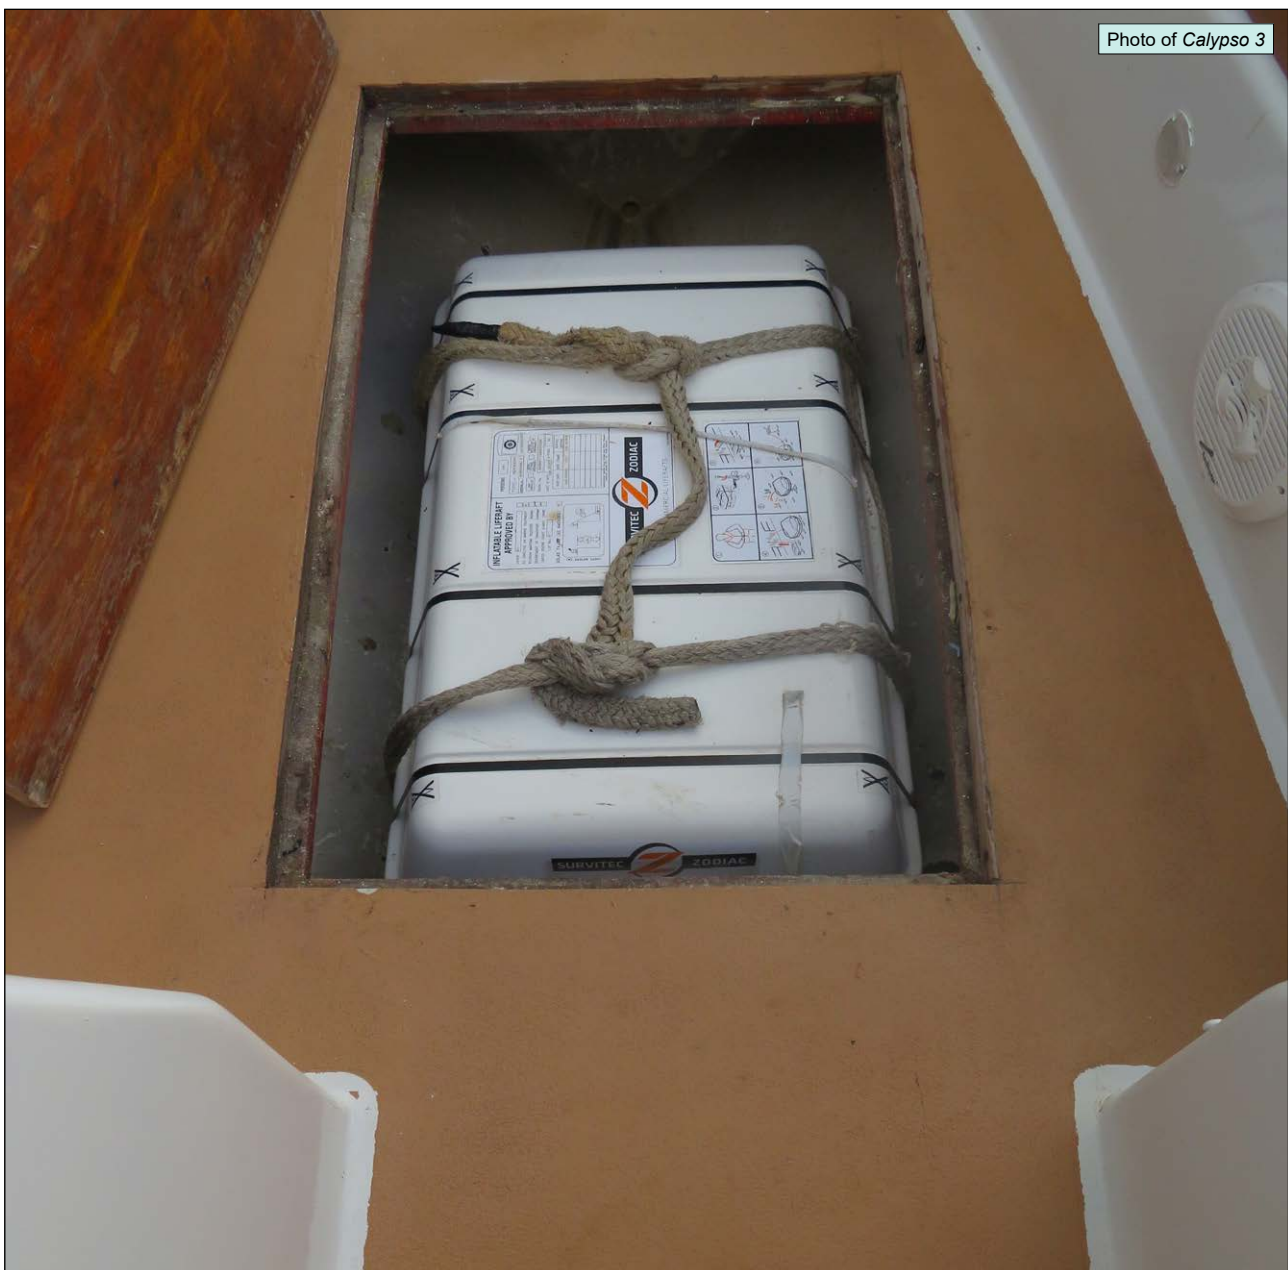
**Figure 8:** Liferaft stowage in the foredeck seating area

*Calypso 2* was equipped with 14 solid foam adult lifejackets suitable for persons weighing over 43kg and two child lifejackets. These were stowed under the seats in the bow. There was one 16-person liferaft in a hard case container stored under the foredeck seating area (**Figure 8**). The vessel carried: a pack of pyrotechnic flares, comprising two orange smoke floats, six red parachute flares and six handheld flares; two lifebuoys, one with a light and one with a line; and two fire extinguishers.
