# ***AAIB Bulletin***

# ***4/2025***

Rockwell Commander 112 TCA	N4698W	23-Dec-24	3
----------------------------	--------	-----------	---

ATR 72-500 (72-212A)	LY-JUP	12-Aug-24	13
----------------------	--------	-----------	----

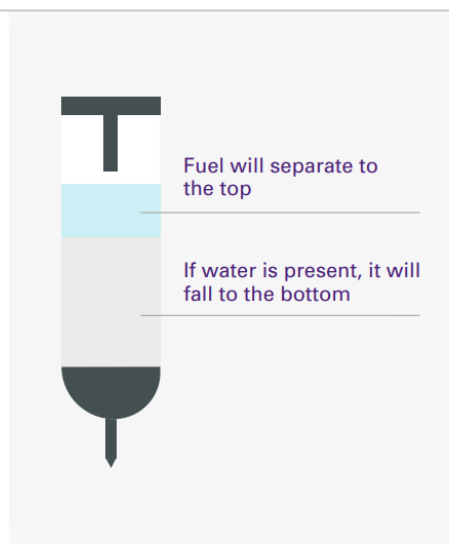
**Figure 2**

The picture illustrates the boundary between a considerable amount of water and the AVGAS. If you see no separation in the sample, confirm that the sample is all fuel rather than all water.

Extract from CAA Safety Sense Leaflet 28

Consider how to dispose of the sample; small amounts of petrol poured onto concrete will evaporate, but tarmac may be damaged. Some aerodromes will have a waste container in which to discard fuel samples. Do not return samples to aircraft tanks unless they are completely free from contamination.

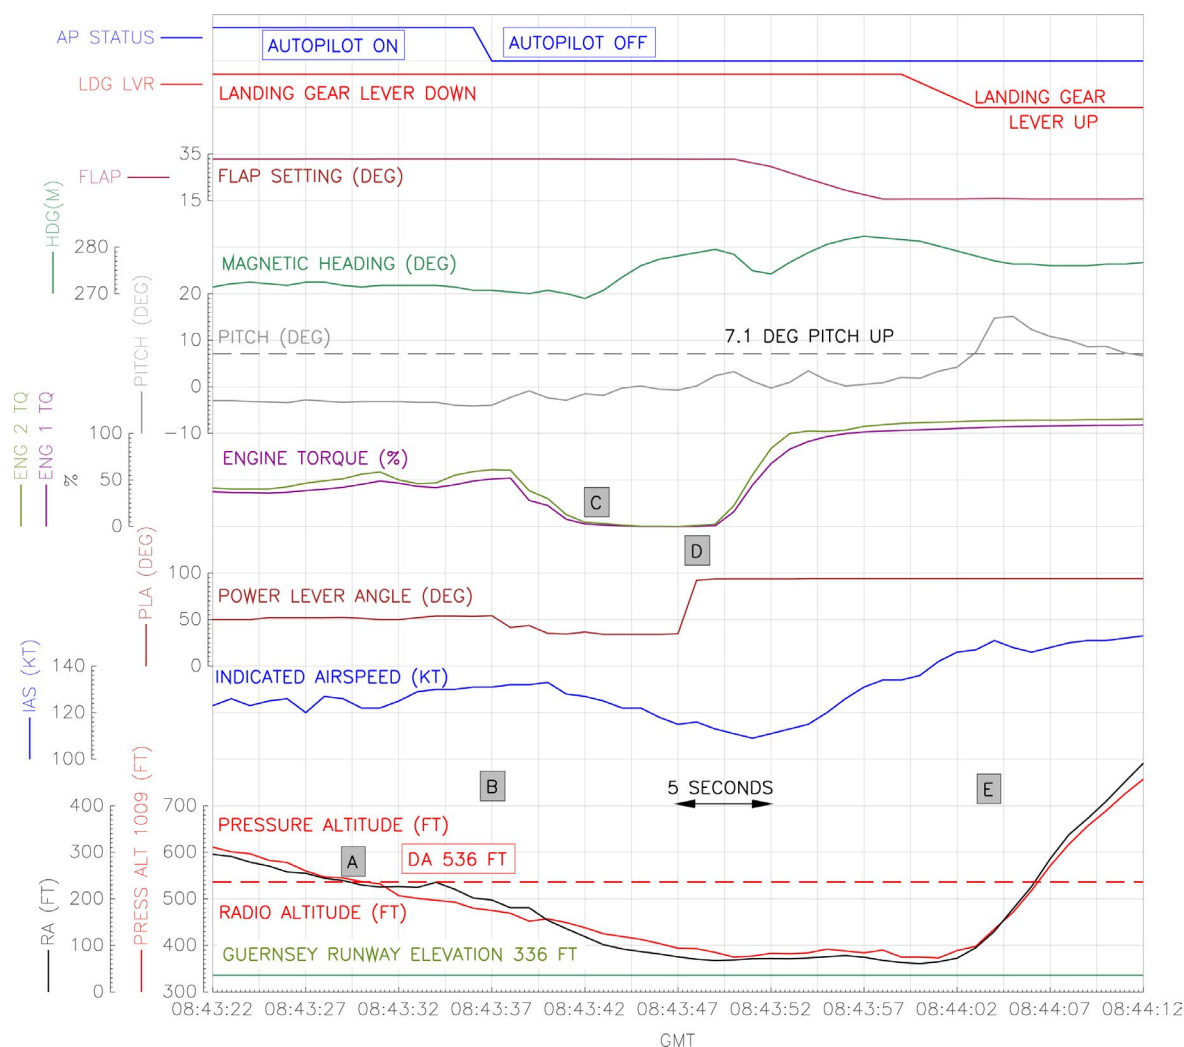
**Figure 2**

At 0843:30 hrs, the recorded pressure altitude reduced below the decision height<sup>3</sup> of 536 ft amsl when the aircraft was just over 0.5 nm from the Runway 27 displaced threshold (point A, Figure 2). The approach continued and the autopilot was disconnected seven seconds later at 475 ft amsl and 131 KIAS (point B).

LY-JUP FDR data during approach and go-around

At 0844:03 hrs, pitch attitude increased above  $7.1^\circ$  and the landing gear lever was selected to the UP position (Figure 2 Point E). The aircraft climbed and pitch attitude continued to increase to a maximum of  $15.8^\circ$  before then reducing as the aircraft continued to climb. At 0844:22 hrs, the aircraft made a radio transmission that it was going around and diverting to Southampton.

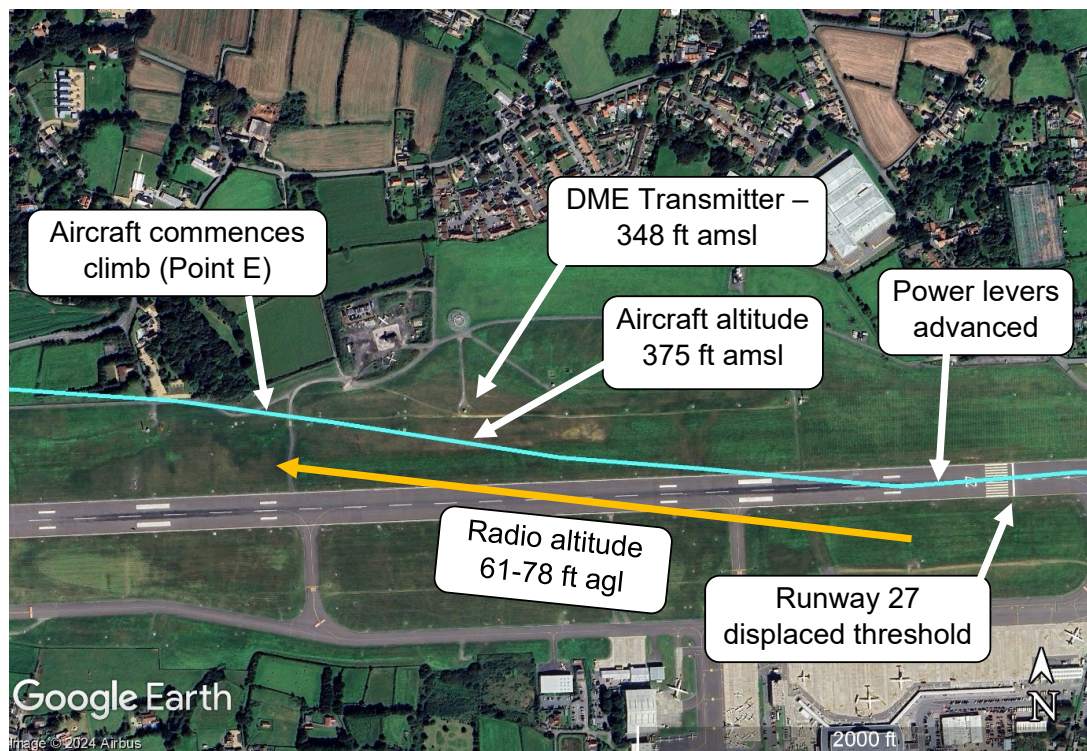
**Figure 3**

LY-JUP ground track during approach and go-around

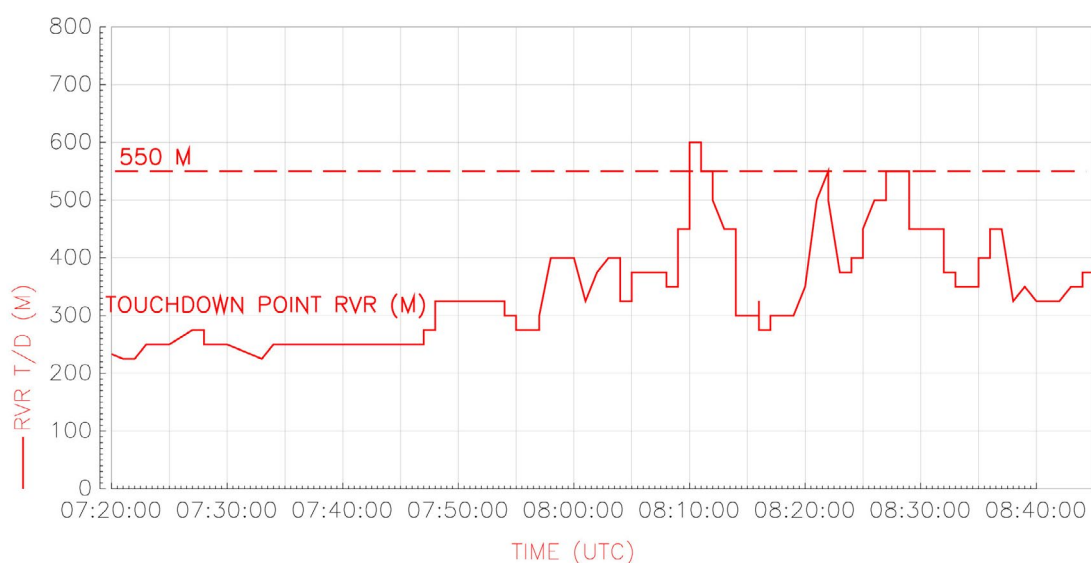
**Figure 4**

The airport at Guernsey has two RVR reading stations – the touchdown and the stop end. The figures for these were recorded every minute during the approach to Runway 27. A plot of the touchdown readings from the time the aircraft departed from Southampton until the time of the go-around is shown in Figure 4.

Runway 27 touchdown point recorded RVR

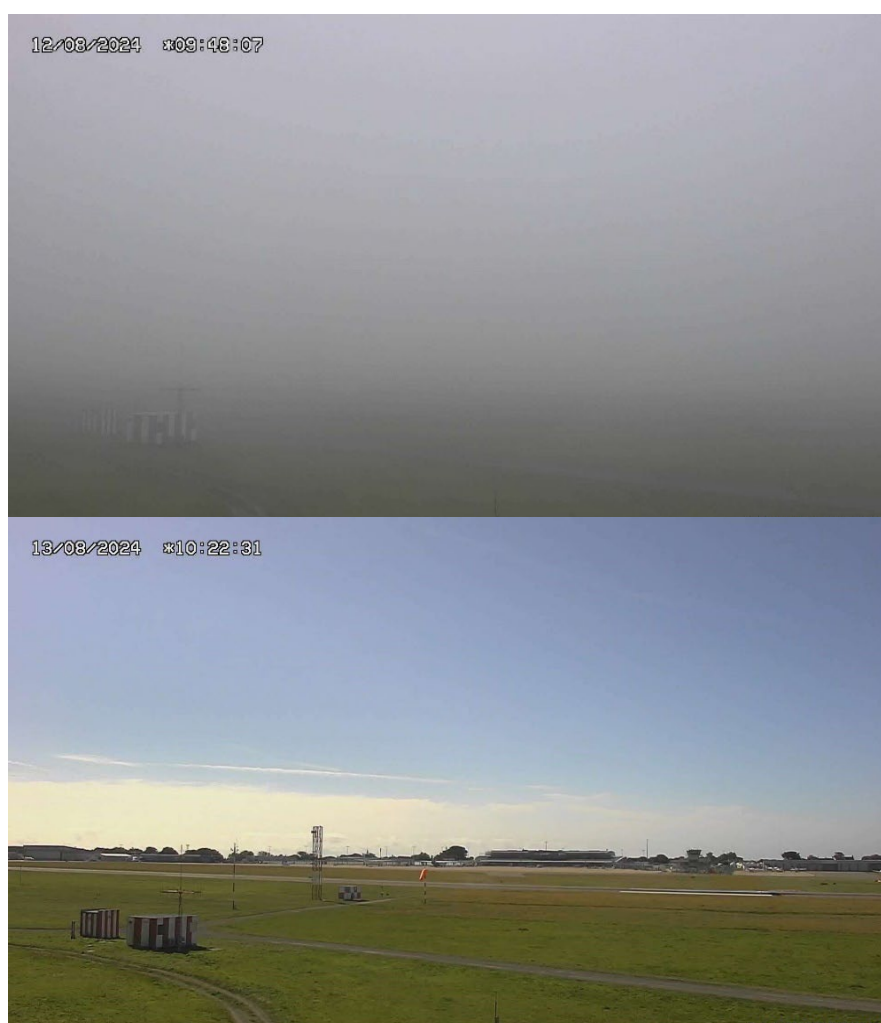
**Figure 5**

The airport is equipped with CCTV, stills of which were provided showing the view of the Runway 27 touch down zone. The stills show the weather around the time of the approach and on the subsequent day when there was no fog.

Airport CCTV images looking south over the Runway 27 touchdown zone (times are BST)

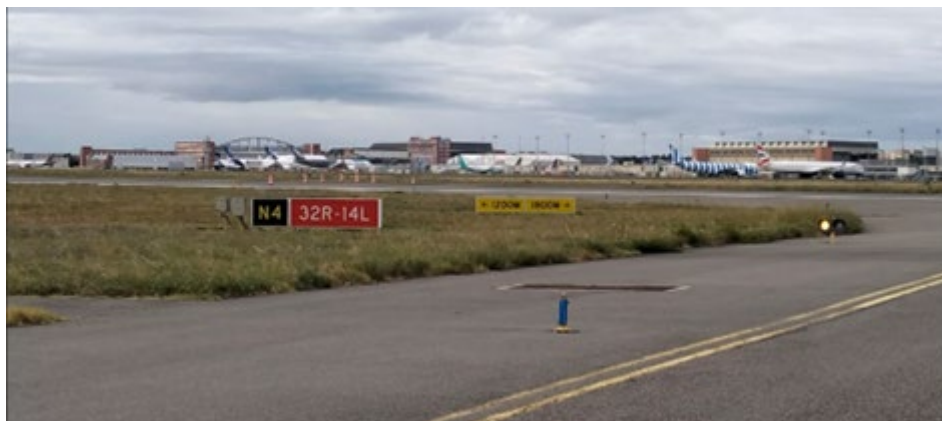
**Figure 3**

The crew completed the line-up flow, part of which requires that *'each pilot silently verifies takeoff intersection'*. This was followed by the line-up checklist as the aircraft entered Runway 32R via N4. Runway signage and guard lights ('wig-wags') were installed on both sides of the taxiway at the N4 holding point for runway 32R, as shown in Figure 3.

Holding point N4 for Runway 32R at Toulouse-Blagnac Airport

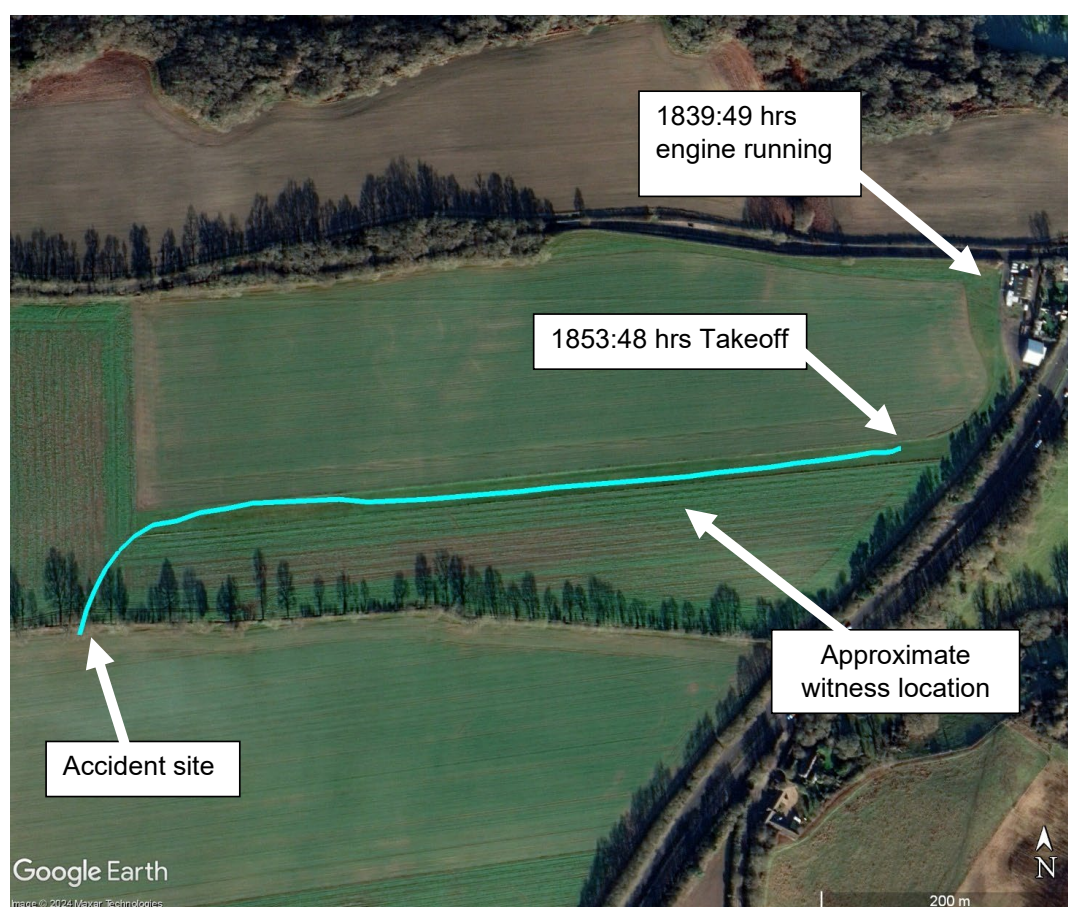
The witness observed the aircraft change heading before “gently floating down, wings level”. It touched down at the edge of the field about two metres from a drainage ditch. It rolled down into the ditch at which point the landing gear collapsed and detached. The aircraft carried on through a hedgerow which brought it rapidly to a stop. The pilot sustained serious injuries during the accident and had to be extracted from the wreckage by the emergency services who had been called by the witness.

**Figure 1**  
G-SSTL GNSS Position data

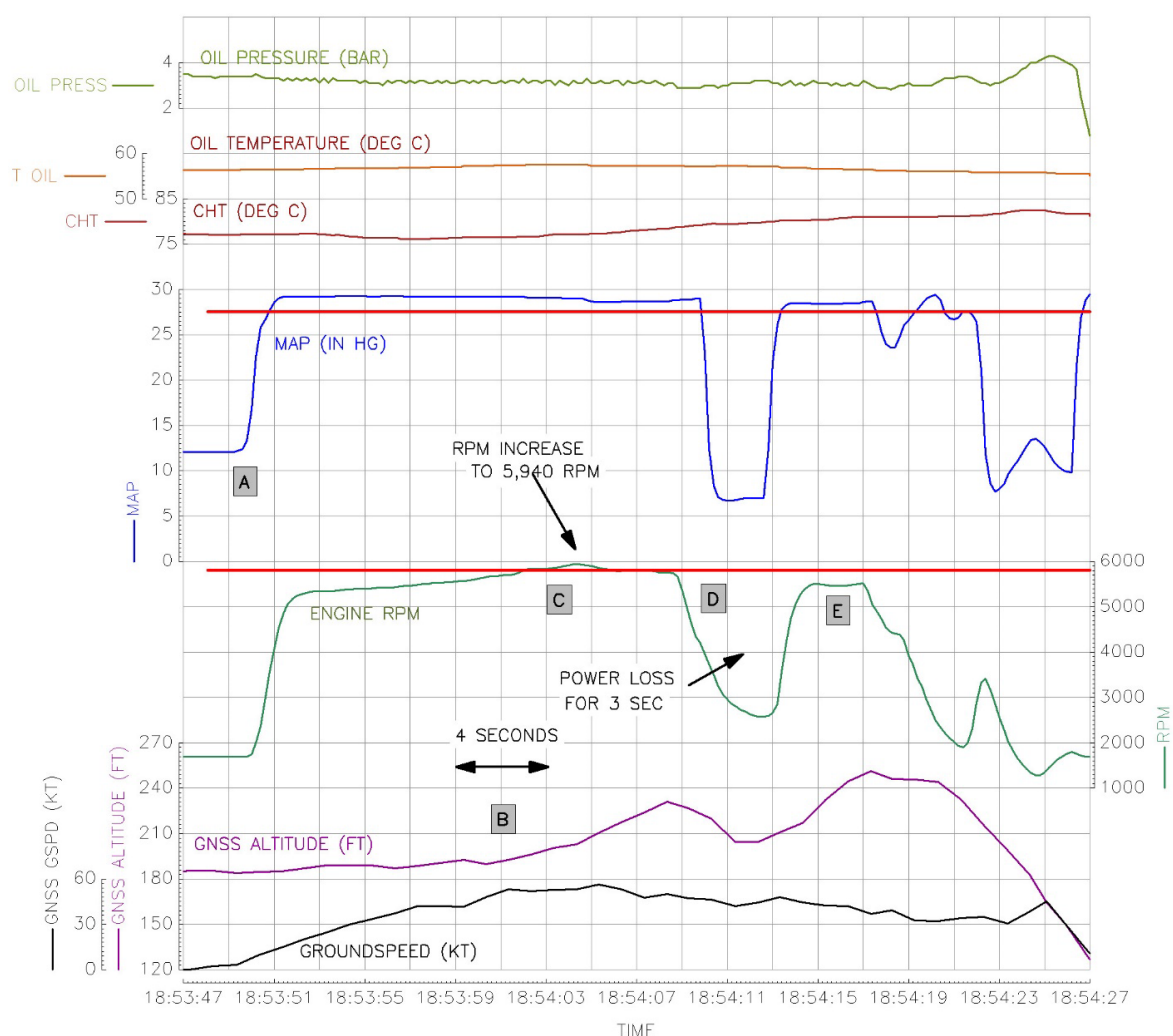
At 1853:48 hrs, the takeoff commenced with a recorded increase in engine rpm and MAP with oil temperature, pressure and CHT all within normal operating limits (Point A, Figure 3).

**Figure 3**  
G-SSTL flight and engine data

The MAP rose to approximately 29 InHg, above the alarm threshold of 27.5 InHg for the engine display. The aircraft accelerated to a groundspeed of approximately 53 kt and started to climb (Point B). At the same time, the engine rpm increased and then exceeded the upper warning limit of 5,800 rpm (Point C). Maximum recorded rpm was 5,940 rpm after which a rapid decrease in engine rpm and MAP was recorded (Point D). This lasted for three seconds before power was restored for a further four seconds (Point E). After this point, there was a reduction in engine power with reducing / fluctuating rpm and MAP. The aircraft descended and hit the ground at approximately 1854:27 hrs.
