# Rail Accident Investigation: Interim Report

Collision between passenger trains near Talerddig, Powys 21 October 2024

> Report IR1/2025 April 2025

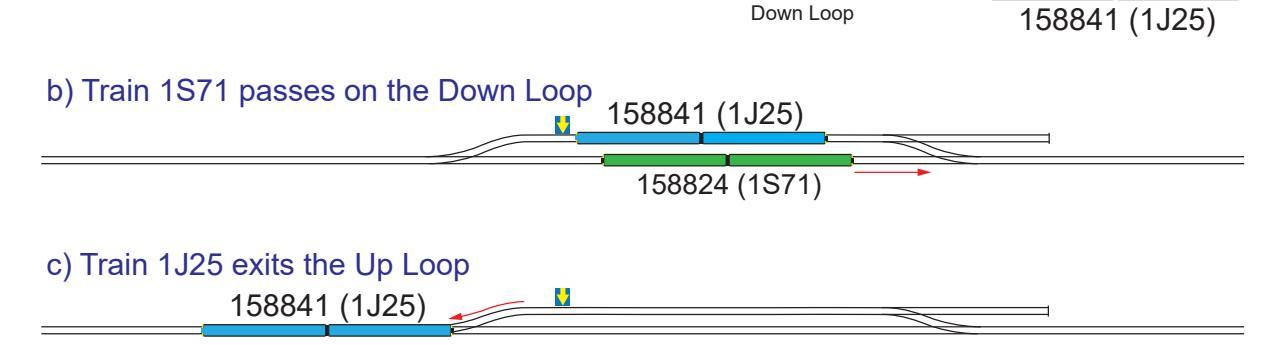
- 40 The signaller's intended operation of the passing loop at Talerddig on this occasion can be summarised in three steps (figure 6):
  - a. Westbound train 1J25 would arrive first, be signalled into the Up Loop and stop at block marker MH1078.

Figure 6: The intended sequence of events at Talerddig passing loop (not to scale).

41 The signaller chose this sequence of operations so that the eastbound train (1S71), which was climbing the steeper gradient on the approach to the loop, would pass through the Down Loop, which has a higher permissible speed than the Up Loop.
